ABBREVIATED HISTORICAL STRUCTURE REPORT ON THE LUCAS MANSION
IN HIDDENITE, NORTH CAROLINA

A Thesis
by
LEAH EILEEN SIMMERMAN

May 2017
Department of Sustainable Technology & the Built Environment

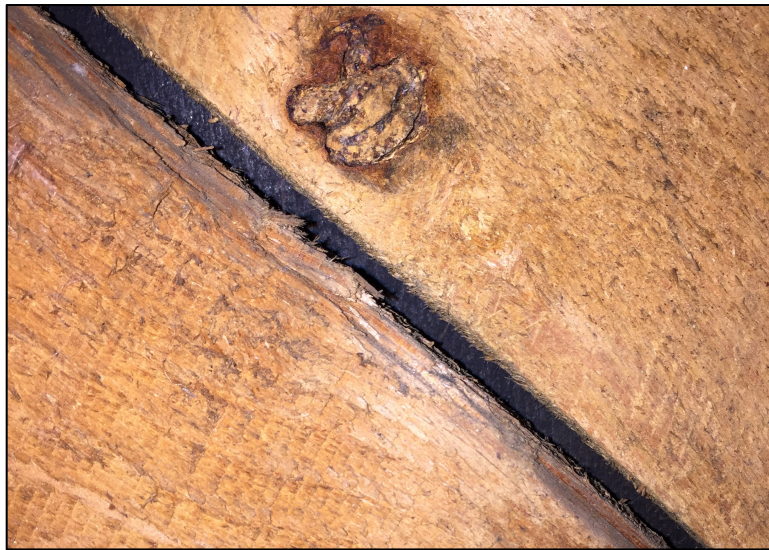
Figure 8. Thin layer of black paper-like material found between siding and sheathing.¹¹

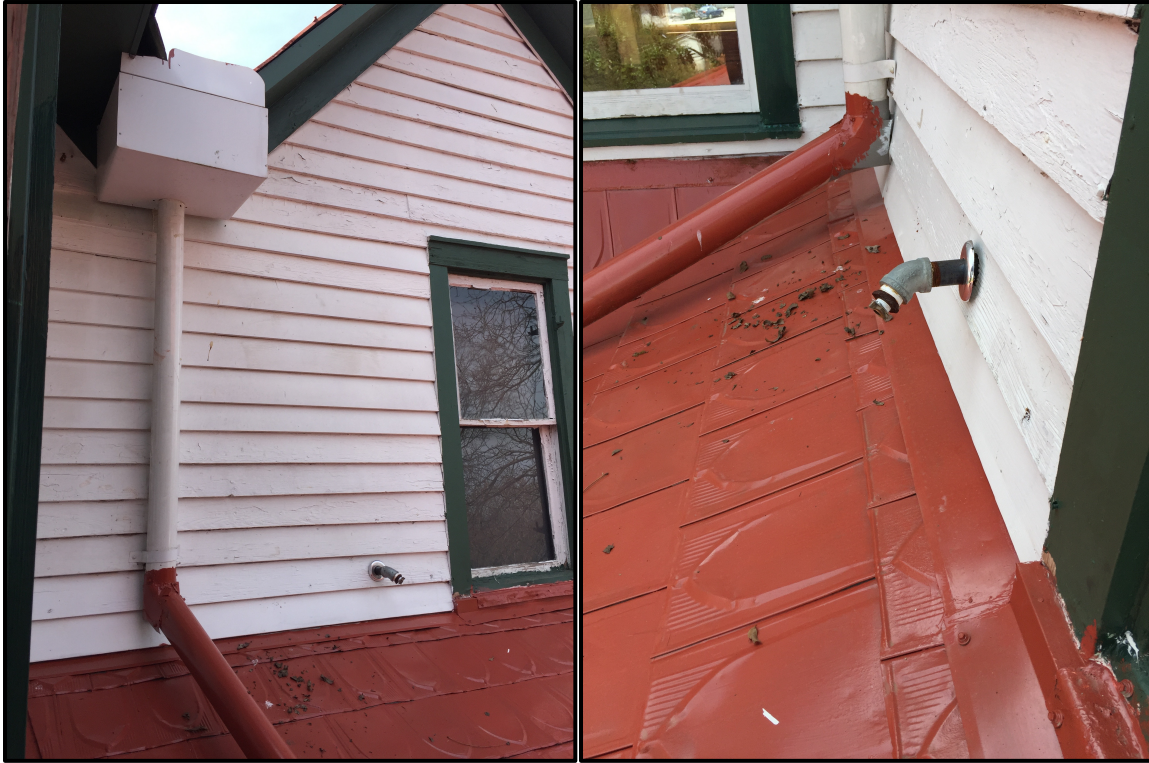
rotten porch posts, railings, ceiling panels, a few porch boards and some trim pieces were replaced on the west side of the building (Houchins, 2013, October). Replaced pieces in this area are already exhibiting considerable rot.

Figure 19. Repair done to second floor roof above copy room (room 209).

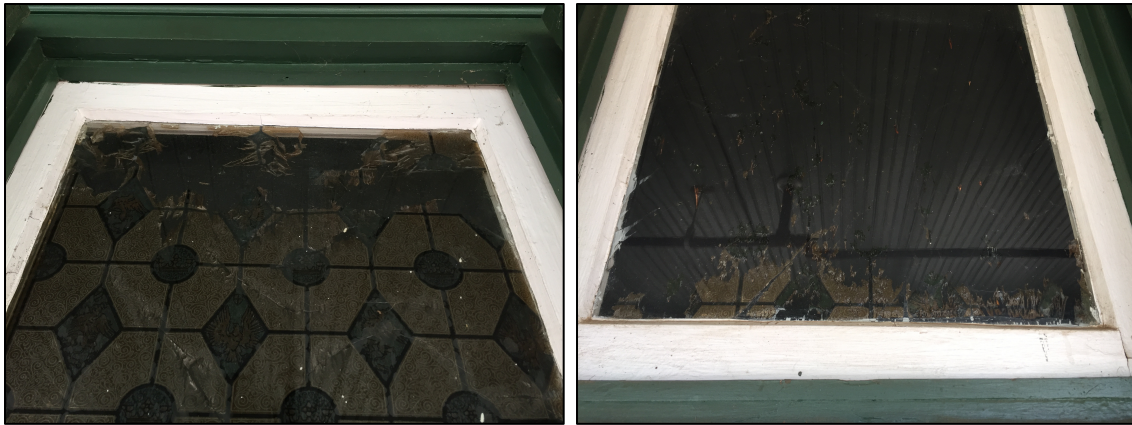
windows on the west wall of one of the smaller gallery rooms (room 216) have a decorative film on them that has deteriorated and is peeling off (Figure 24). It is unclear if this film is original but, based on its current condition, it is unlikely it can be salvaged. Removing the interior sheathing in room 217 exposed the interior side of three casement windows. Each of these windows is painted shut. Both windows had two hinges on one side and a simple bolt latch on the opposite side. The hardware was also painted over.

Figure 24. Windows on the west wall room 216 that have a decorative film that has deteriorated.

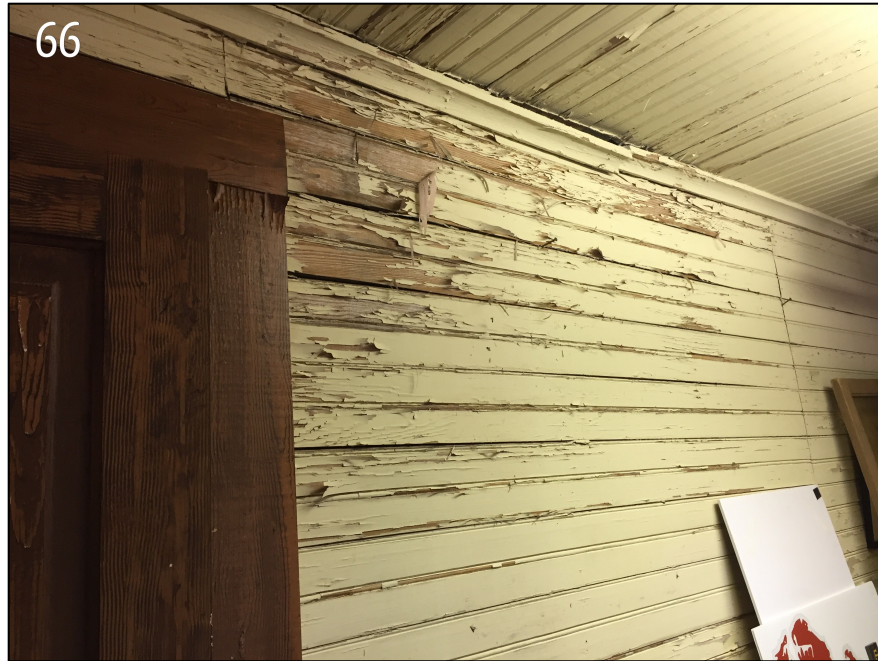
The remainder of notable moisture problems found on this floor are under or adjacent to the second floor porch roof. The first example of this is the damage in the corner of room 217, which has peeling paint and warped wood. The staff at the Hiddenite Center have noticed that this area becomes wet to the touch when they have storms with driving wind from the west.

Figure 29. Moisture damage in room 219, instance 66.

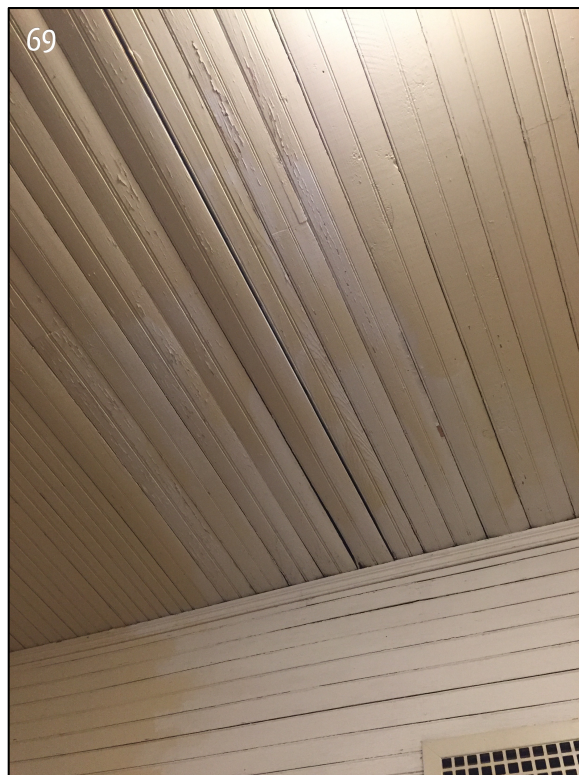
Just outside of room 219 moisture damage on the ceiling of the stair hall (room 218) appears to be radiating out from the exterior wall, which is below the porch roof's connection to the wall (Figure 30). This area is adjacent to the area on the west porch with a large roof leak; water could be wicking in from this location. The leak in the porch roof pours water during heavy rains, and significant damage can be seen on the ceiling of the porch. This is also a section of roof that regularly experiences gutter overflow.

Figure 30. Moisture damage on the ceiling of room 219, instance 69.

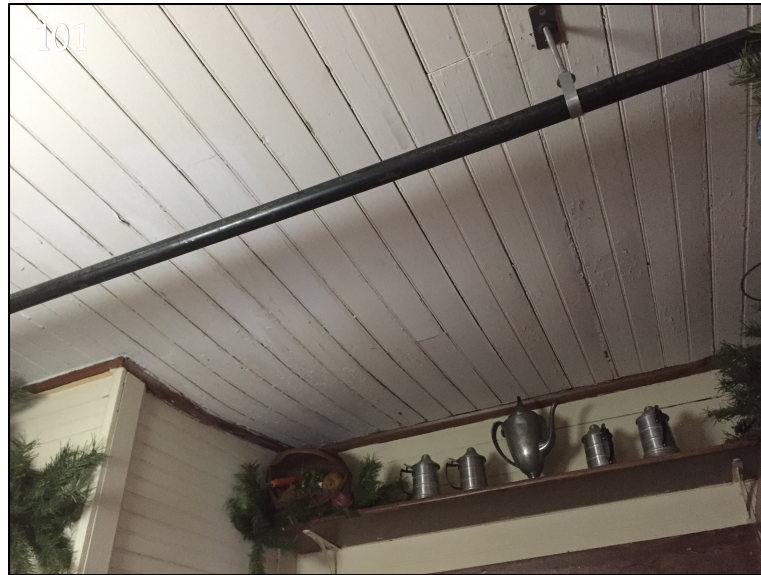
not been addressed. The substantial damage on the ceiling of the bedroom and the ceiling and walls of the bathroom came from the sprinkler malfunctions in the main gallery room directly above. The 1985 sprinkler leak was primarily concentrated in the historic parlor (room 113). They had to remove a large section of the ceiling in this room to repair the broken pipe, then the same boards were put back up. These areas have looked the same for years (A. Houchins, personal communications, March 27, 2017).

Figure 32. Sag in the ceiling of the historic kitchen (room 111) that continues to progress; instance 101.

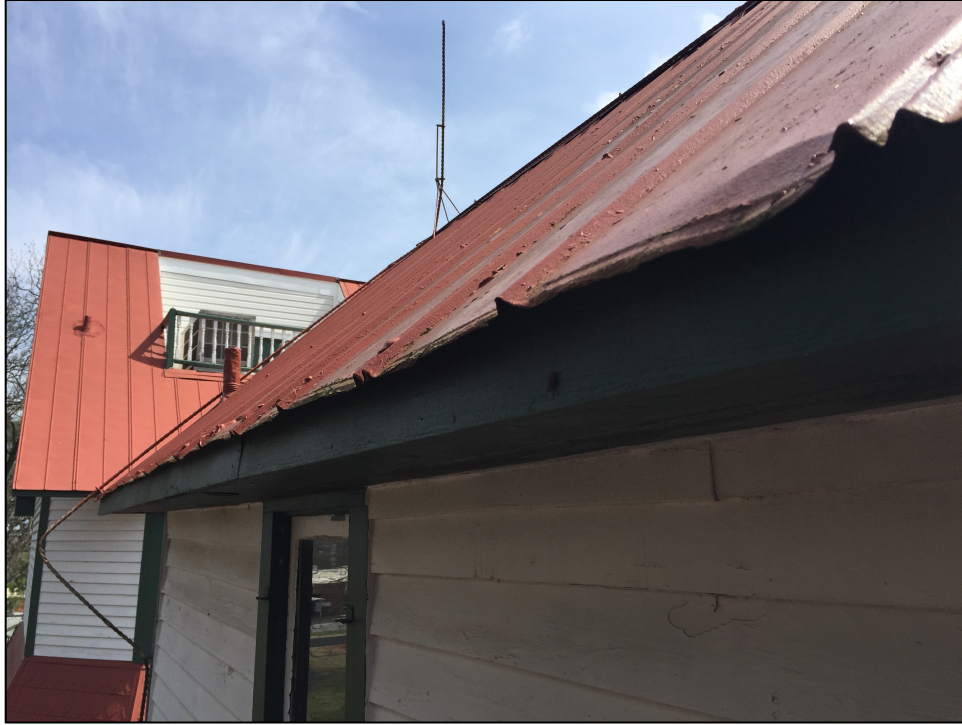
Figure 33. The upper roof has no gutter or drip edge.

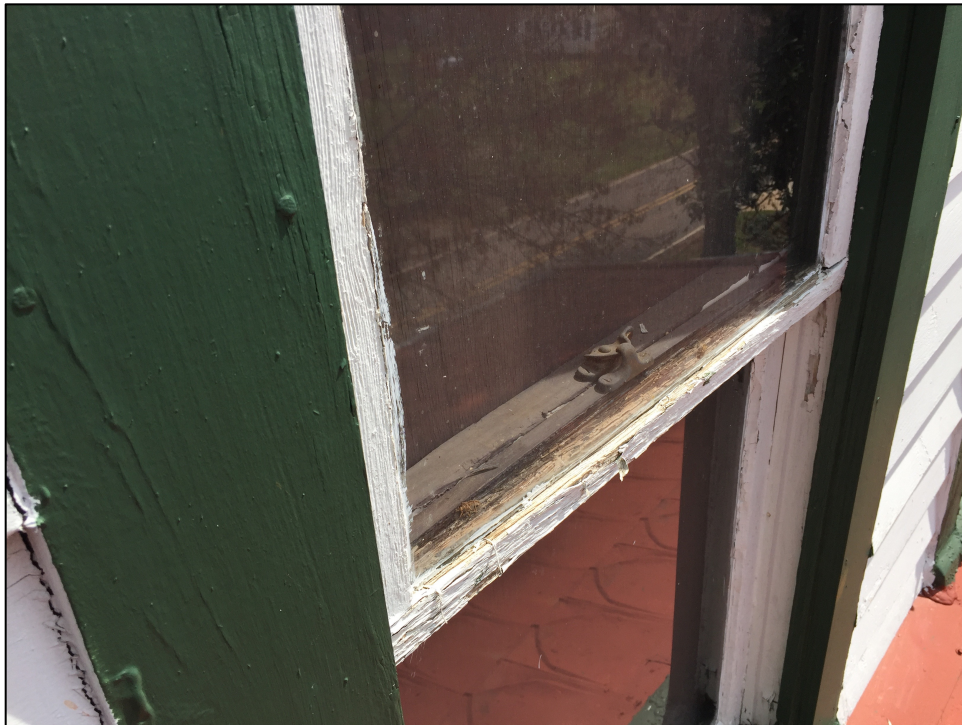
Figure 34. Third floor window with considerable moisture damage.

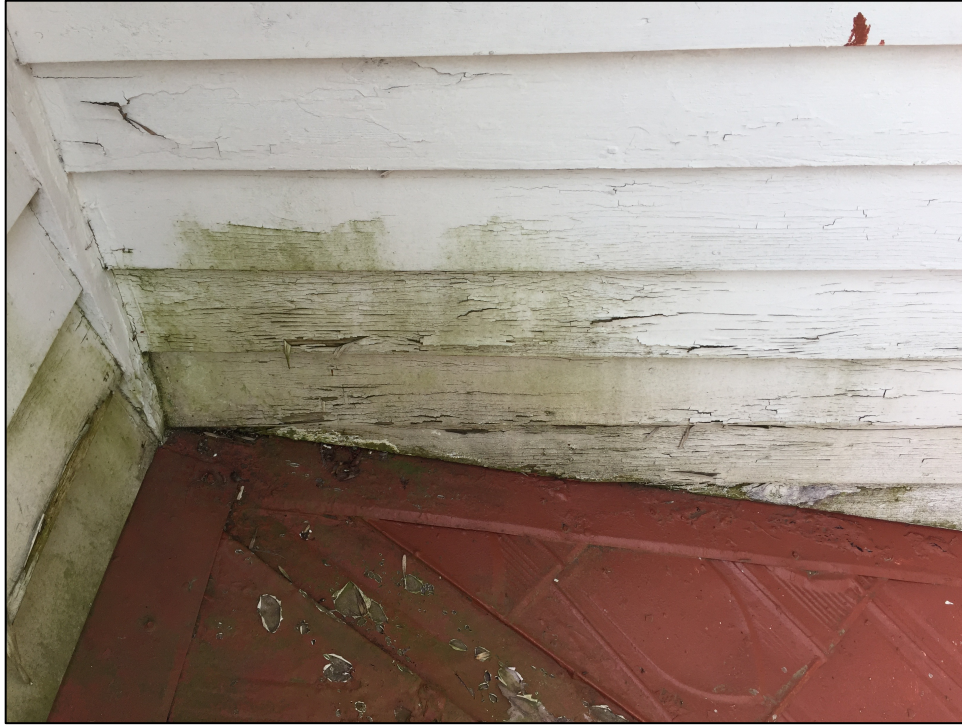
Figure 35. Moisture damage on the lower siding boards above the second floor roof.

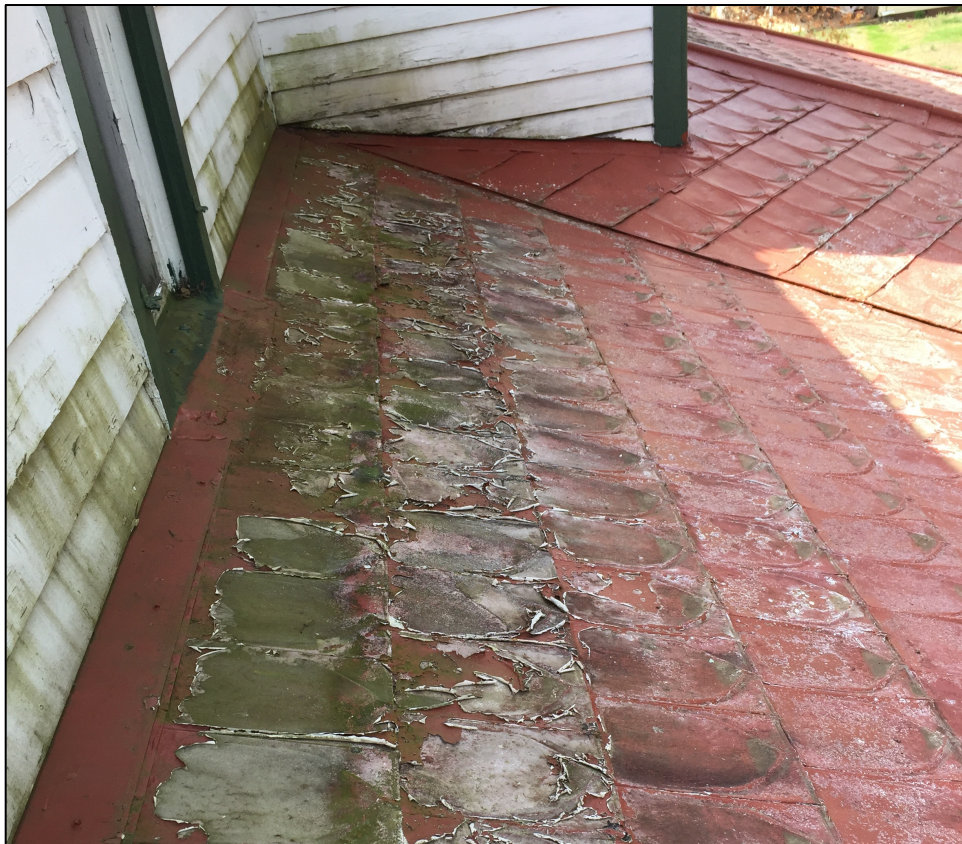
Figure 36. Peeling paint and moisture damaged siding on the second floor roof.

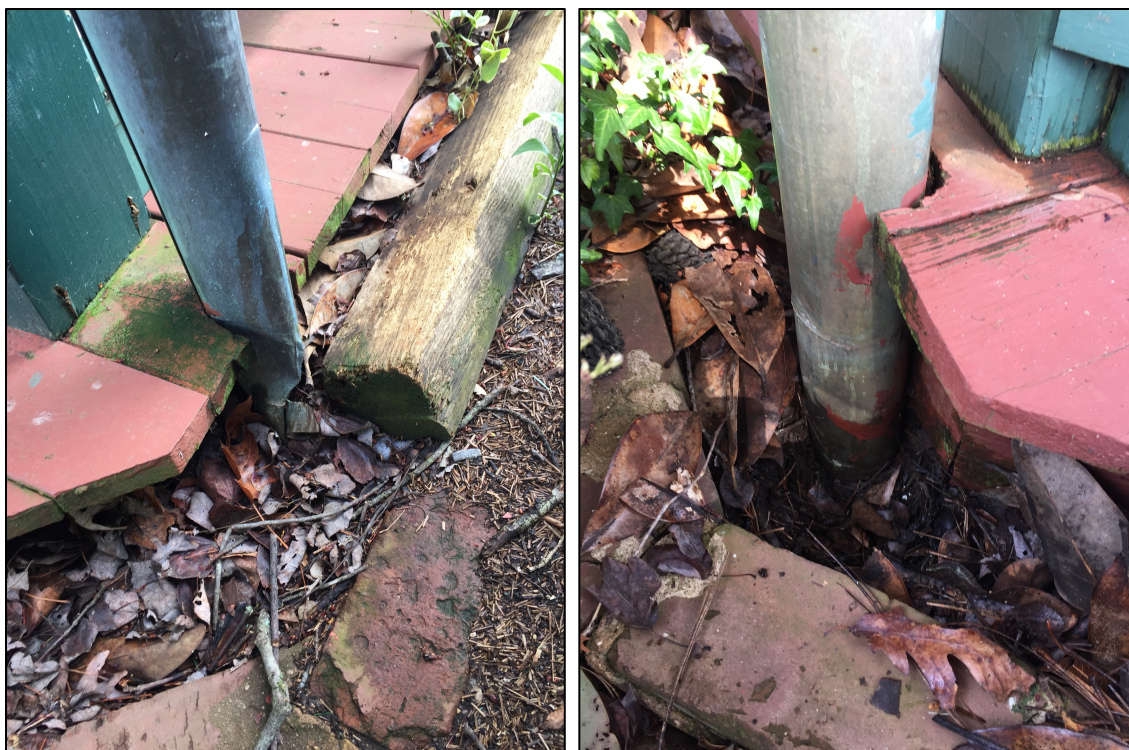
Figure 37. Compromised downspouts on the west side of the building.

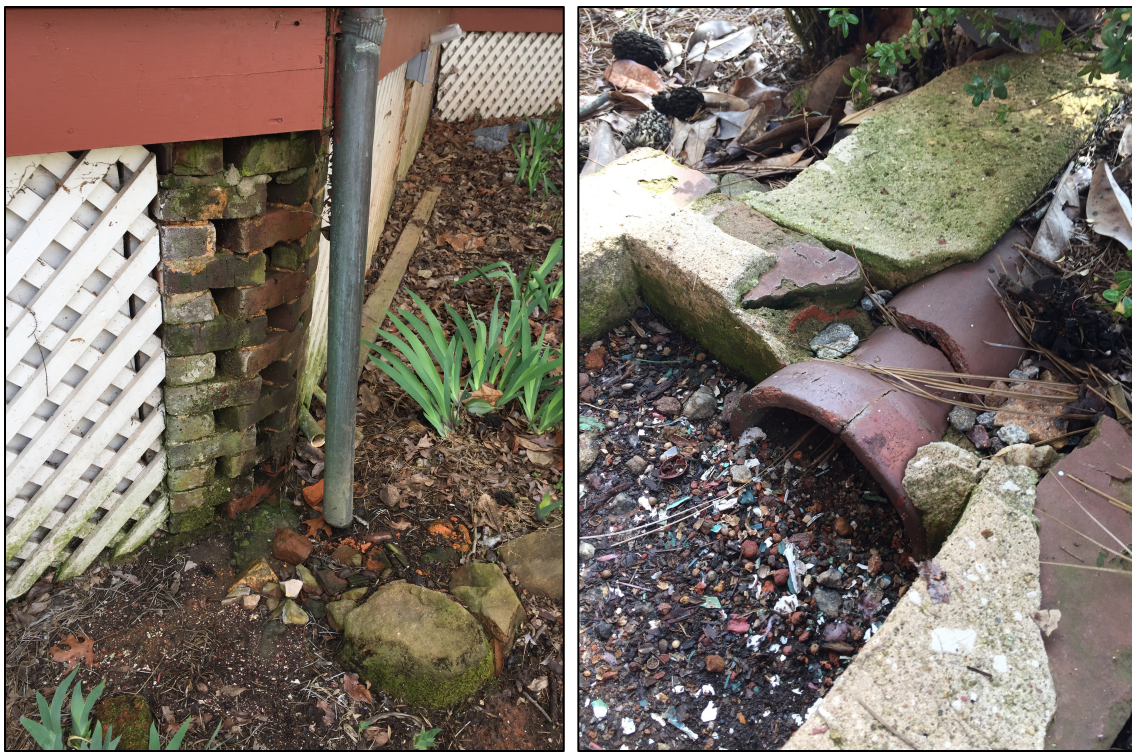
Figure 38. Compromised water drainage from down spouts.

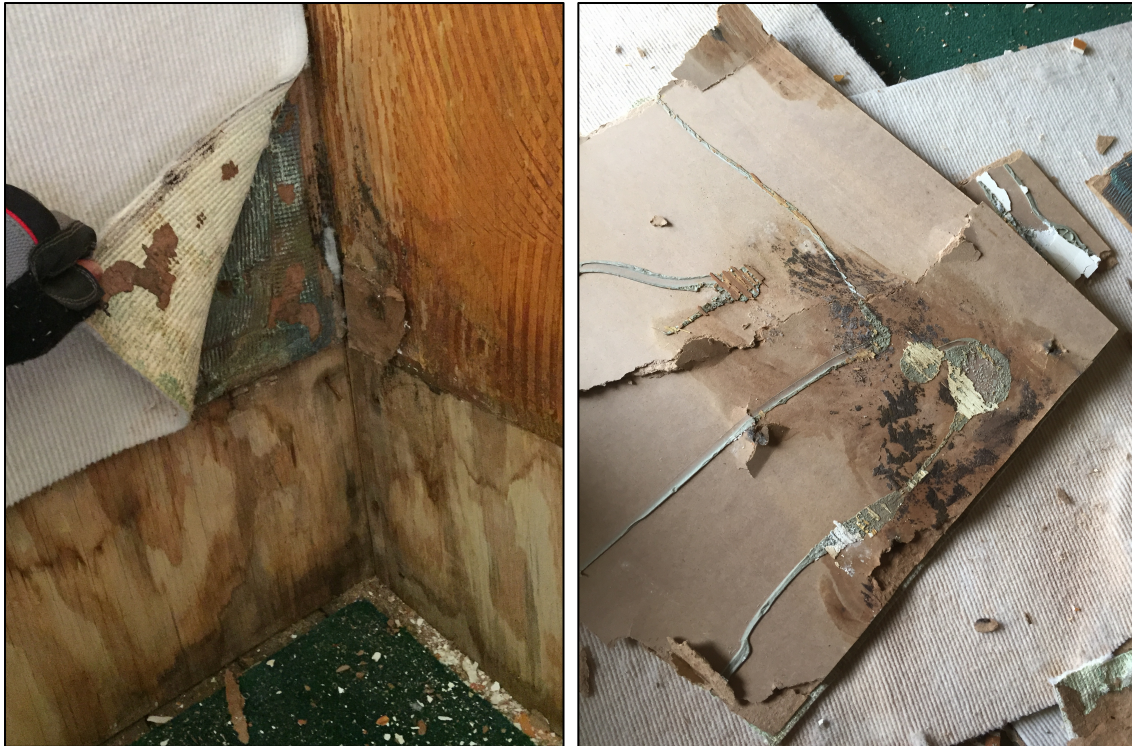
Figure 41. Molding and water stained material from northwest corner of room 217
