DAYLIGHTING AND OCCUPANT DENSITY: AN INDOOR ENVIRONMENTAL
QUALITY ANALYSIS OF APPALACHIAN STATE UNIVERSITY CLASSROOMS

A Thesis
by
SARAH MORGAN HOOPER

Submitted to the Graduate School
Appalachian State University
in partial fulfillment of the requirements for the degree of
MASTER OF SCIENCE

August 2017
Department of Sustainable Technology & the Built Environment

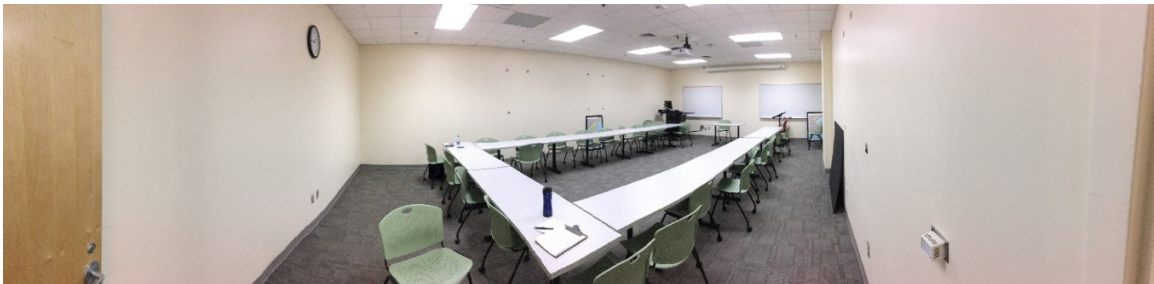
Figure 2: Panorama from main entrance of Room 251 in Anne Belk Hall.

Finishes. The room had a dark, multicolored carpet that was clean and well-maintained. The walls were gypsum wall board painted off-white, with a few scuffs marks, and overall in good condition. The ceiling consisted of 2 foot by 2 foot white ACT with few moisture stains.

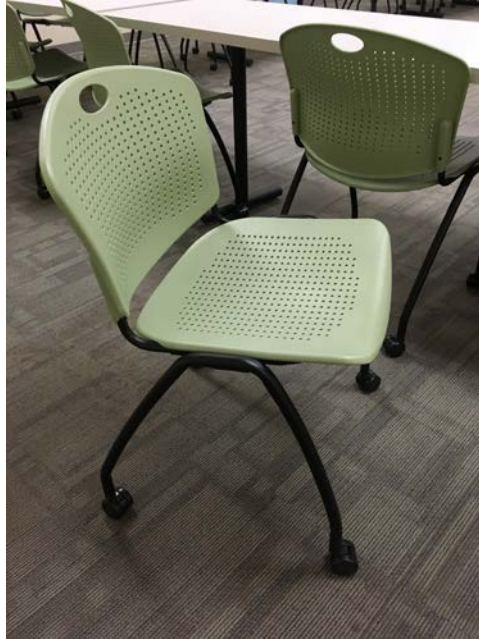
Figure 3: Chairs in Anne Belk classroom.

The desks were long and narrow, measuring approximately 18 inches wide by 6 feet long. They had metal legs and laminated tops and were in very good condition. The chairs were mostly plastic with metal hardware (Figure 3). The seat and back were pale green and the legs were black. The chairs were sleek and modern and all were in very good condition.

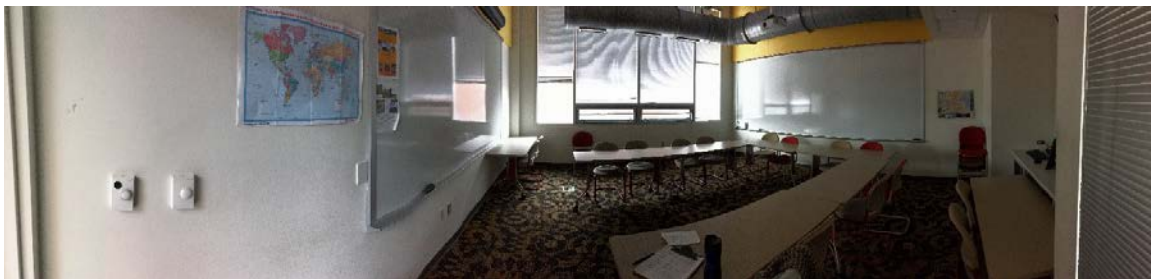
Figure 5: Panorama image from main entrance of Room 161 in Appalachian Hall.

Finishes. The floor finish was a modern multicolored carpet with abstract designs in dark browns, greys, and tans. The carpet was in excellent condition with no visible stains, rips, or snags. The walls were gypsum wall board, the bottom half being white, and the upper half a bright yellow. The walls also had no obvious impurities. The ceiling finishes varied, with concrete, white ACT, and gypsum wall board panels, all of which were in pristine condition.

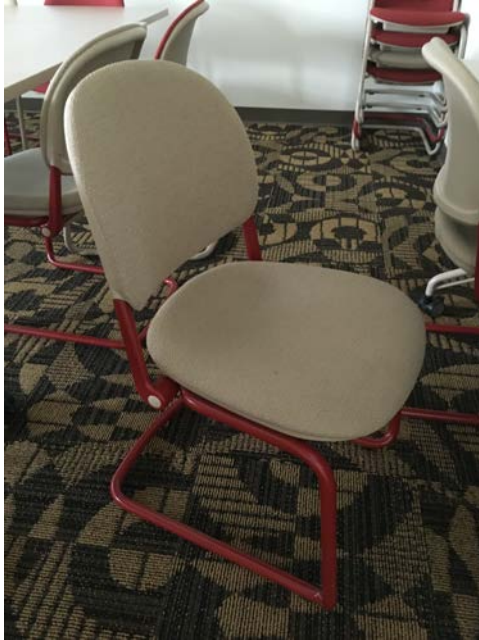
Figure 6: Chairs in Appalachian Hall classroom.

The classroom contained six long tables with fold-up metal legs and laminate tops. The tables measured 2 feet wide by 6 feet long and all were in excellent condition. The seating in the room consisted of more modern desk chairs (Figure 6), with tan upholstery and red metal frame and legs. All of the seats were in excellent condition, with no signs of stains or damage.

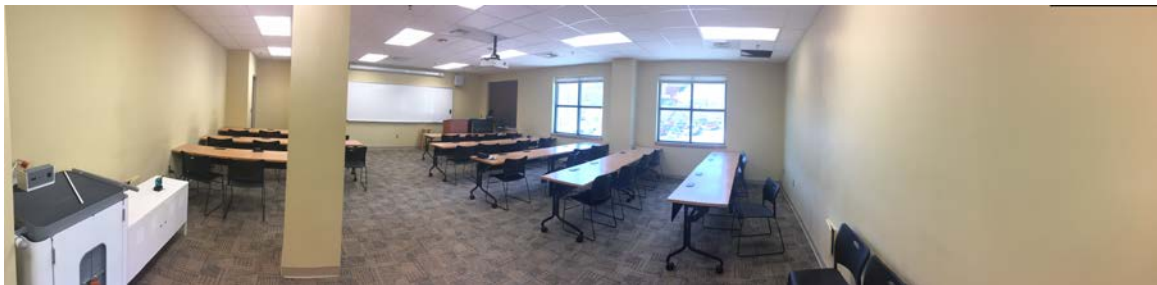
Figure 8: Panorama image from main entrance of Room 224 in the Beasley Media Complex building.

Observational Features. Another very new classroom on campus, Beasley Media Complex room 224 was in very good condition. With south facing windows, new furniture, and three brightness settings for the lights, the room embodied “new” without sacrificing typical

classroom design. Everything appeared to be in excellent working condition. The room is situated on the second level of the complex, with three interior and one exterior, south-facing wall.

Finishes. The carpet was a modern print carpet of tans and browns in excellent condition with no visible stains, rips, or tears. The walls were a pale yellow-tan painted gypsum wall board and were also in excellent condition. The ceiling was white ACT with no visible signs of moisture damage, missing panels, or rips.

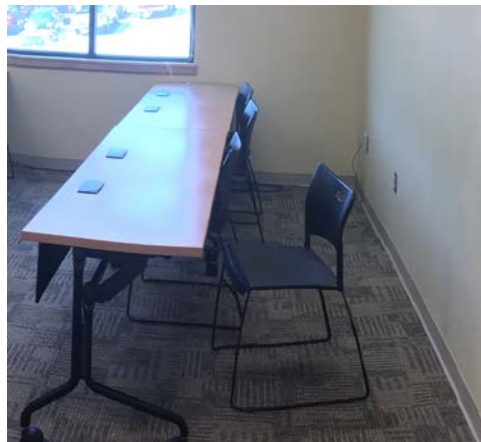
Figure 9: Chairs in Beasley Media Complex classroom.

The desks in the room were a standard metal frame and wood laminate top, with fold-up legs. All were in excellent condition with no peeling laminate. The chairs had a black metal frame and black plastic seat and back (Figure 9). All of the chairs were of the same style and color and all were in excellent condition.

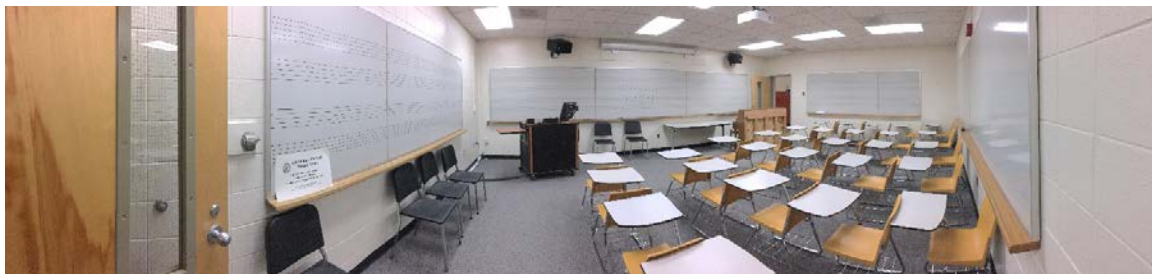
Figure 11: Panorama image from main entrance of Room 206 in the Broyhill Music Center building.

Observational features. This classroom falls into the average classroom design typology as observed by this study. With no windows, grey carpet, and white walls and ceiling, it would be impossible to guess the location and use of the room if it weren't for the white boards on every wall with music scales drawn in permanent marker. Located nearly in the center of the

building, on the second floor, all four walls are interior. Overall, the room was in good condition, with some visible wear on finishes and furniture.

Finishes. The floor covering in the room was a dark multi-toned carpet and was in fair condition. There were several visible stains at the time of observation. The walls were standard CMU block painted off-white. Whiteboards wrap the entire perimeter of the room, covering almost as much area as the CMU. There were several scuff marks, but no evidence of major wear that could harm or distract occupants. The ceiling was white ACT, with a couple visible moisture stains, but no tears or additional damage.

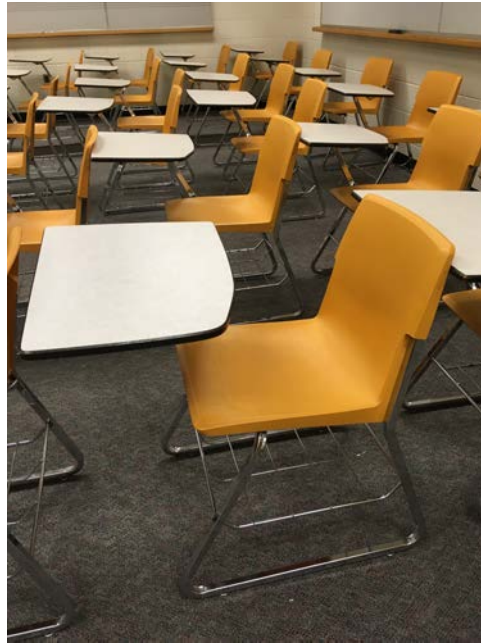
Figure 12: Seating in the Broyhill Music Center classroom.

Seating and occupant density. The seating in the room consisted of chair-desk combination pieces as seen in Figure 12. The frames were metal, the seats were yellow plastic, and the desk was a laminated composite material with an off-white top (see Figure 12). All of the seats appeared to be in good condition, with little to no visible wear.

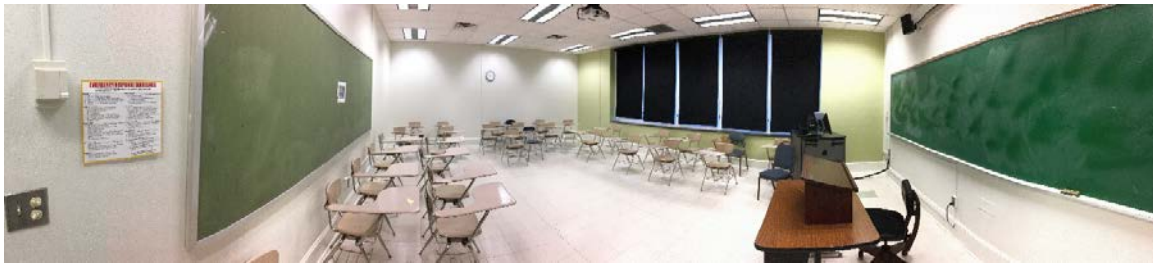
Figure 14: Panorama image from main entrance of Room 111 in Chapell Wilson Hall.

Observational features. Aside from a pop of color and new lighting fixtures, this room was standard overall. All finishes and furniture appeared to be in good condition, with few to no signs of degradation. The room was located on the ground floor of the building, with three interior walls and one exterior, south-facing wall.

Finishes. The floors were finished with white speckle 1 foot by 1 foot VCT, with a pale green accent pattern near the entrance. The floors were in good condition, with little to no stains or rips. The three interior walls were white gypsum wall board, while the exterior wall was gypsum wall board painted a faint yellowish-green. All walls were in very good condition, with no visible wear. The ceiling was white ACT, also in very good condition, with no visible moisture stains or wear.

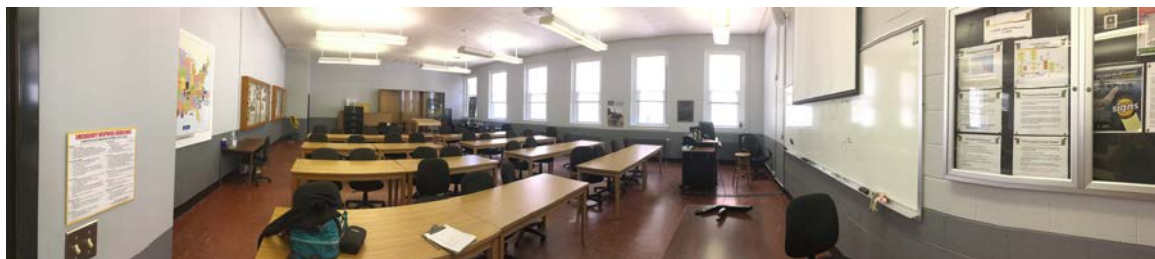
Figure 17: Panorama shot from main entrance of Room 237 in D.D. Dougherty.

Observational Features. Although it is located in one of the oldest buildings on campus, this classroom was in overall great condition. Located on the second level of D.D. Dougherty, the classroom has three interior walls and one exterior wall on the north side of the building. The room is the largest observed in the study, with the largest allowable area per occupancy.

Finishes. The floors of the room were finished with 1 foot by 1 foot VCT tile that was brown-red in color. There were no missing or broken pieces visible to the researcher. Two walls were gypsum wall board and two were painted CMU blocks. All four walls were painted two-toned with a dark grey from the finish floor to about 2 feet 8 inches in height, with a lighter shade of grey the rest of the way up the ceiling. All walls were in great condition, with little to no scuffs or wear. The ceiling was finished with 1 foot by 1 foot ACT with penetrations for air transfer between the sub ceiling and the room. The tiles were in good condition, with some raised due to pressure differentials between the outdoors, hallway, and room.

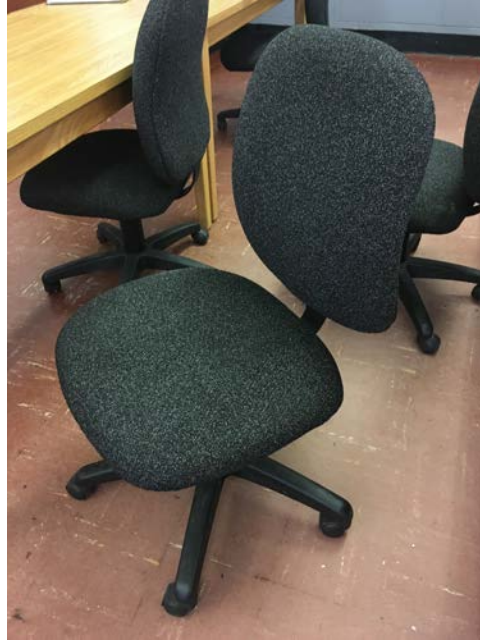
Figure 18: Chairs in the D.D. Dougherty classroom.

tables as desk spaces, which were simple and wooden. Both the tables and chairs were in very good condition, with little to no visible surface wear or damage. The chairs had more cushion than any other observed in the study and seemed fairly new.

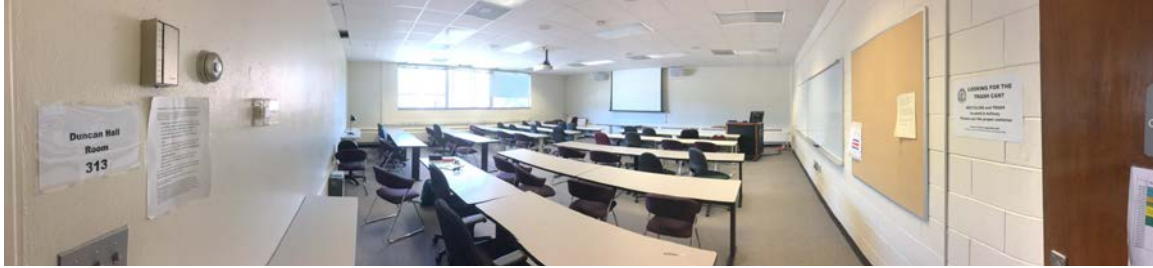
Figure 20: Panorama image from main entrance of Room 313 in Edwin Duncan Hall.

Observational Features. Another standard classroom, Edwin Duncan 313 is in fair to good condition overall, and has few defining features. Located on the third floor of the building, the room has two exterior and two interior walls. Although it is a corner room, only the western wall has windows. Used primarily by the Department of Sustainable Technology and the Built Environment, the room is nearly always booked for classes.

Finishes. The ceiling of the room consisted of white ACT, most of which were in fair to good condition. At least three moisture stains were visible at the time of the study, as well as ceiling tiles with small rips or tears. The floor had a dark blue-grey carpet finish in fair condition. There were visible stains and a dirt path in heavy traffic areas. Three walls were painted CMU

block, while one had a plaster finish. All walls were white, with few scuff marks and in overall good condition.

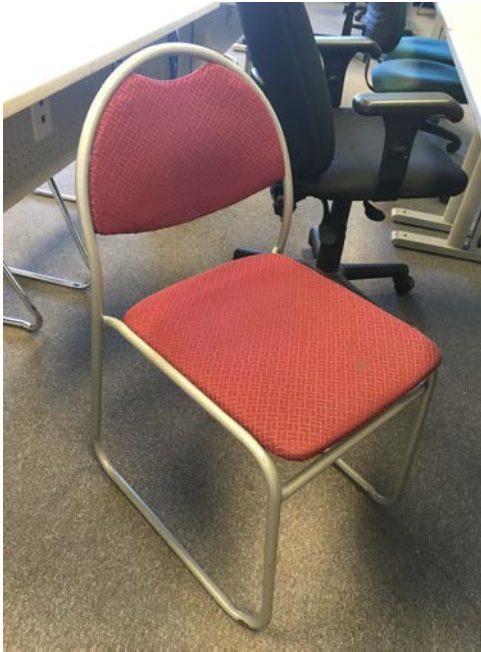
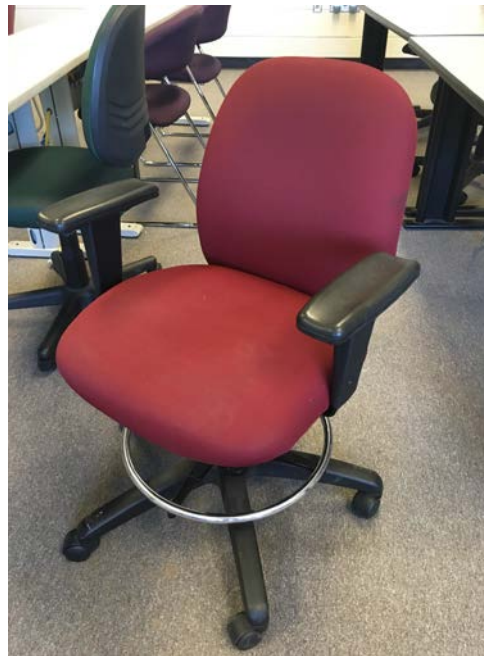
Figures 21 and 22: Chair types in Edwin Duncan classroom.

Interestingly, the room contained five different styles of chairs out of the 40 total. Two were most common, although the other three styles occurred at least twice. See Figures 21 through 26 for examples of each style. Most seats were in good condition, and were of the standard cushioned office chair variety. Some, such as the office chair seen in Figure 23 had stains of unknown origin or malfunctioning parts. The tables had black metal frames and white laminated tops and all were of the same style. All of the tables were in good condition, with little to no visible wear.

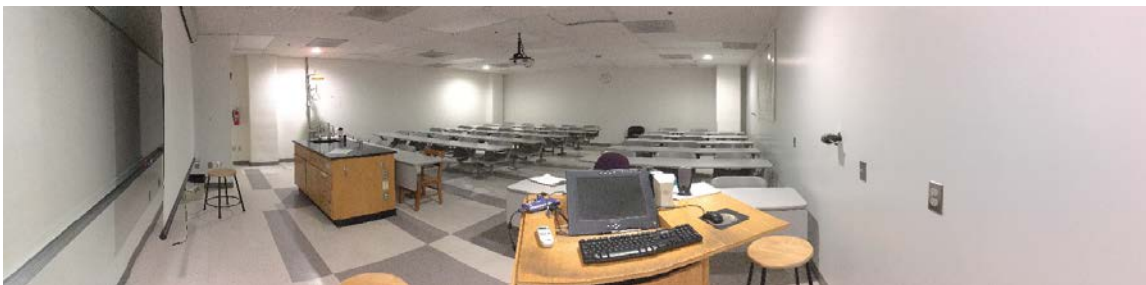
Figure 27: Panorama image from main entrance of Room 337 in Garwood Hall.

Observational Features. This room is located on the third floor of Garwood Hall and serves as a lecture space for the Department of Chemistry. In fair to good condition overall, the room had many signs of wear on both furniture and finishes. The room is on the south side of

Finishes. The ceiling consisted of white ACT in fair condition. There were two tiles that were ripped in half, but still in place, and visible moisture stains. The floor had both grey and white VCT in a checkered and line pattern. All tiles were in good condition with little to no signs of wear. The walls were finished with white painted gypsum wall board and were in great condition.

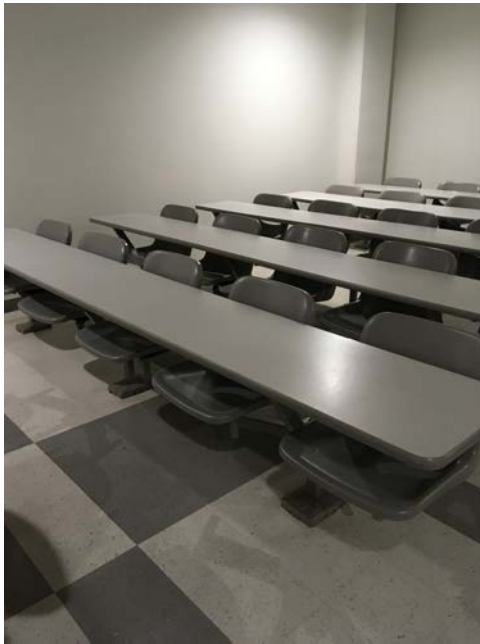
Figure 28: Seating in Garwood Hall classroom.

As previously mentioned, the seating consisted of semi-permanent desk-chair combinations that mount to the floor of the room. The seats pivot on an arm so that they can be accessed. The seats were plastic, and the desks were plastic and laminate finish with a steel frame to support the weight of both the occupants and the desks.

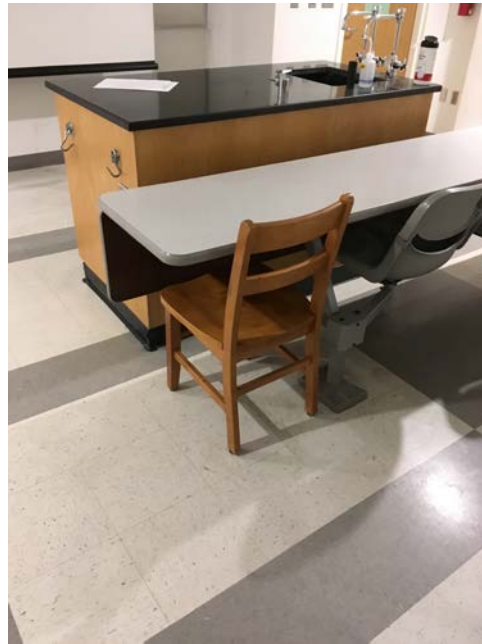
Figure 29: Wooden chair replacement in Garwood Hall classroom.

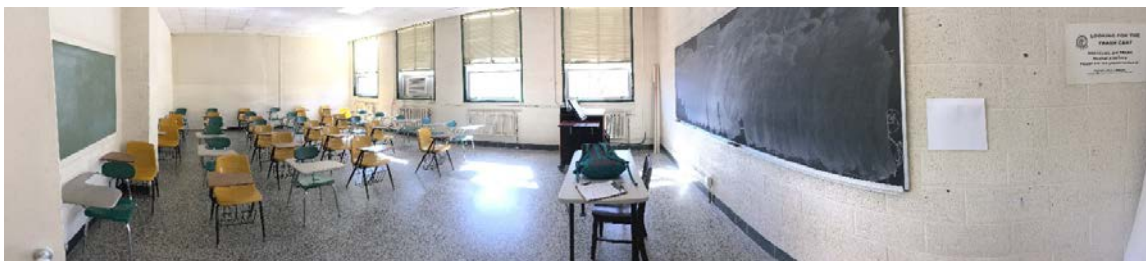
Figure 31: Panorama shot from main entrance of Room 219 in I.G. Greer.

Observational Features. Located on the southern side of the building with a lot of windows, this room was in overall good condition. With outdated furniture and finishes, the room could use updates if it had not been located in a building that is scheduled for demolition in the campus master plan. The room has three interior walls and one exterior wall located on the south wall of I.G. Greer and serves as a lecture space for the Department of Philosophy and Religion.

Finishes. The ceiling was finished with white 2 feet by 2 feet ACT, most of which very clean and in good condition with little to no signs of moisture damage or tears. All four walls were CMU that had been painted off-white and were overall in good condition, with the exception of the west wall being very dirty with scuffs and stains. The floor was graveled epoxy with white, grey, and black flecks. The floor was in very good condition with no visible signs of wear.

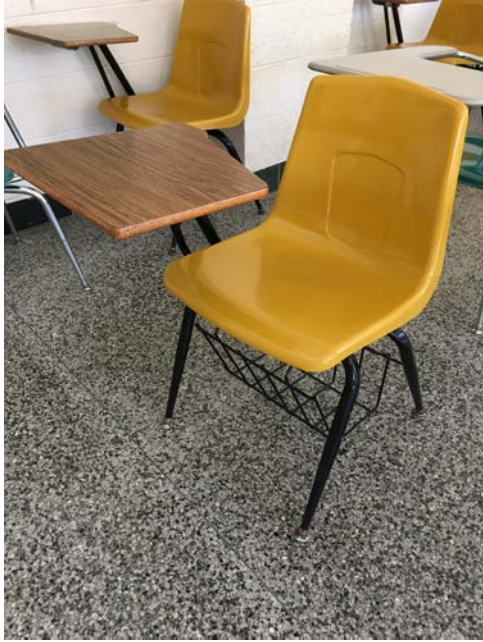
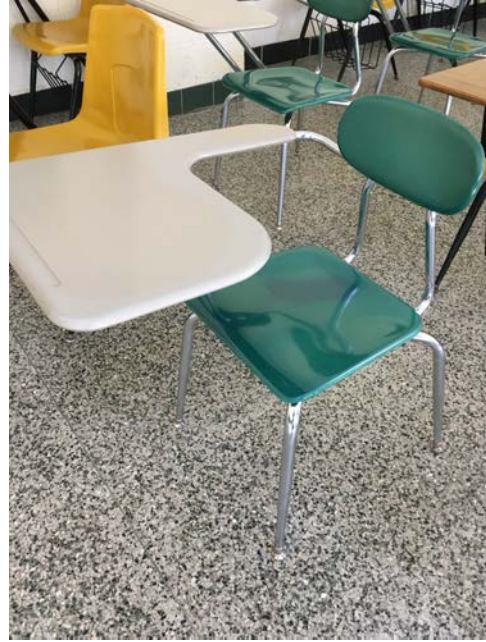
Figures 32 and 33: Seating types in I.G. Greer classroom.

The seating in the room consisted of two desk-chair combination types. One was that seen in Figure 32, with a yellow plastic seat, black metal frame, and wooden laminate desktop. The other was the style seen in Figure 33, with a green hard plastic chair, metal frame, and grey plastic composite desk. There were approximately half of each type, and all of which were in very good condition with little to no signs of wear.

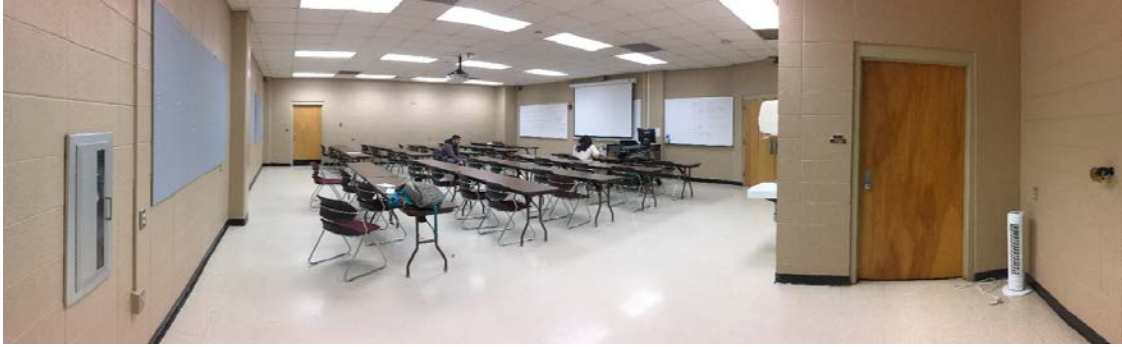
Figure 35: Panorama image from main entrance of Room 11 in Katherine Harper Hall.

Observational Features. Katherine Harper Room 11 was one of the more generic classrooms observed in this study. It seems to fit within the same group of older classrooms that are outdated in design and furniture, as well as technological advances such as access to daylight, occupant temperature control, and smart lighting systems. The lighting was harsh, but this is very common for commercial spaces such as classrooms and offices. Overall, the room was clean and well maintained. There were a few scuffs and scratches on the walls, but nothing that could harm or significantly distract occupants. The room is interior and sits on the lower level of the building.

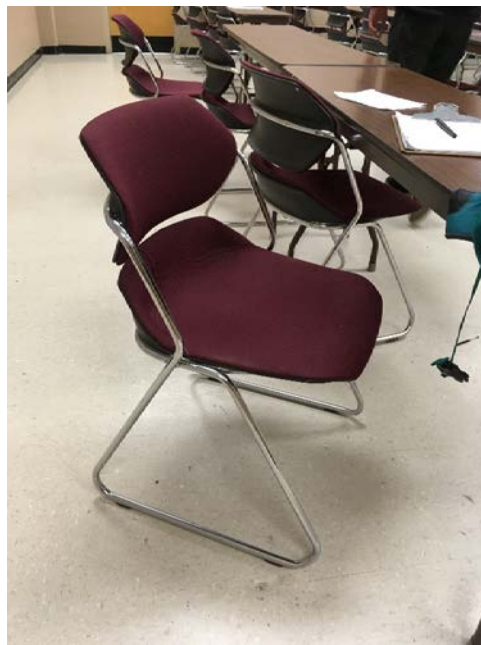
Figure 36: Seating in Katherine Harper Hall Room 11.

The seating consisted of long (18 inch by 4 feet) wood laminate tables with brown metal legs. The standard tables were in good condition and were a few years old. The modern ergonomic chairs had a metal frame and cushioned seat, with a sleek design (see Figure 36). Overall, the seating allows for great adaptability to the conditions in the classroom and can be moved around easily.

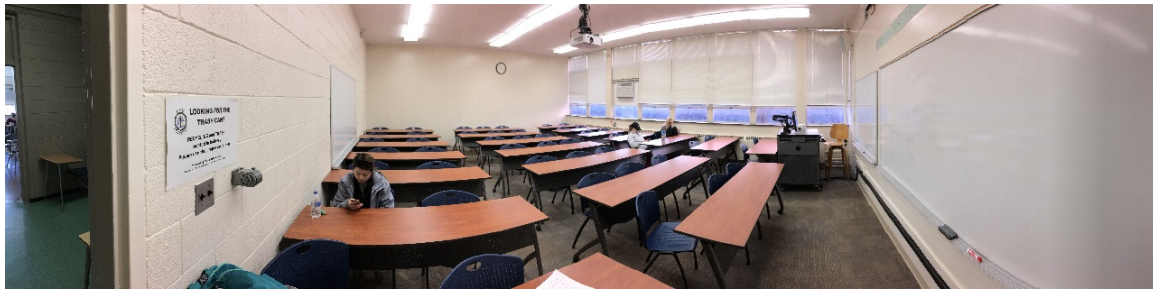
Figure 38: Panorama image from main entrance of Room 105 in L.S. Dougherty.

Observational Features. Although it fits into the “standard’ classroom typology as defined by the findings in this study, this classroom was in great condition overall. The furniture was new and modern, the lighting fixtures have been replaced, and the finishes were clean and

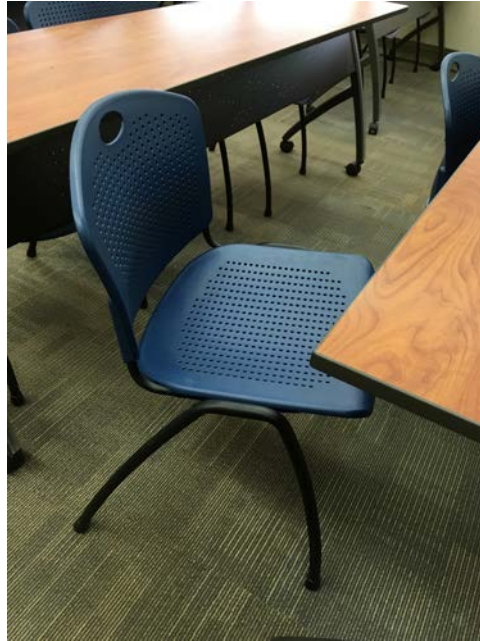
Figure 39: Seating in L.S. Dougherty classroom.

Both the desks and chairs in the classroom at the time of the study were new and in excellent condition. The desks were long and narrow, measuring approximately 2 feet wide by 8 feet long. The frames were black metal and the tops were wood laminate. The seats, as shown in Figure 39, were blue hard plastic with a metal black frame and an ergonomic design.

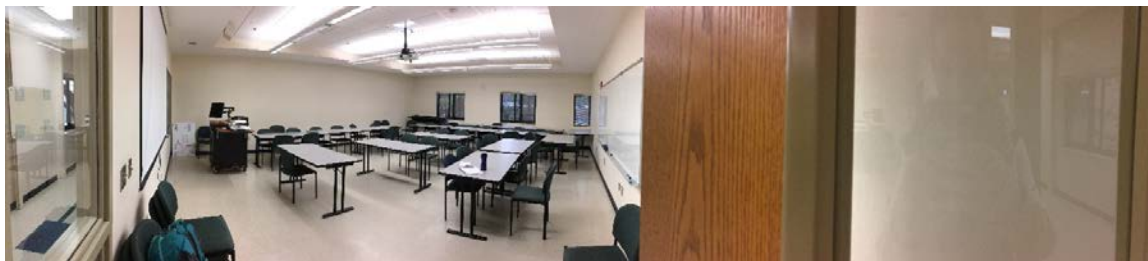
Figure 41: Panorama image from main entrance of Room 223 in the LLA

Observational Features. Another classroom that can fit into the “standard” classroom typology as defined by the results of this study, Room 223 in the Living Learning Academic Center was overall in good condition with simple furniture and finishes. Located on the second

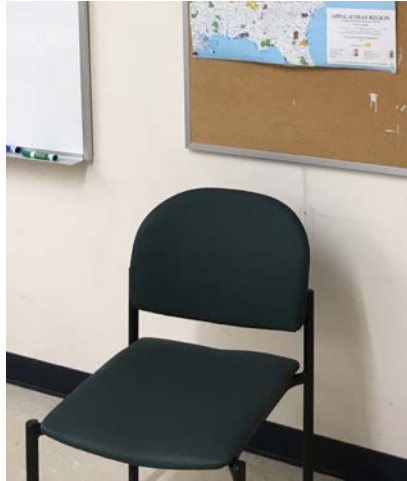
Figure 42: Chair type in L.L.A. classroom.

All of the seats in the room at the time of the study were the same design as the one shown in Figure 42, with dark green cushion and upholstery and a black metal frame. All seats appeared to be in very good condition, with little to no signs of wear. The desks were long and narrow with a black metal frame and white laminate top, and overall in very good condition.

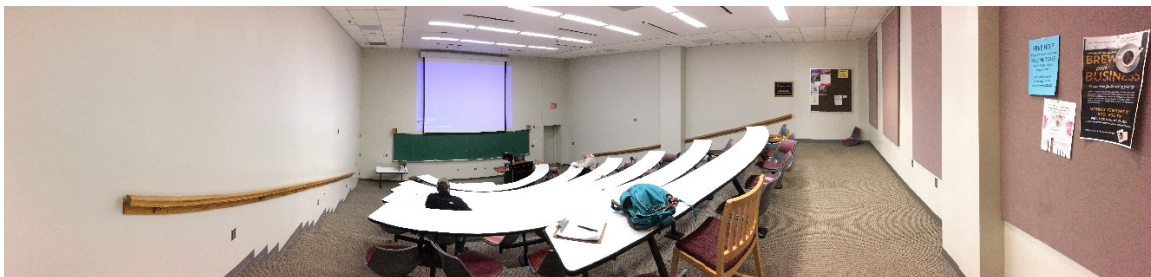
Figure 44: Panorama image from main entrance of Room 1018 in Peacock Hall.

Observational Features. Located on the first floor in the interior of Peacock Hall and with no exterior walls, Room 1018 was in overall good condition at the time of observation. The room serves as a lecture space for the Department of Management.

Layout and configuration of room. The room measures 39 feet long by 28 feet wide, with the longitudinal axis running perpendicular to the seating rows, as seen in Figure 44. The ceiling height varies due to the sloped floor, but has a minimum of 9 feet along the back wall of

Finishes. The ceiling consisted of both ACT and gypsum wall board painted white. The ACT was in good condition, with some stains and moisture damage, while the gypsum wall board was clean and well maintained. All four walls were white painted gypsum wall board, in very good condition. The floor was finished with a multicolored brown carpet, which was in very good condition with little to no signs of wear.

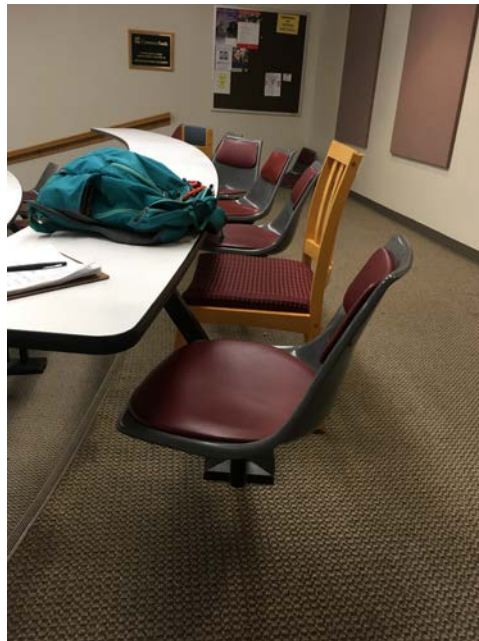
Figure 45: Seating types in Peacock Hall classroom.

The seating in the room was comprised of desk chair combinations similar to those found in Garwood Hall. The chairs were attached to the desks and swing outward to be accessible to occupants. The desks and chairs were constructed of steel and grey plastic, with red leather upholstery as shown in Figure 45. Most were in very good condition, but there were two missing chairs in the back row, which had been replaced with cushioned wooden desk chairs.

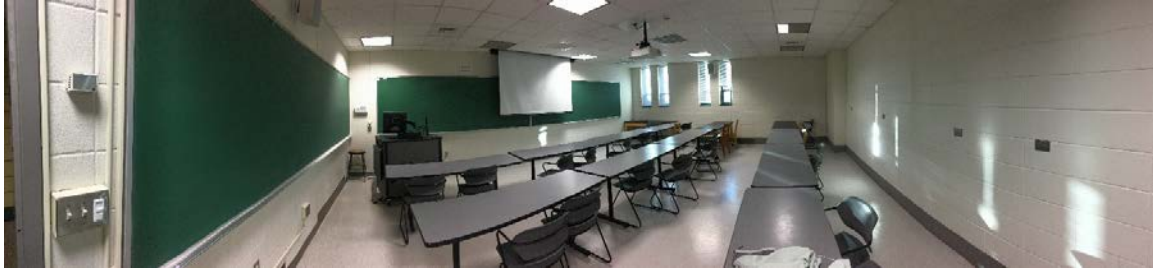
Figure 47: Panorama image from main entrance of Room 157 in Rankin.

Observational Features. Located on the second floor on the southeastern side of Rankin West, this classroom was overall in very good condition at the time of observation. It is used primarily as a lecture space for the Biology Department.

Finishes. The ceiling in the room was white ACT in very good condition with little to no signs of moisture damage or wear. The floor was 1 foot by 1 foot white VCT, also in very good condition with little to no signs of damage or wear. The walls were all white CMU block with a light grey trim. Aside from scuffs here and there, the walls were also in very good condition.

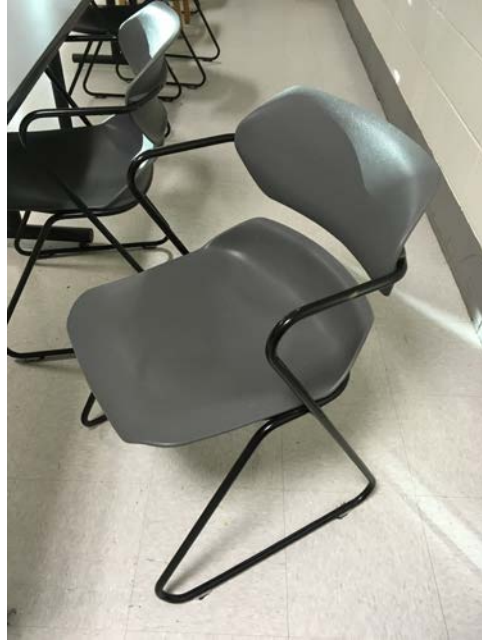
Figure 48: Seating type in Rankin Hall West classroom.

The seats in the room were grey plastic with a black frame and in very good condition with little to no signs of wear. The desks were standard length with black metal frames and a grey laminate top, also in very good condition.

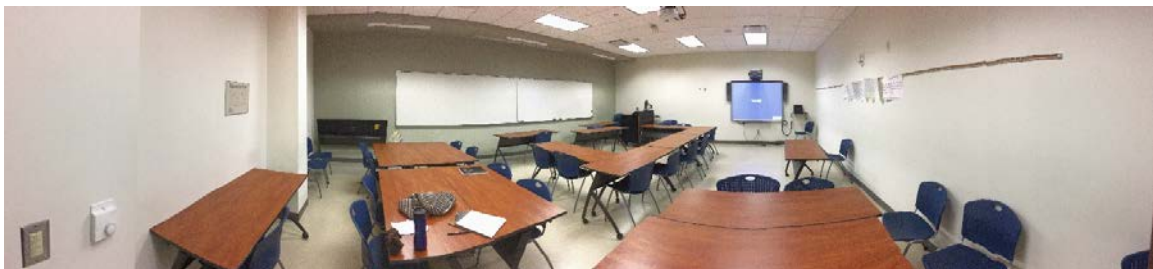
Figure 50: Panorama image from main entrance of Room 237 in the Reich College of Education.

Layout and configuration of room. The room measures 24 feet wide by 31 feet long, with the longitudinal axis running parallel to the camera view in Figure 50. These dimensions

The desks were arranged in somewhat of a U shape, with several small grouped tables and a presumed orientation toward the wall with the white boards. This is unique in that with the current configuration, nearly all seated occupants could view two walls as well as be in groups for discussion.

Finishes. The floor was an off-white epoxy resin over concrete in very good condition. The walls of the room were gypsum wall board, three of which being white and one accent wall being painted a grey-green. The walls had visible scuffs, but were overall in good quality. The ceiling was white ACT with no visible signs of damage or moisture.

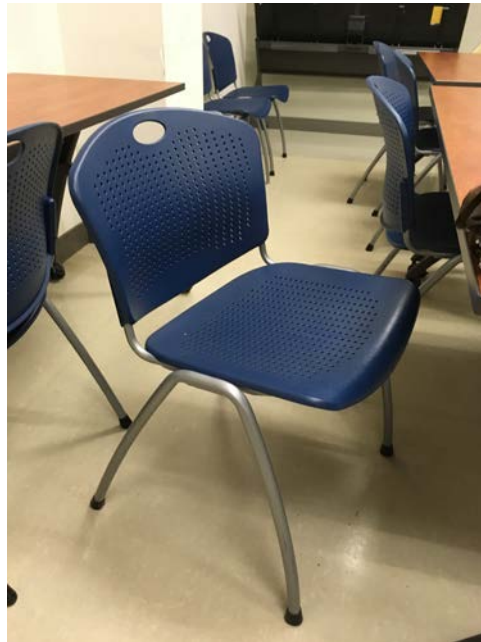
Figure 51: Seating type in Reich College of Education classroom.

Seating and occupant density. The capacity of the room is listed as 36, while the researcher counted only 26 seats at the time of observation. With the listed capacity and measured room area, each occupant would have 20 square feet per occupant, but with the

current configuration each occupant would have 28 square feet of space. This measured value is a positive difference of 43.48%, much more than the recommended space.

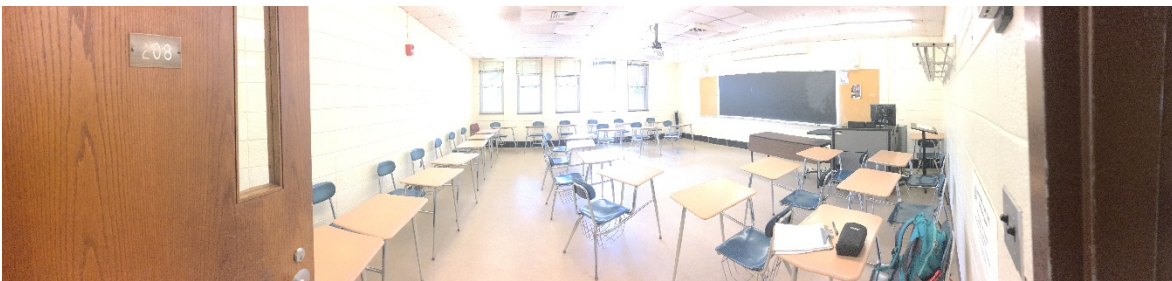
Figure 53: Panorama image from main entrance of Room 208 in Sanford Hall.

Observational Features. Located on the second floor of Sanford Hall, this classroom has three interior walls and one south-facing exterior wall. The room was overall in good condition, with some finishes in need of repair or replacement.

Finishes. The ceilings of the classroom were white ACT in poor to fair condition, with sagging sections, moisture stains, and some with extensive damage. The floors were 1 foot by 1 foot VCT, with grey and multicolored specks, overall in very good condition with no peeling sections or signs of wear. The walls were all CMU painted an off-white with grey trim and overall in good conditions. Scuffmarks were present, but no extensive damage or wear.

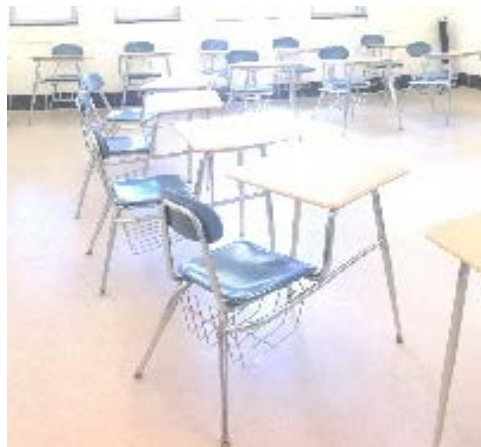
Figure 54: *Seating type and arrangement in Sanford Hall classroom.*

The seating consisted of standard desk-chair combination pieces, all of which were constructed of a metal frame and a light brown plastic composite desktop with a blue plastic seat

(see Figure 54). All pieces of furniture appeared to be in very good condition, with little to no signs of wear.

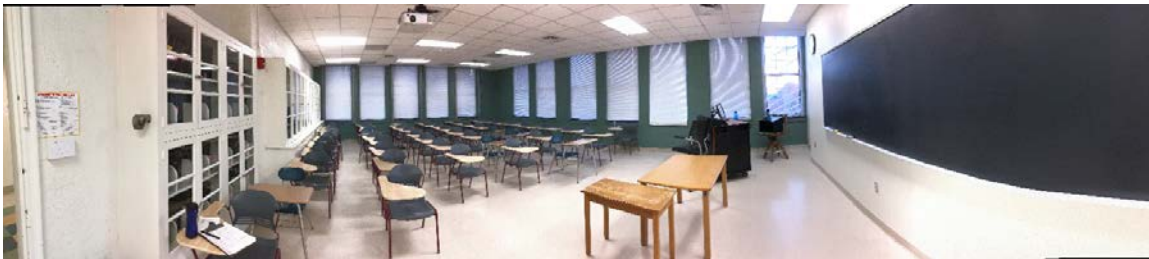
Figure 56: Panorama shot from main entrance of Room 200 in Smith-Wright Hall.

Observational Features. Located on the second floor of Smith-Wright Hall, room 200 was bright and open primarily due to it having two exterior walls lined with large windows on the south and east sides of the classroom. The room was overall in good quality and has been well maintained since the building's renovation in 2006. It serves as a lecture space for the Department of Psychology.

Finishes. The ceiling in the room was white ACT in excellent condition with no signs of moisture or damage. The floor was light grey VCT, overall in very condition with little to no signs of wear or damage. Three of the walls were CMU block and one interior wall was gypsum wall board. The two exterior walls were painted a dark teal and the two interior walls were painted white. All walls were in very good condition with little to no signs of wear or damage.

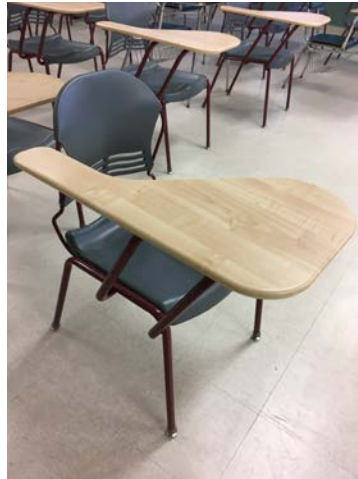
Figure 57: Seating type in Smith-Wright Hall classroom.

material. All of the seating was in excellent condition, except for one desk that had deteriorated and had student drawings on the bare wood.

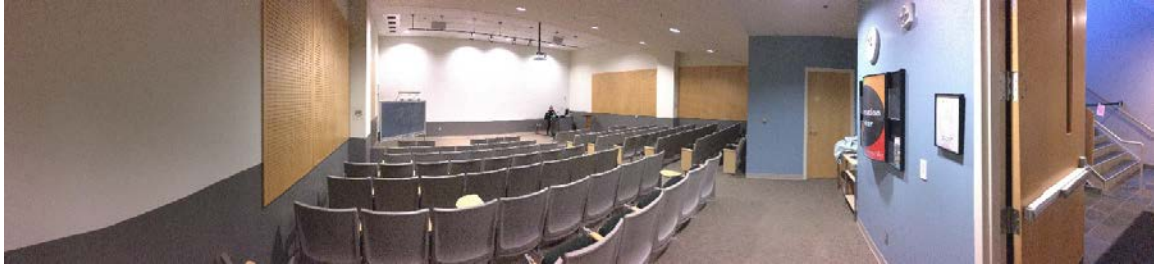
Figure 59: Panorama image from main entrance of Room 1102 in the Turchin Center.

Observational Features. Similar to a small auditorium, this classroom is the only one of its kind in the Turchin Center building. In excellent condition overall, the room is located on the lower level of the building with two exterior walls and two interior walls. It is used primarily as a lecture space for the Art Department and as a seminar space for the Turchin Center for the Visual Arts.

Layout and configuration of room. The room measures approximately 38 feet long by 35 feet wide, totaling an area of 1,330 square feet. The dimensional ratio of these measurements is 1.09, a 32.63% deviation from the golden ratio. The longitudinal axis of the room runs perpendicular to the camera angle as seen in Figure 59.

Finishes. The ceiling in the room consisted of both white ACT and white gypsum wall board, all of which were in excellent condition. The floor was multicolored grey carpet in good condition with some stains, but no visible rips or tears. The walls were gypsum wall board, three of which being light grey and one being blue. All of the walls were in excellent condition with no signs of damage or wear.

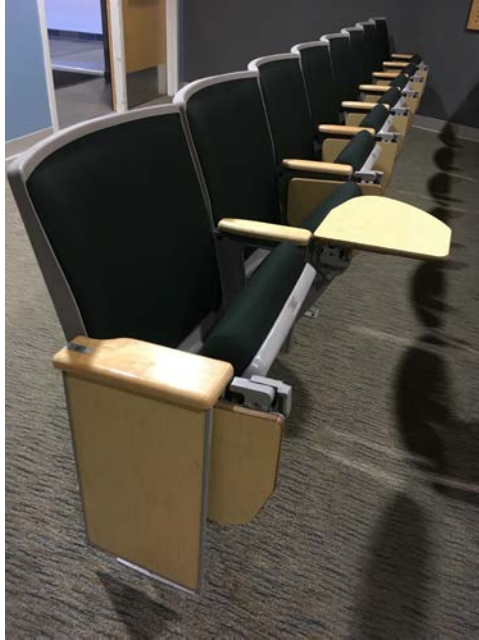
Figure 60: Seating type in Turchin Center for the Visual Arts classroom.

Seating and occupant density. The capacity of the room was listed as 80 occupants, and the researcher found the same number of seats in the classroom at the time of observation. With the measured square footage, this equates to 16 square feet of space per occupant, a negative 11.76% difference from the recommended area of 18 square feet per occupant. This could potentially be due to the room being more of an auditorium setting, where the recommended space per occupant is less than in that of a classroom.

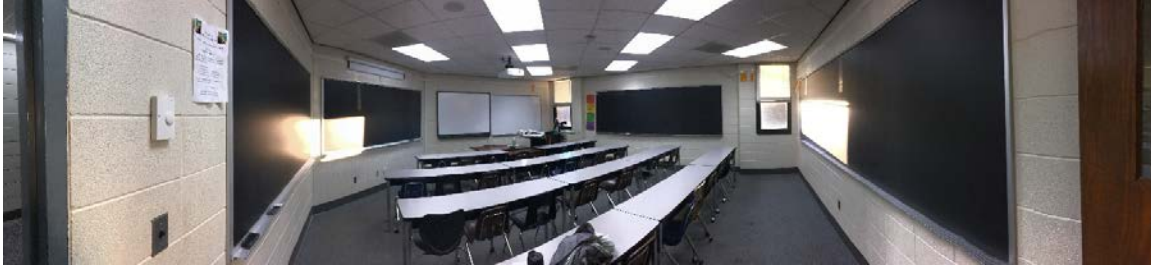
Figure 71: Panorama shot from main entrance of Room 308 in Walker Hall.

Observational Features. Room 308 in Walker Hall is located on the third floor of the building and has one exterior wall and three interior walls. The exterior wall faces southeast and allows for daylight access. The room was overall in very good condition, with standard fixtures and furniture.

Finishes. The ceiling in the room was finished with white ACT in very good condition, with little to no signs of damage or wear. The walls were painted off-white CMU block and were in good condition with a few scuffmarks. The floor was finished with a blue-grey carpet in fair condition with some stains and signs of wear.

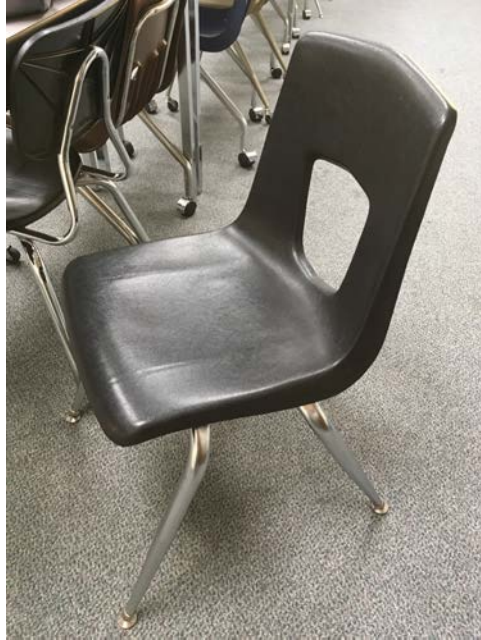
Figure 72: Seating type in Walker Hall classroom.

The seats in the room were simple with metal frames and a black plastic seat and back. The chairs were all in very good condition, with the exception of two of a different style, which appeared old and worn. The desks were a standard length metal frame and laminated top, all with no signs of wear or damage.
