TO RESTORE OR NOT TO RESTORE?
ASSESSING PRE-PROJECT CONDITIONS OF A HABITAT RESTORATION PROJECT
ON THE NEW RIVER, NORTH CAROLINA

A Thesis
by
BOBBIE JO SWINSON

Submitted to the Graduate School
at Appalachian State University
in partial fulfillment of the requirements for the degree of
MASTER OF ARTS IN GEOGRAPHY

August 2014
Department of Geography and Planning

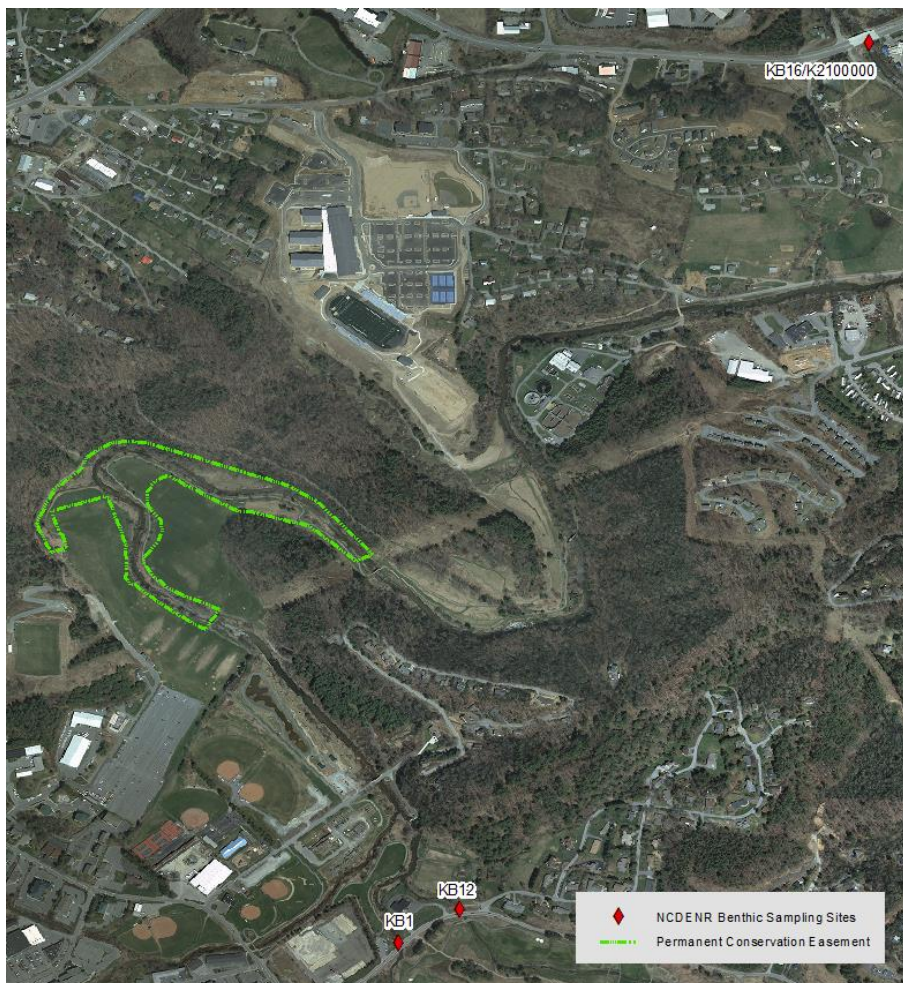
Fig 2 North Carolina Department of Environment and Natural Resources benthic macroinvertebrate sampling locations.

Two NCDENR benthic macroinvertebrate monitoring sites (KB1 and KB12) used for developing the EA are located approximately 650 meters upstream from the restoration area on the Middle Fork, tributary of the South Fork of the New River, and the East Fork, tributary of the South Fork of the New River, respectively. The third monitoring site (KB16), carrying the longest data record, is located approximately 2.6 km downstream of the project area (Figure 2). All samples on the Middle Fork and East Fork streams were assessed using the EPT method, while the South Fork site (KB16) has historically been assessed using the full SQM.

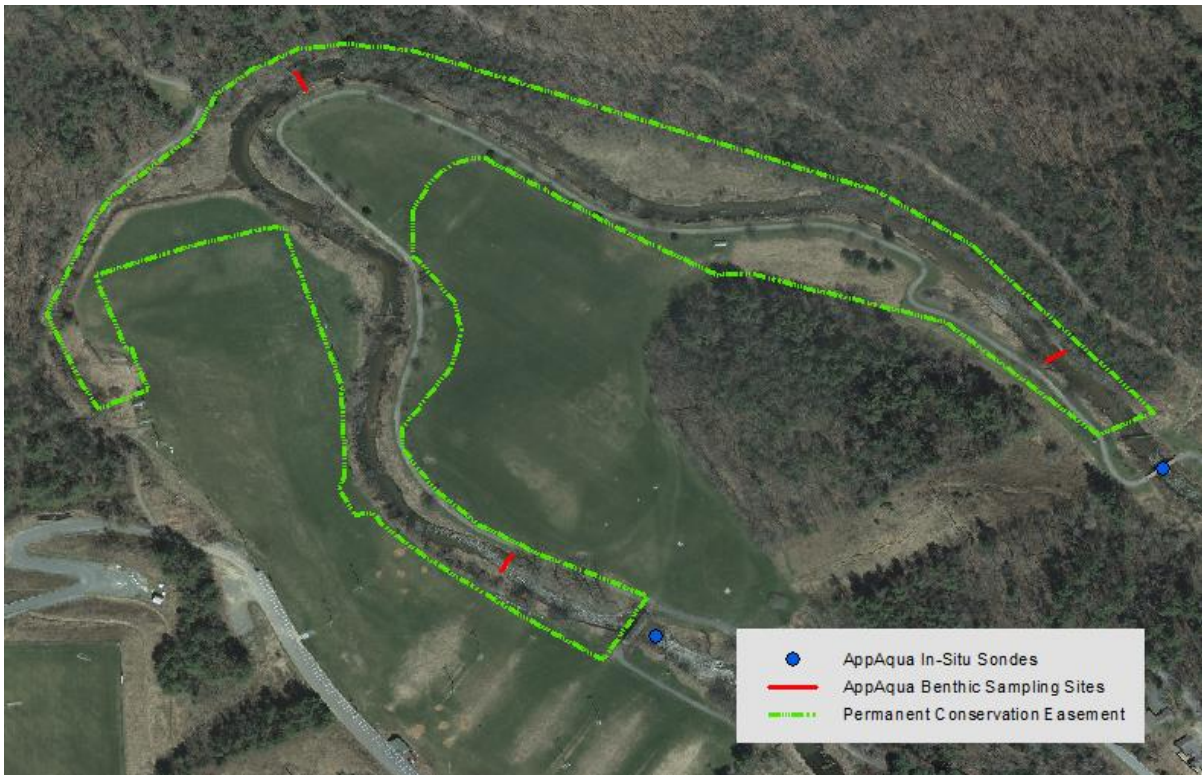
Fig 3 AppAqua benthic macroinvertebrate sampling sites and in-situ water quality monitoring stations within the restoration project reach.

The lack of benthic macroinvertebrate data collected within the restoration reach prompted AppAqua researchers to collect and analyze macroinvertebrate populations within the study area in spring 2013. The restoration reach was divided into three sections based on the geomorphic characteristics of the channel. The two large bends in the river create a distinct upper, middle, and lower reach, which was conducive to sampling and analysis of macro invertebrate populations (Figure 3). The data were analyzed and assigned NCIBI ratings according to a modified protocol of the NCDENR SQM. This modification differs from the SQM in that members of insect families are averaged rather than genus and species.

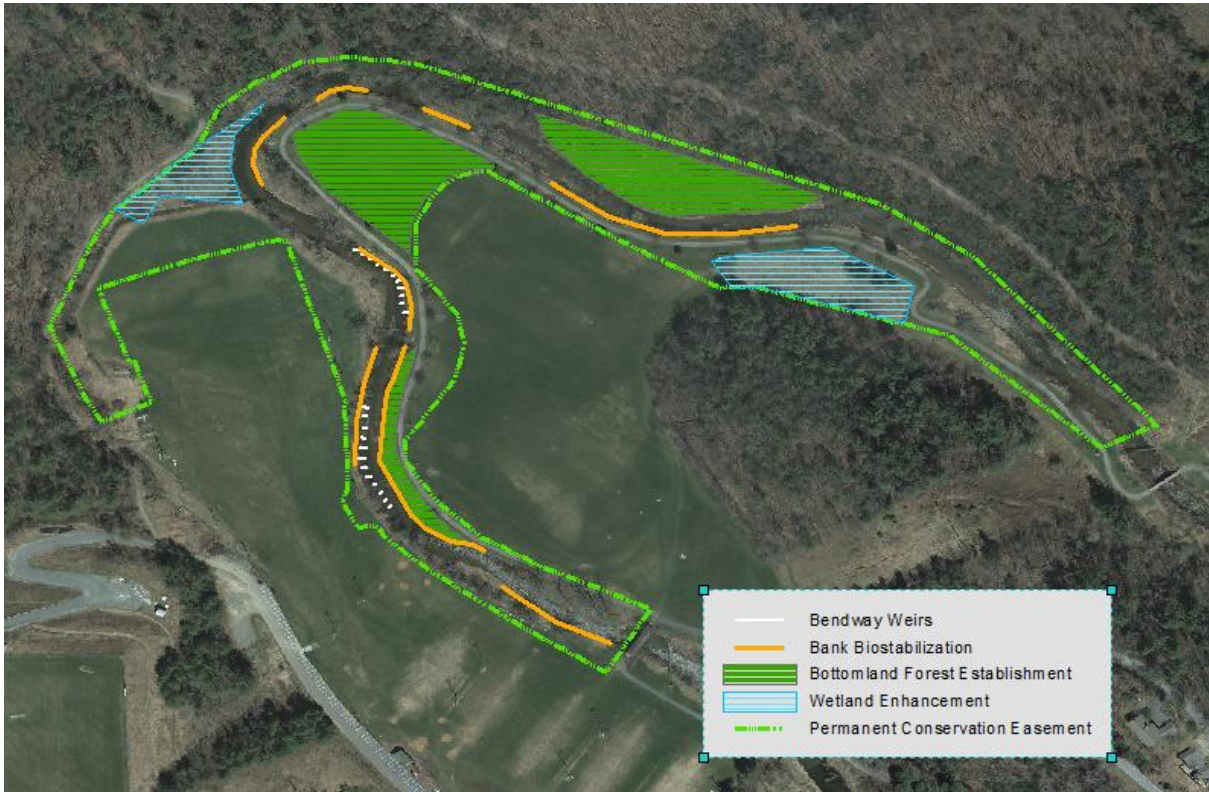
Fig 4 The overall site plan for the restoration. Primary restoration measures include rehabilitation of wetland areas, invasive species control and re-vegetation, riparian buffer extension and establishment, and bottomland hardwood forest re-vegetation as well as installation of bendway weirs.

Channel and stream bank stabilization will be attempted by installing anchored slab bundles at the toe of unstable slopes, bank grading and vegetation, and installing bendway weirs. Additionally, clusters of large boulders will be placed to help direct the flow towards the center of the channel and away from the stream banks. An overall site plan is shown in Figure 4.

According to the EA and detailed project report, stabilizing stream banks is expected to “eliminate the input of failing soils to the stream.” Slab bundles are expected to increase bank stability while increasing habitat diversity by increasing woody material in the stream and subsequently increasing colonization by macro invertebrates. Increasing the vegetation along the stream banks is anticipated to increase habitat diversity for birds, amphibians,

reptiles, insects, and small mammals, while providing shade for the stream thereby lowering water temperature. The installation of bendway weirs at the two extreme curves in the river are expected to redirect the river current away from the banks, reducing bank undercutting and subsequent bank failure.

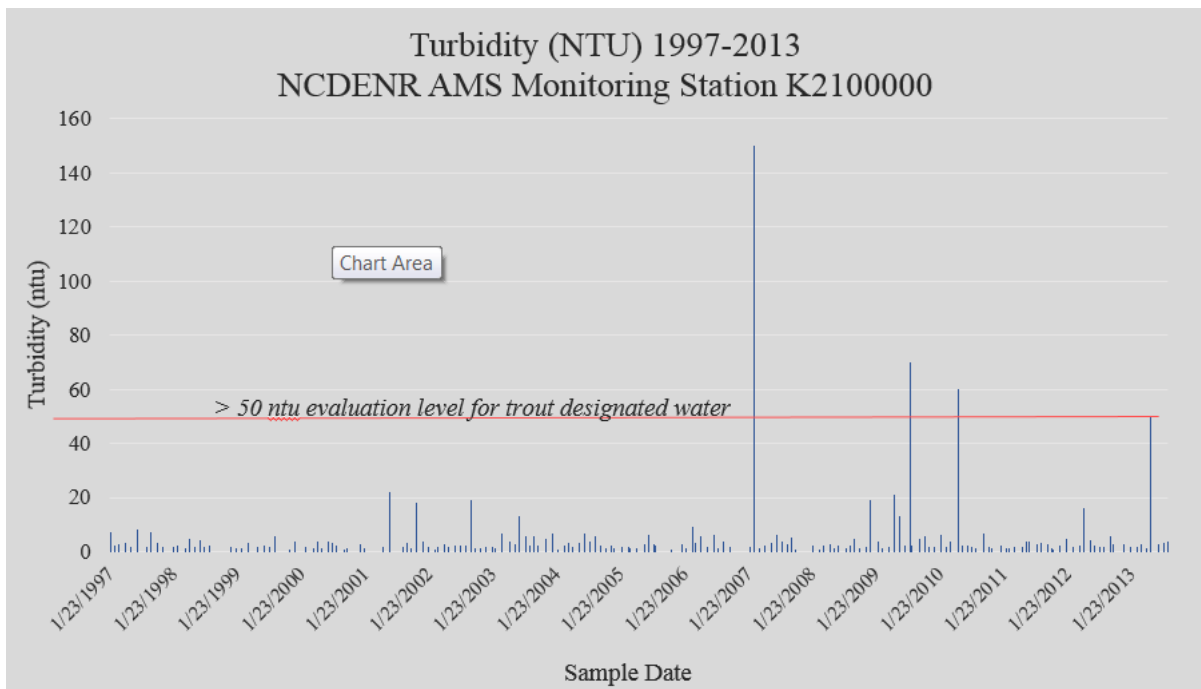
Fig 5 Turbidity (ntu) measurements recorded at the North Carolina Department of Environment and Natural Resources AMS Station K2100000 from 1998-2013. Downloaded from U.S. Environmental Protection Agency's Storet/WQX website. The North Carolina evaluation level for turbidity for trout designated streams is >50.

Turbidity measurements over time at monitoring station K2100000 are shown in Figure 5. Generally, ntu measurements were well under the 50 ntu evaluation level in North Carolina, although spikes between 50 and 150 ntu were recorded post 2007. However, land disturbing activities just upstream of the water quality monitoring station K2100000 and benthic macroinvertebrate sampling station KB16, has been cited by NCDENR as likely to be affecting water quality and benthic populations at these sampling stations (NCDENR 2011). Also, these land-disturbing activities occurred approximately 2km downstream from the restoration site.

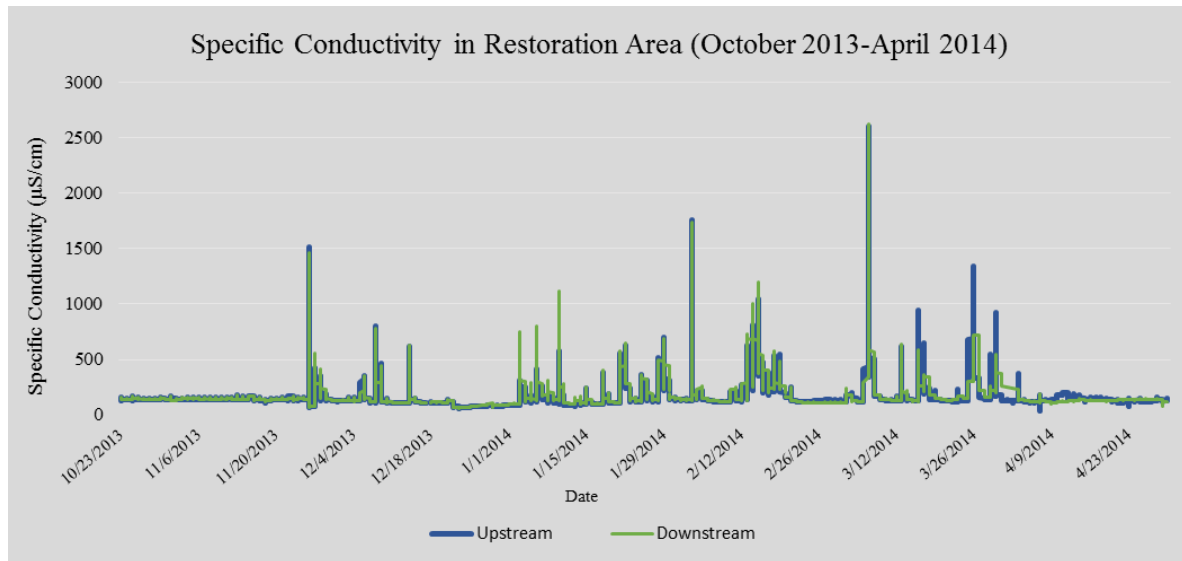
Fig 6 Specific conductivity ($\mu\text{S}/\text{cm}$) as measured at AppAqua water quality monitoring stations. One sonde is located at the upstream end of the project (blue line), and another is located at the downstream end (greenline). Significant spikes in conductivity are seen during winter storms and rain events. Typically the sondes have similar measurements, however, during precipitation events the measurements between sondes may deviate from each other. This indicates that runoff between the sondes could be influencing water quality in the reach.
