ALKIRE, JENNIE G., M.S. Replacement Windows in Historic Houses: A Study of the College Hill Historic District in Greensboro, North Carolina. (2008)
Directed by Professor Jo Ramsay Leimenstoll. 80 pp.

REPLACEMENT WINDOWS IN HISTORIC HOUSES: A STUDY
OF THE COLLEGE HILL HISTORIC DISTRICT IN
GREENSBORO, NORTH CAROLINA

A Thesis Submitted to
The Faculty of the Graduate School at
The University of North Carolina at Greensboro
in Partial Fulfillment
of the Requirement for the Degree
Master of Science

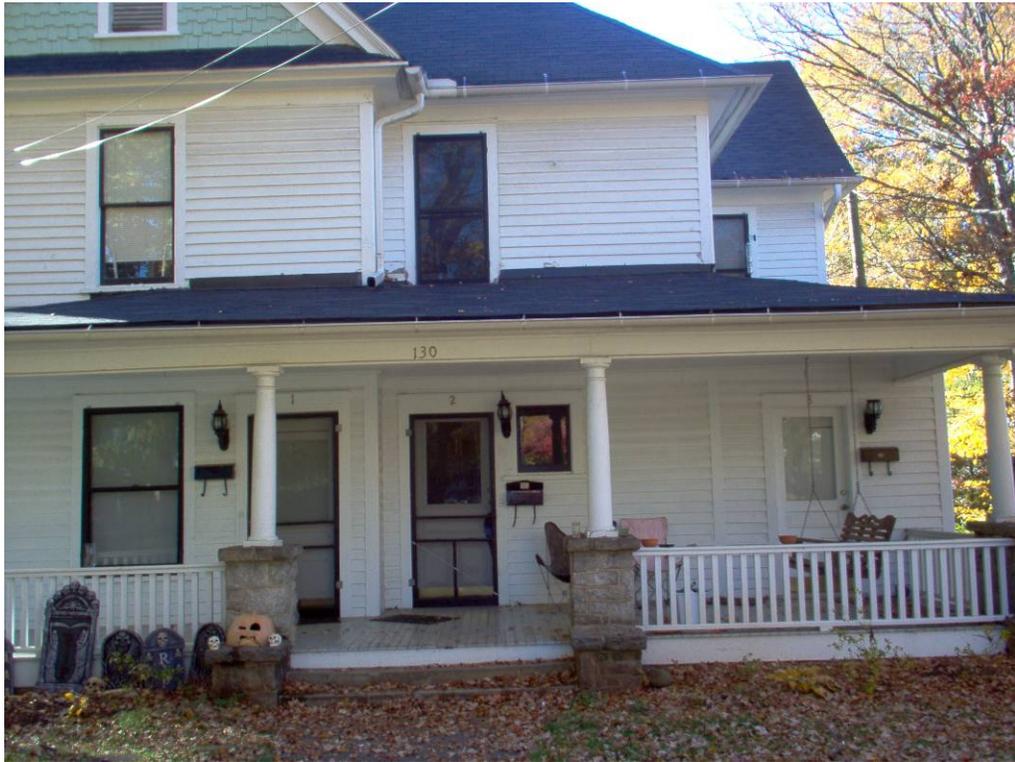
Figure 1. 130 S. Tate St., ca. 1905-10; Queen Anne: Original Windows.

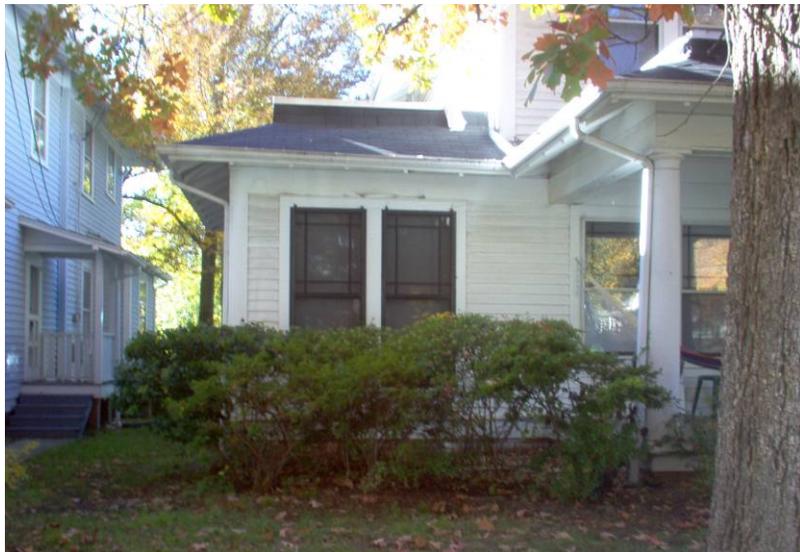
Figure 2. 200 S. Tate St., ca 1920-25; Four-square: Original Windows.

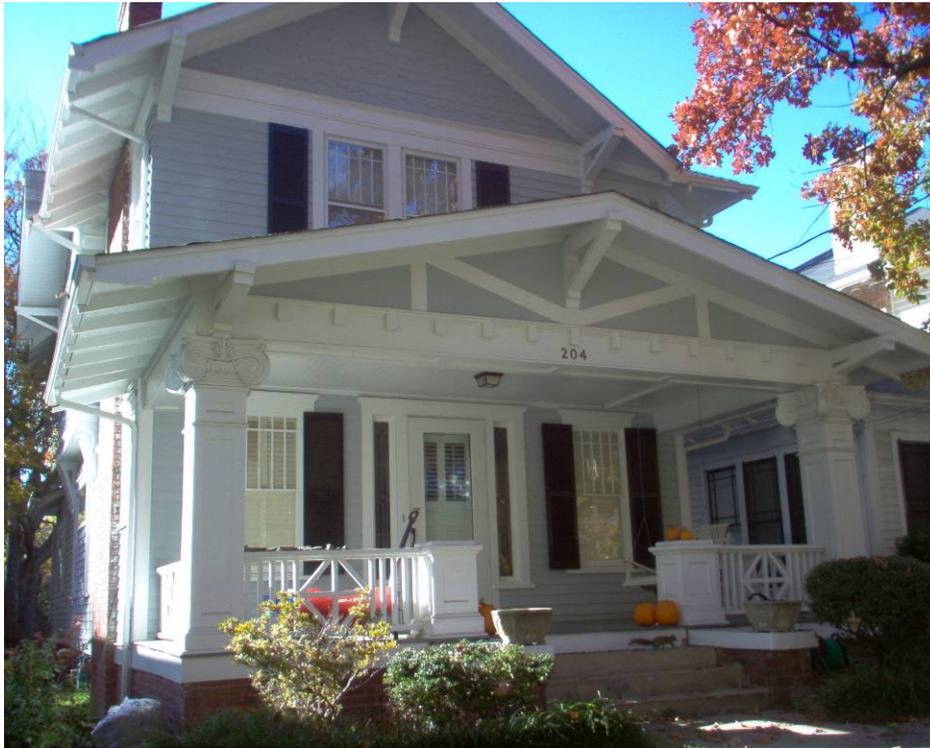
Figure 3. 204 S. Tate St., ca.1917; Craftsman - Neo-Classic: Original Windows: Note Streetscape Interest Developed by the Variety of Window Styles in the Adjacent Dwellings.

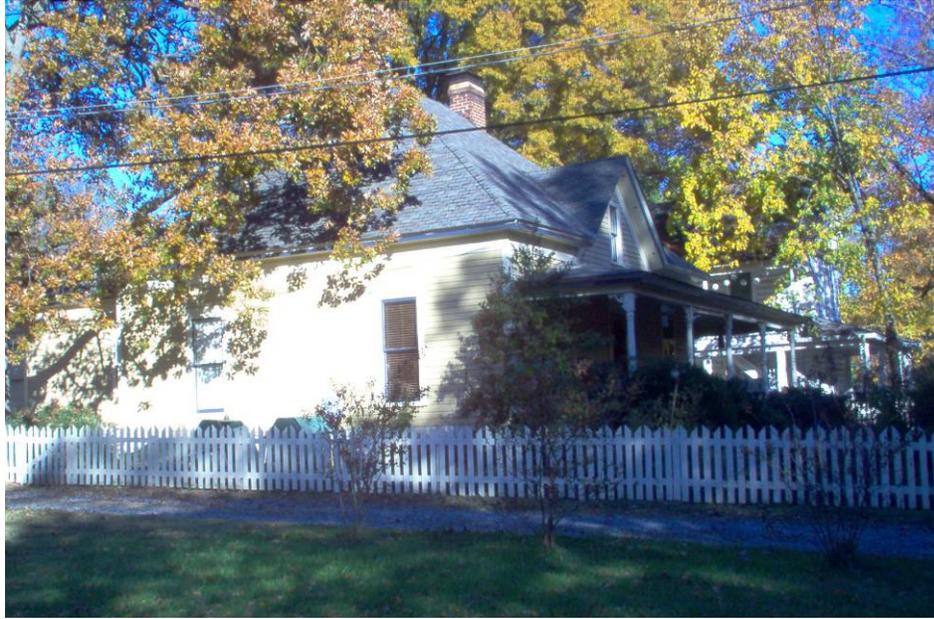
Figure 4. 822 Rankin St., ca. 1900-03; Cottage with Hip-roof: HCD Purchased / Rehab Dwelling: No Replacement COAs on Record.

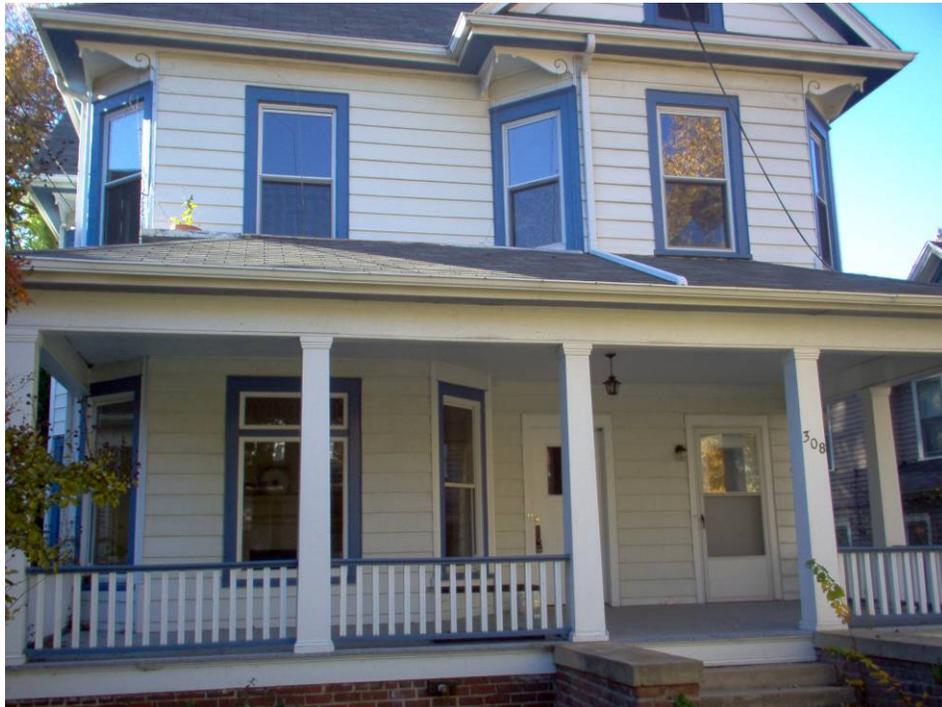
Figure 5. 308 S. Tate St., ca 1905-10; Queen Anne - Colonial-Revival: 1983 Window Replacements: Non-HCD House.

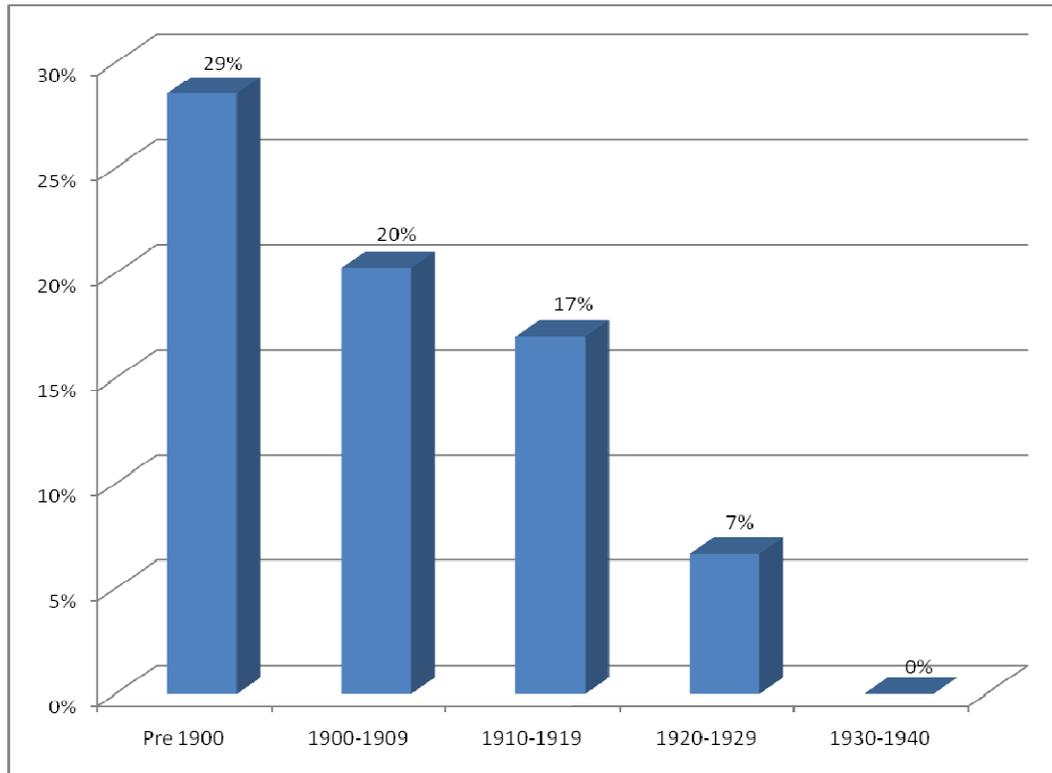
The final intent of the research was to investigate for patterns that could be linked to the date of construction, window location, or architectural style with either replacement or original windows, or both. The research did find several links. Not too surprising was the link with the date of construction. Figure 1 provides a clear image of how the age of the building is represented in the granting of COAs for window replacement. It is easy to note that 28.57% of the single-family residences built before 1900 have had replacements installed. Houses constructed in the decade between 1900 and 1909 had barely more than 20% with windows replaced. In the dwellings constructed from 1910 to 1919, just 16.98% of the units have replacement windows in them, while the number of replacements for the decade between 1920 and 1929 dropped significantly, by 10% to 6.67%. The more recently constructed houses, from 1930 to 1940, the end of the period of significance within the district, had not had any windows replaced.

Figure 6. Percent of Structures with Window Replacements, by Original Construction Decade.

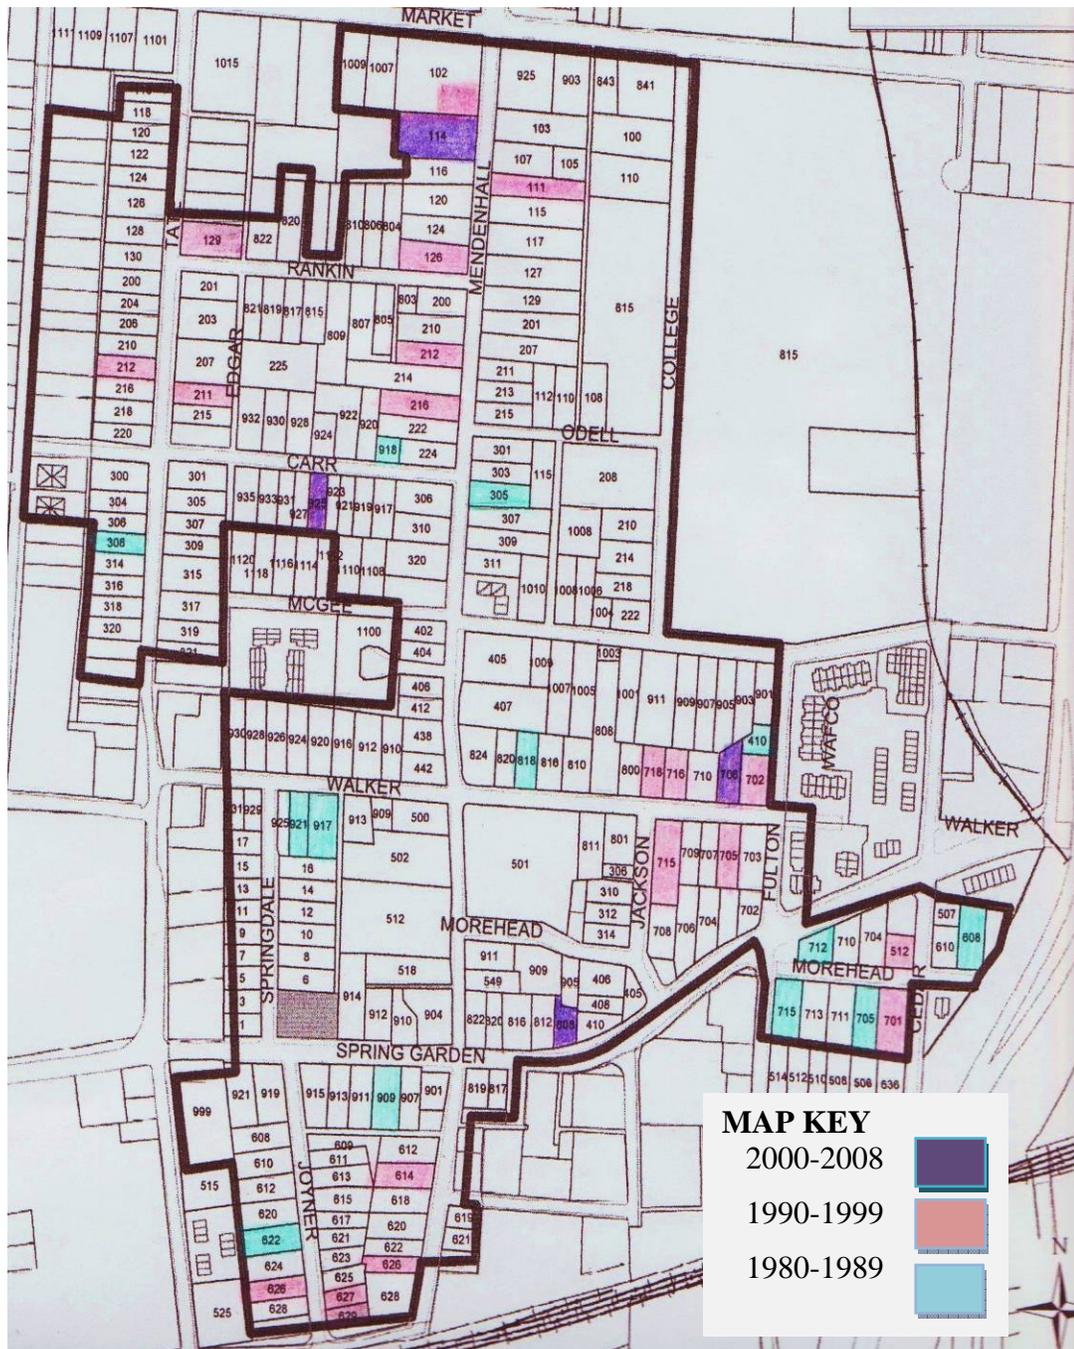
Figure 2. on the following page illustrates an example of cluster effect which is indicated in the College Hill Historic District. Note the several small clusters, generally located at the edges of the district. The figure shows the location of all of the contributing structures which have received COAs for window replacement based upon decade.

Figure 7. Single-Family Residences within College Hill Historic District that Received COAs for Window Replacement, by Decade.

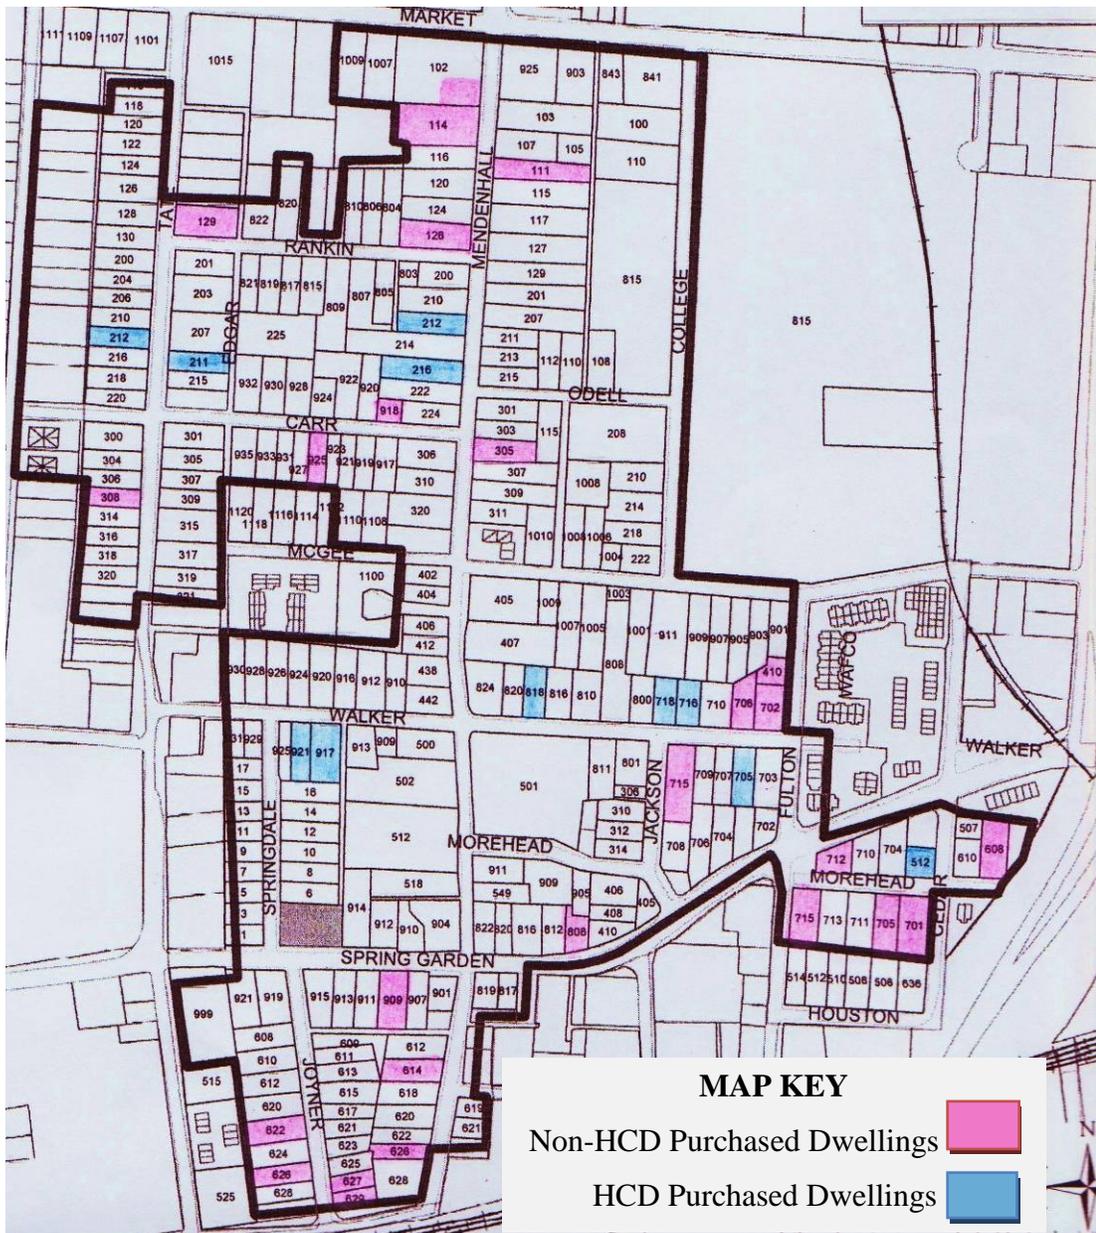
The following figure shows the HCD purchased dwellings and the non-HCD purchased dwellings, showing the cluster effect of the replacement window activity since the designation of the College Hill Historic District.

Figure 8. Cluster Effect of HCD and Non-HCD Dwelling Units, with Window Replacements.

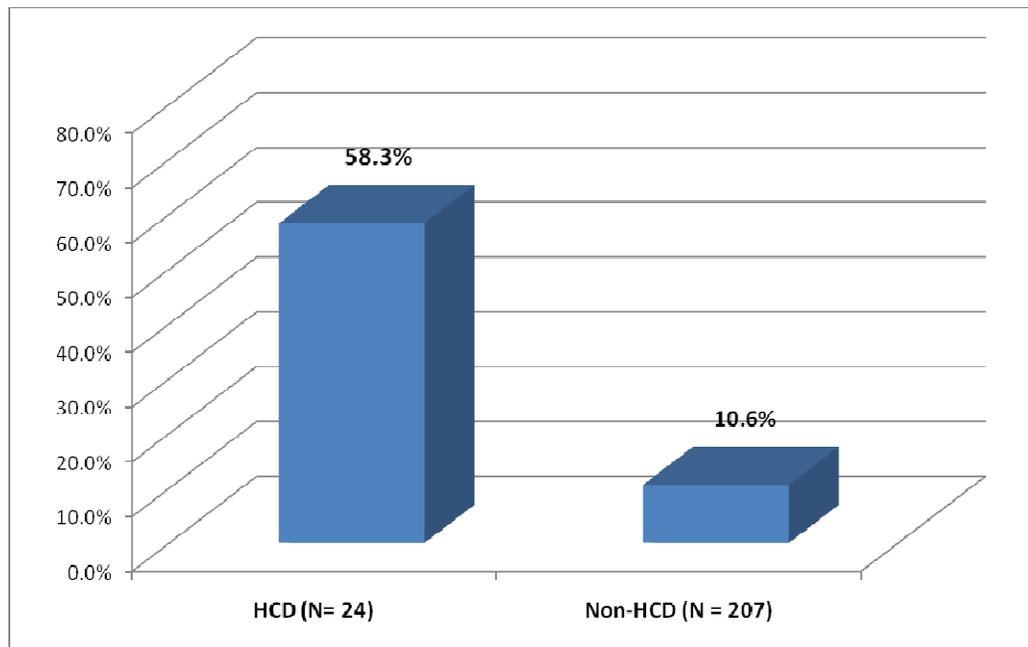
The following graph is a depiction of the number of HCD purchased dwellings, a total of 24, which were recorded as contributing, viewed as the percentage of the total number of non-HCD houses in the district, 207, and the percentage of HCD houses that received COA's for replacement windows, 58.3%, as they fit within the limits of the research. The graph shows that more than half of the HCD purchased houses, which were admittedly the ones in the worst repair in the district, received window replacements. Yet, the HCD houses make up just 10.6% of the total district. The graph includes the COA's granted for replacement units for any number of windows in the HCD purchased houses.

Figure 9. Percentage of HCD Status Structures with Replaced Windows.

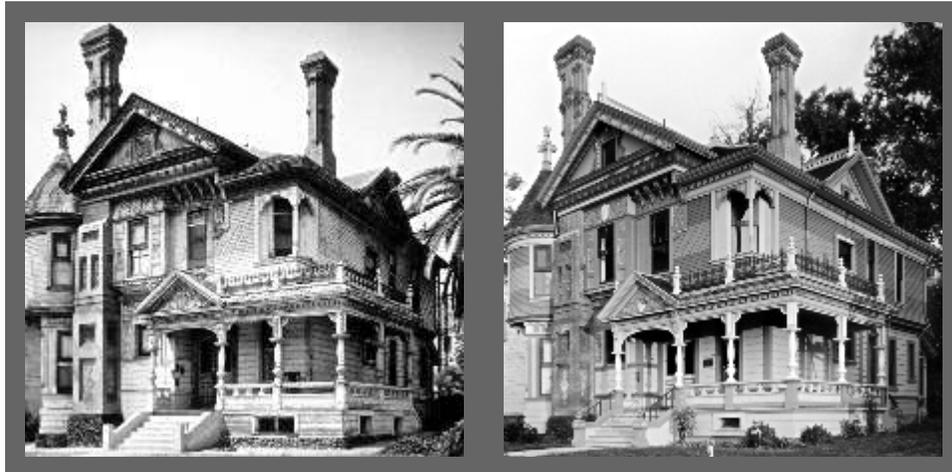
Preservation of the exterior of the Hale House, Los Angeles, California, involved repainting the exterior walls and decorative features in historically appropriate colors. In excellent example of the Preservation treatment focused upon the ongoing maintenance of historic materials and features. Photo: Before, NPS files; After: Bruce Bohner.

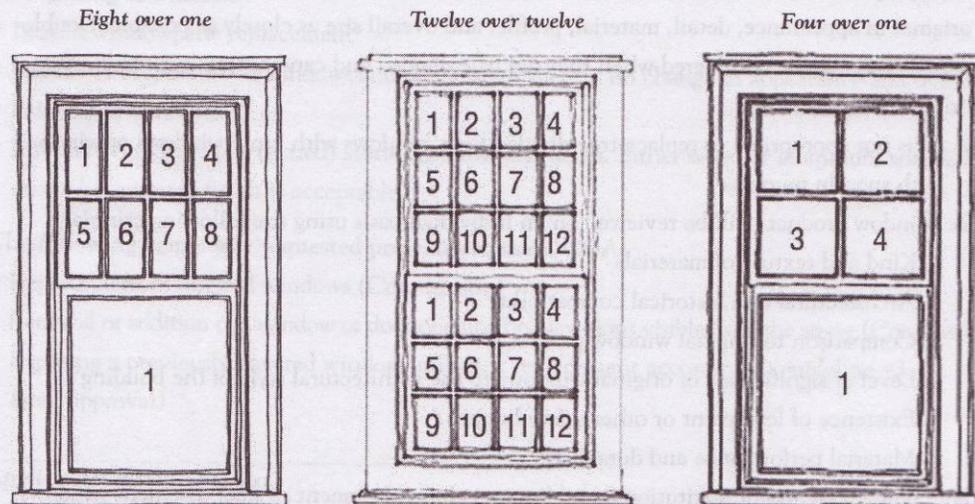
What is a Muntin? A muntin is a thin wooden bar used to hold panes of glass in place. Often the muntin configuration is indicative of the architectural style of the house. Most historic windows have “true-divided light windows,” which means that each window section is an individual pane of glass with a wood muntin that goes from the outside of the window all the way through to the inside of the window.
