DAVIS, MONICA T. M.F.A. Tracing Changes and Revealing Culture: A Study of Shotgun Houses in the East Wilson Historic District, 1988-2019. (2022)
Directed by Dr. Asha Kutty. 86 pp.

TRACING CHANGES AND REVEALING CULTURE: A STUDY OF SHOTGUN HOUSES
IN THE EAST WILSON HISTORIC DISTRICT, 1988-2019

A Thesis

Master of Fine Arts

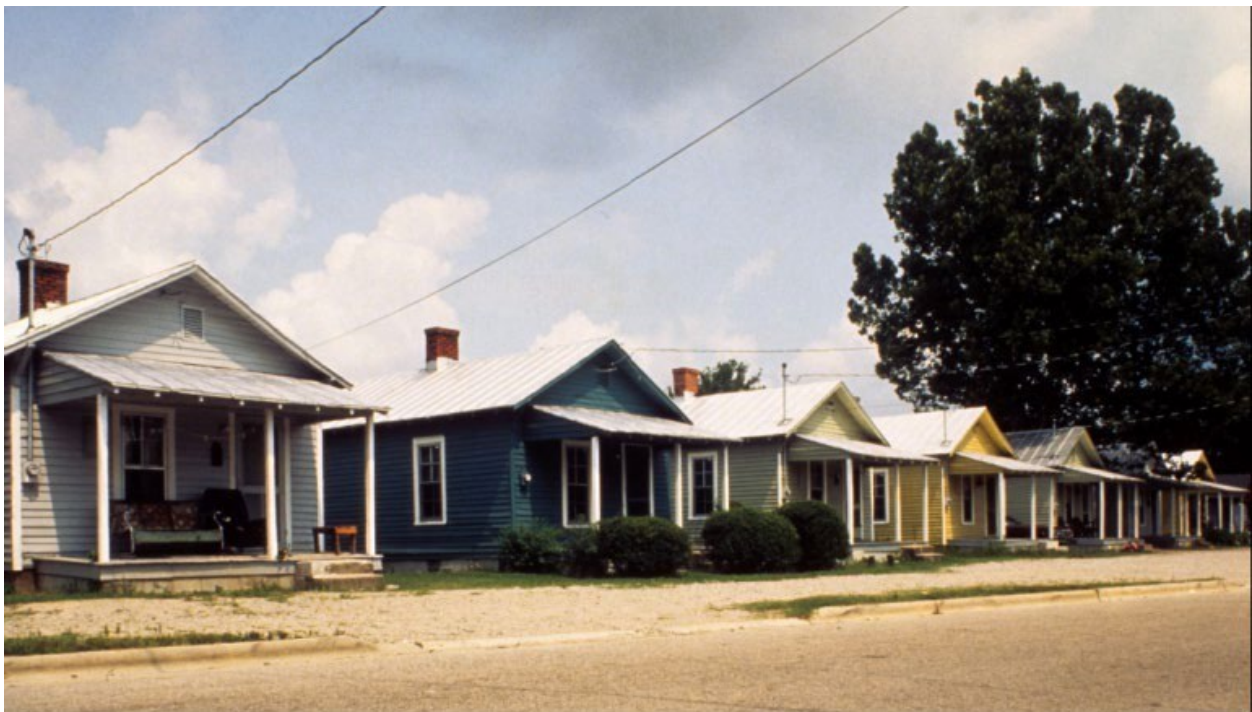
Figure 6. Historic image of Shotgun Houses on East Vance Street circa 1988.

is illustrated in Figure 6, five turn-of-the-century examples are found along East Vance Street. The triple-pile shotgun built primarily in the 1910s is another popular version. The type consists of a main block two rooms deep and a gable-end kitchen wing to the rear. The alterations to the shotgun included porch posts and enclosed back porches; these adapted back porches housed bathrooms that were added between the 1930s and 1960s. The "double shotgun" appeared during the mid-1920s in small numbers. The interior space of the shotgun houses was purposeful to maximize space. The rooms were aligned in a single row without the use of an interior hallway. (Mattson, 1988)

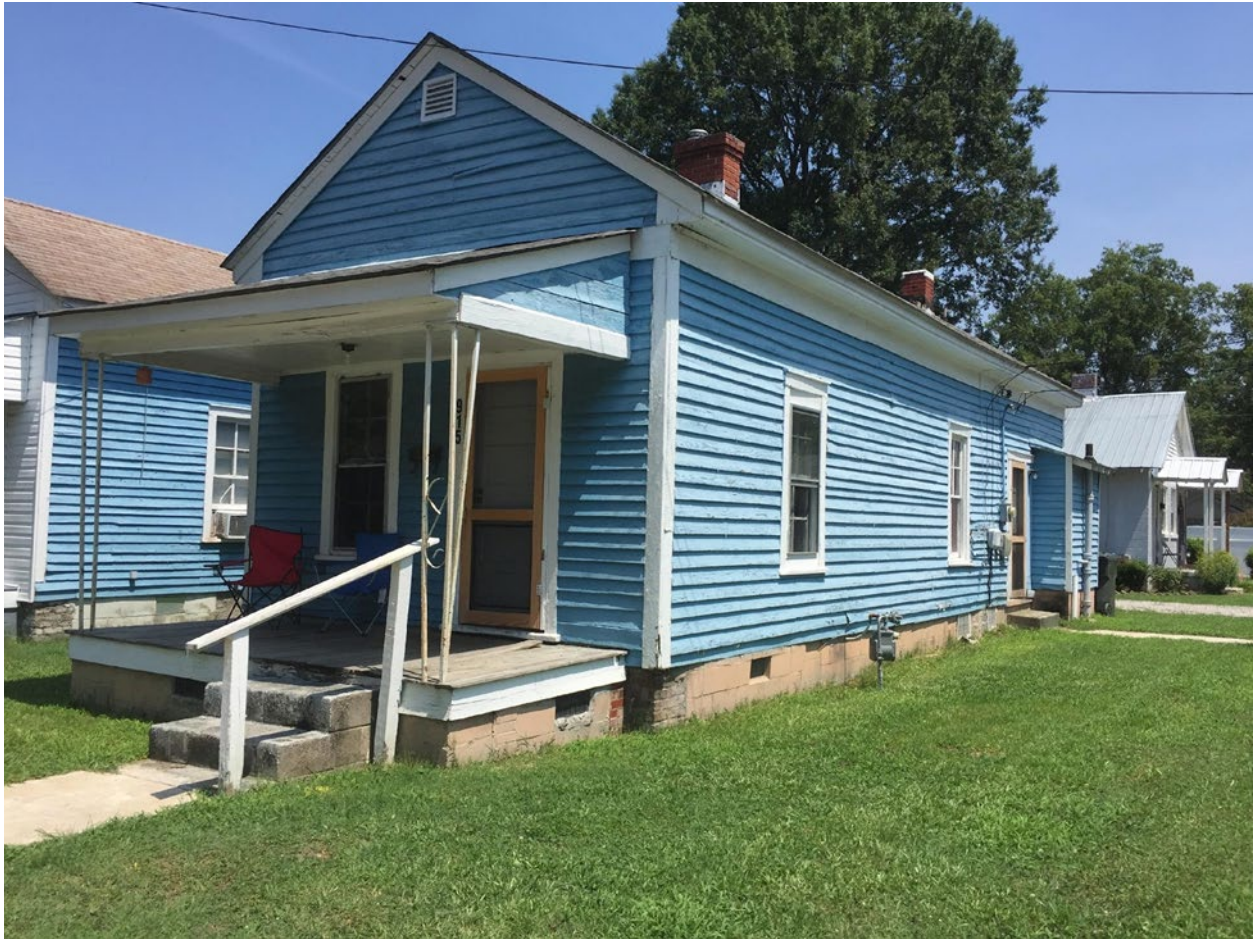
Figure 17. 915 Washington Street, Wilson, NC.

Shotgun house that exhibits good condition. The exterior wood clapboards do not show areas of deterioration, and the foundation is sound. The original five-panel exterior wood door is intact.

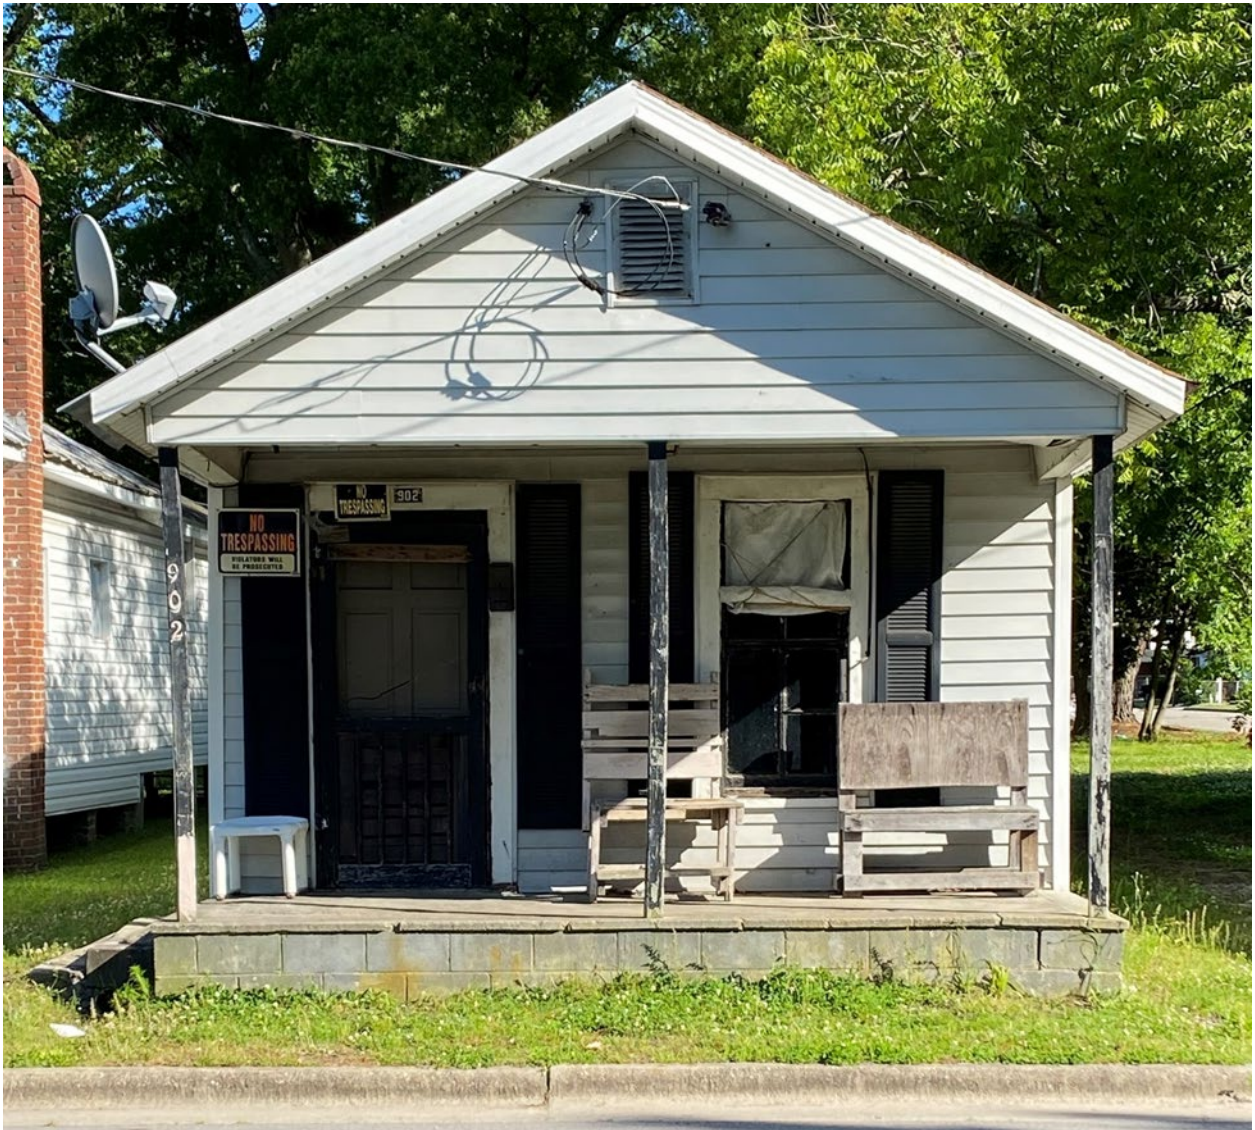
Figure 18: 902 Wainwright Street, Wilson, NC.

Shotgun house exhibits fair condition. The aluminum siding does not show areas of deterioration. However, the simple wood porch posts need replacement and repainting.

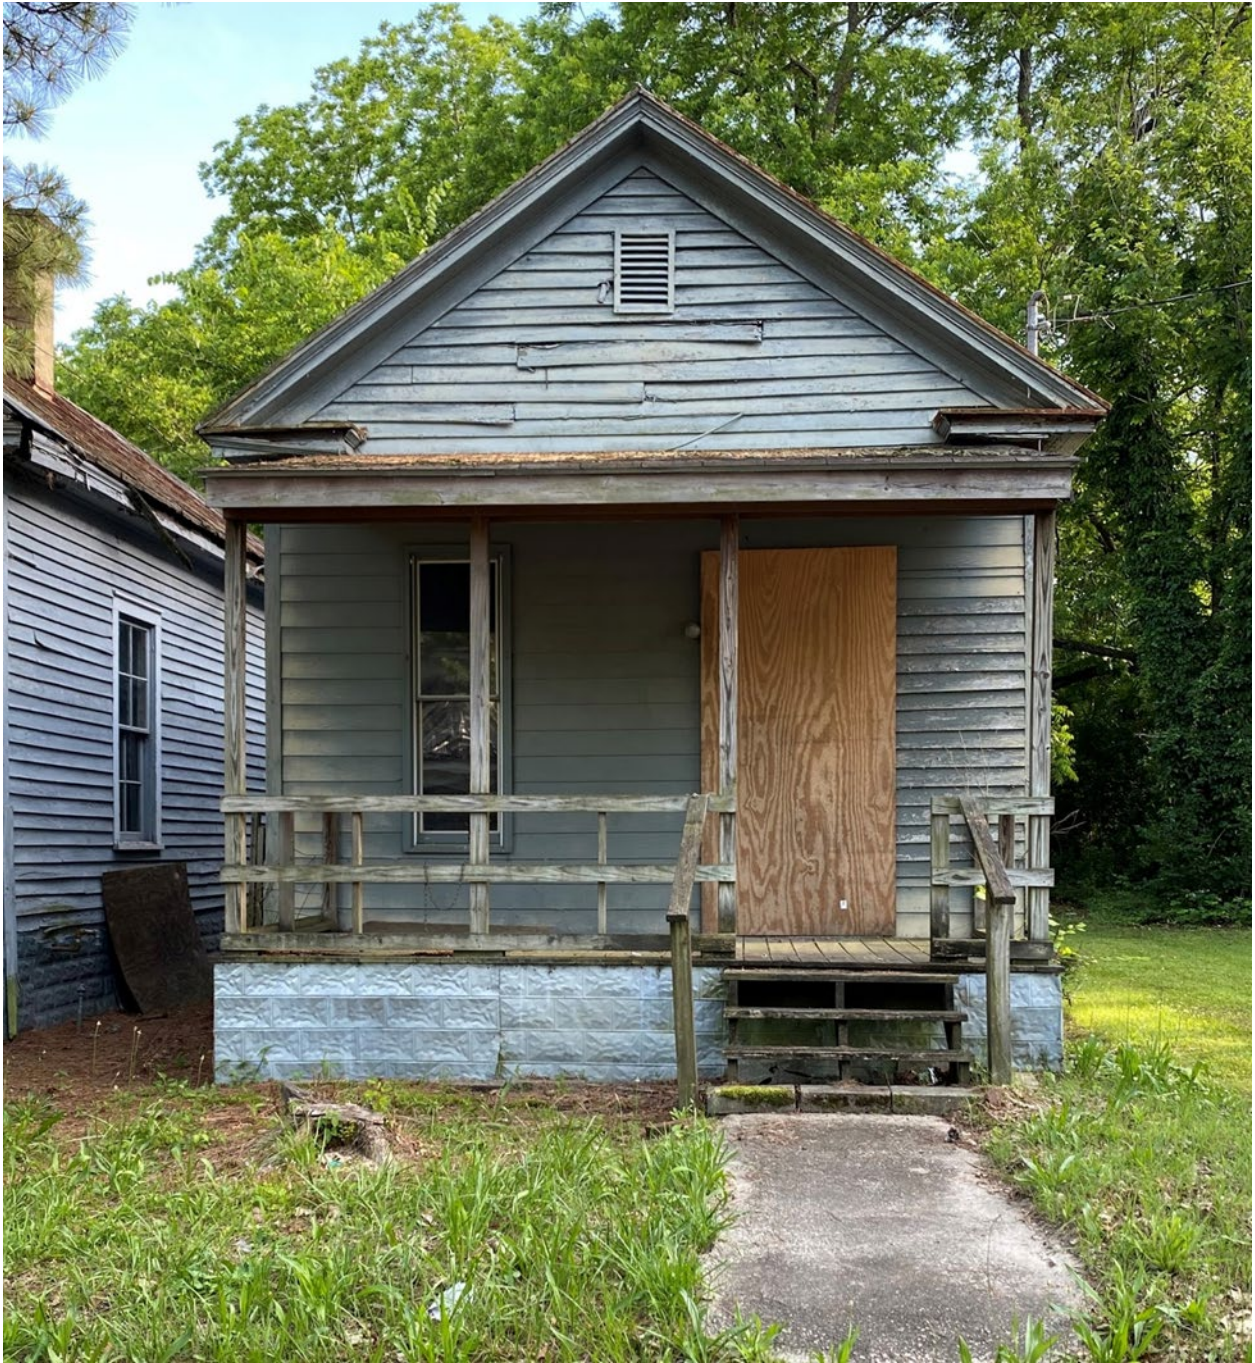
Figure 19. 416 Green Street, Wilson, NC.

Shotgun house exhibits deteriorated condition. The exterior wood clapboards have several areas of deterioration. However, the stamped sheet metal foundation is intact and does not require extensive repair.

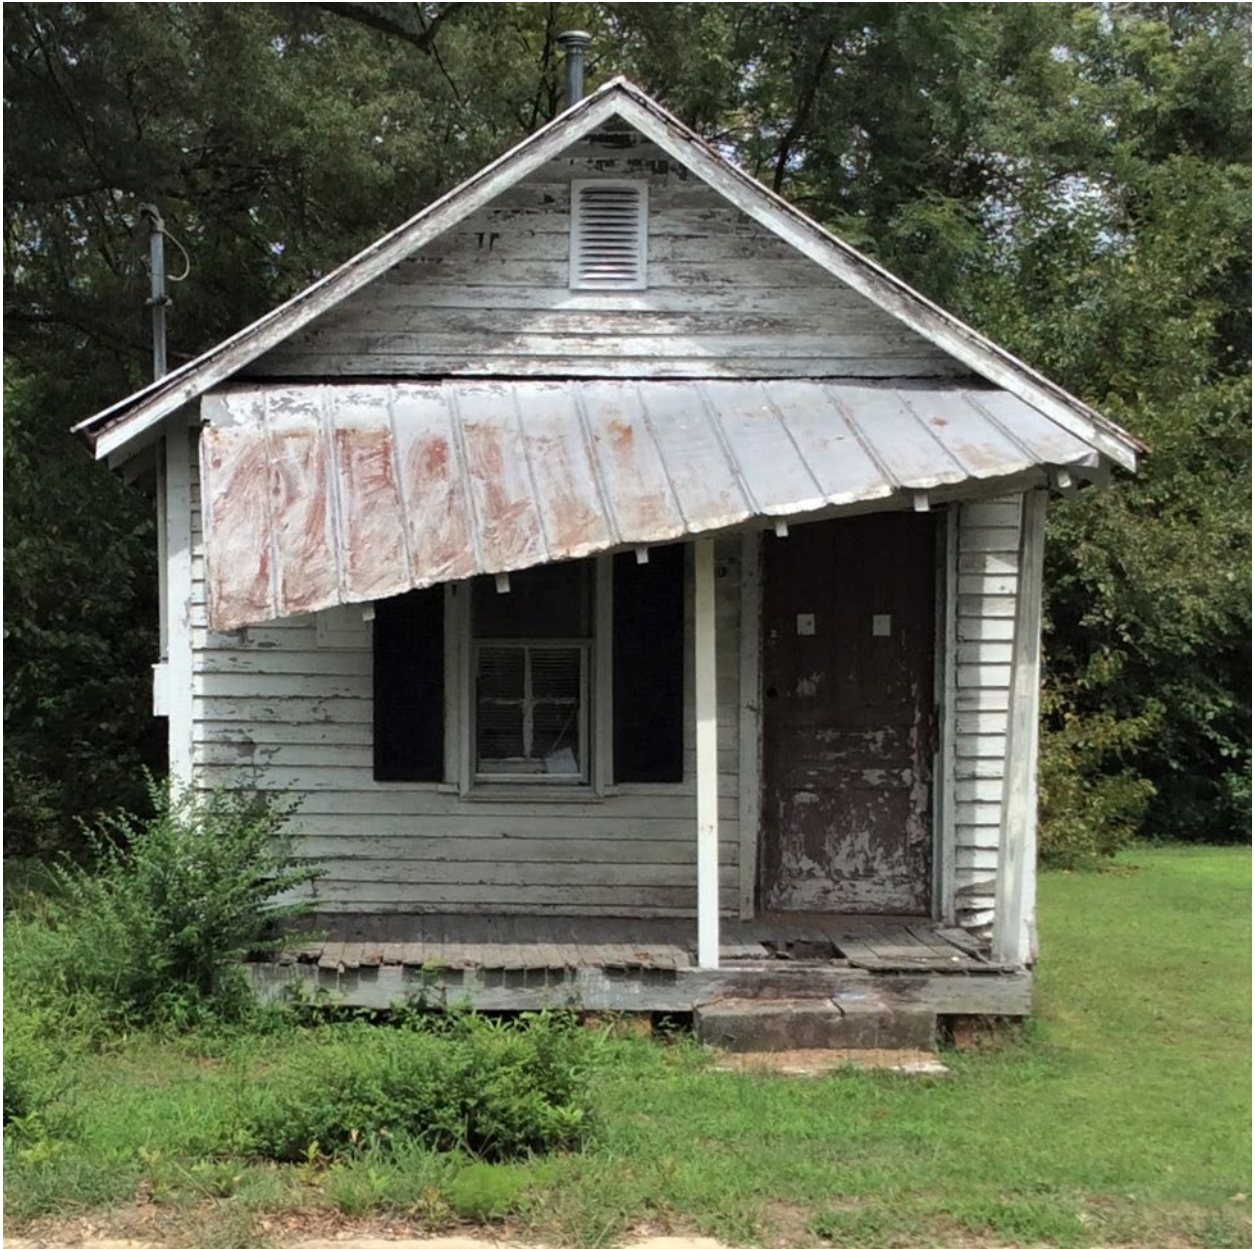
Figure 20. 901 Washington Street, Wilson, NC.

Shotgun house exhibits ruinous condition. The shed roof porch is in danger of collapsing because the end porch post has been removed.

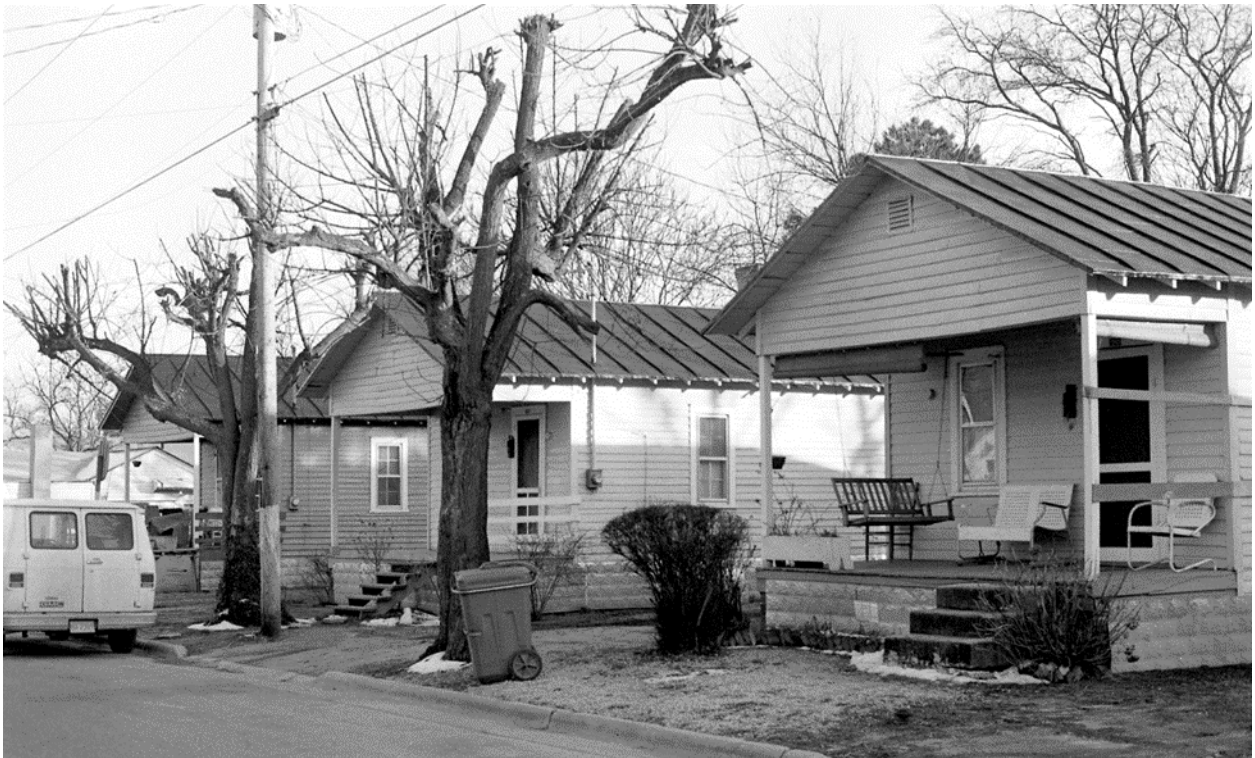
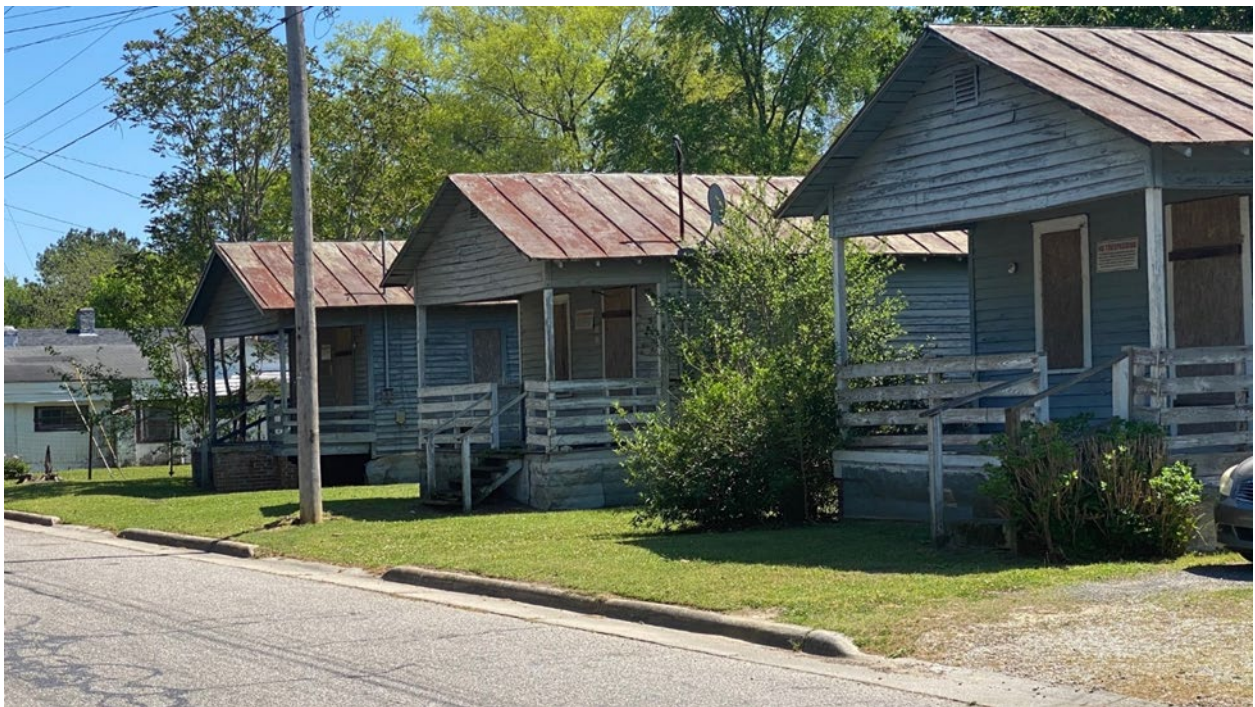
Figure 27: 1210, 1212, 1214 Carolina Street East, Wilson, N. 1988 Archival Image.

1210, 1212, 1214 Carolina Street East, Wilson NC – Deteriorated and Vacant. Top Image, archival photograph. Bottom image, photograph taken Spring 2020. The material integrity of the shotgun houses illustrates the original standing seam metal roofs, original wood clapboards for the exterior material coverings, and stamped sheet metal foundations. Due to the current vacant occupancy the material and condition of the front door and front window are not able to be determine. The architectural integrity of the shotgun houses illustrates the original form and the original simple porch form. The archival photograph illustrates the use of the front porch and the sense of community. The landscape has changed significantly with the lost mature trees that is seen in the archival photograph. The current photograph due the current condition and vacant occupancy of the shotgun houses does not exhibit community engagement. Example of disinvestment in the district – deterioration.

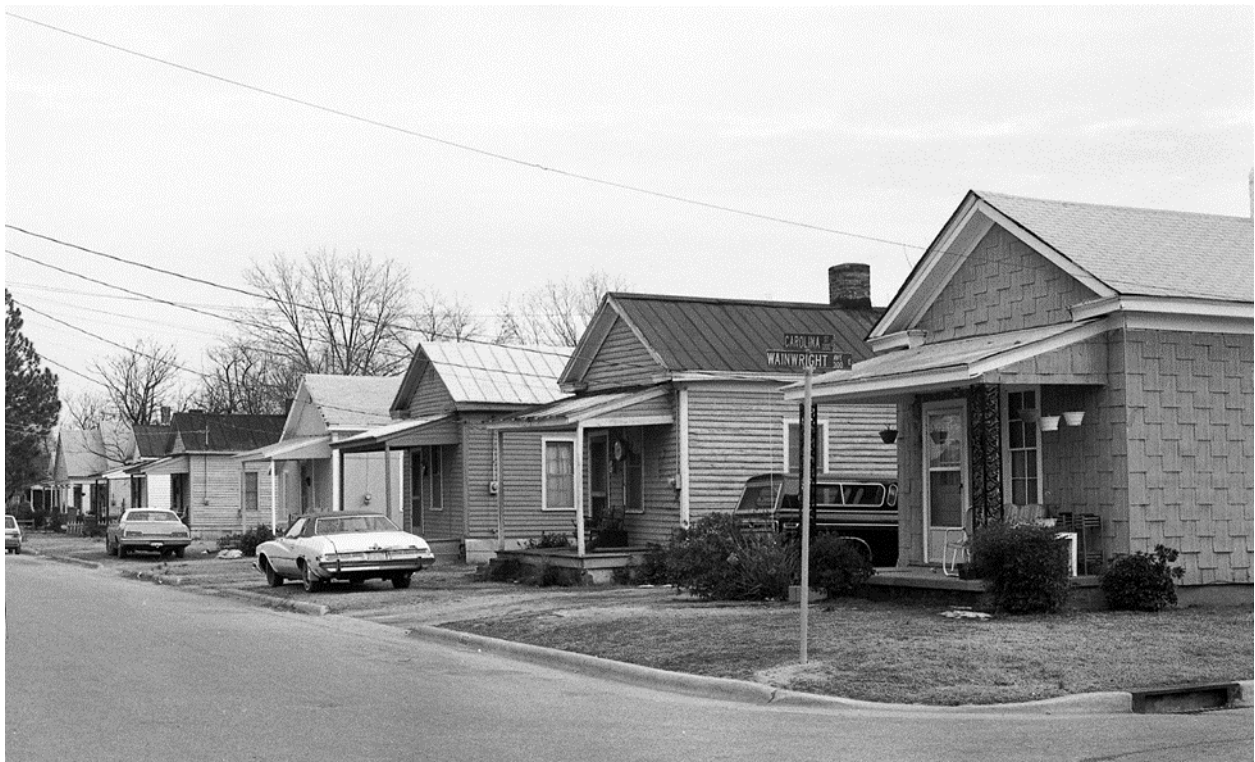
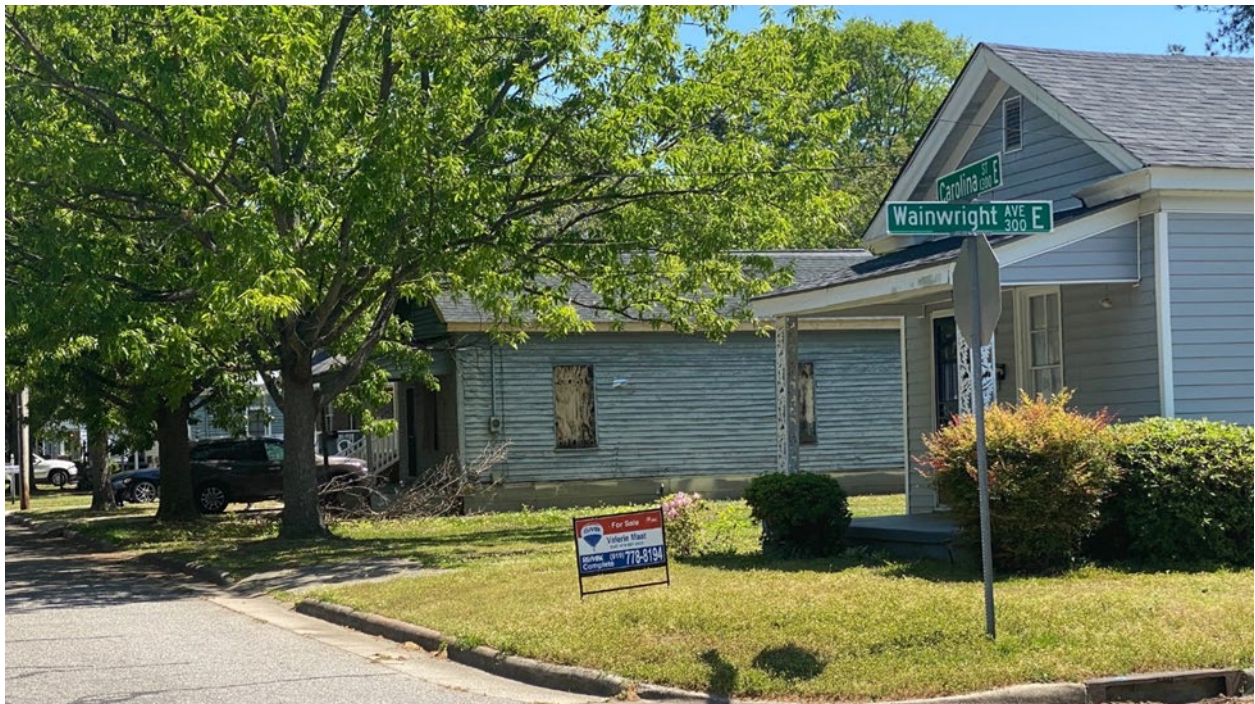
Figure 29: 1300 Block of Carolina Street East, Wilson, NC. 1988 Archival Image.

1300 Carolina Street East, Wilson NC – Rehabilitated, 1302 Carolina Street East, Wilson NC – Demolished, 1304 Carolina Street East, Wilson NC – Vacant. Top image, archival photograph. Bottom image, photograph taken Spring 2020. The material integrity of the shotgun house 1300 Carolina East has been altered, the photo comparison illustrates asphalt shingled roof, the exterior Masonite shingles covering has been replaced with vinyl siding. The front door has been replaced and the front wood window is original to its construction date. The decorative metal porch posts are still intact. The architectural integrity of the shotgun house illustrates the original form. The front gable vent which was covered by the wood shingles in the archival photograph is exposed and visible in the bottom current photograph.

The streetscape has been altered with the demolition of the shotgun house at 1302 Carolina Street East and the vacant occupancy and deteriorated condition of the shotgun house at 1304 Carolina Street East. The archival photograph illustrates the use of the front porch as living space for 1300. Note boarded up windows on 1304. Image also represents the only owner-occupied shotgun house in the entire East Wilson District which was for sale at the time of the photograph taken in 2020.

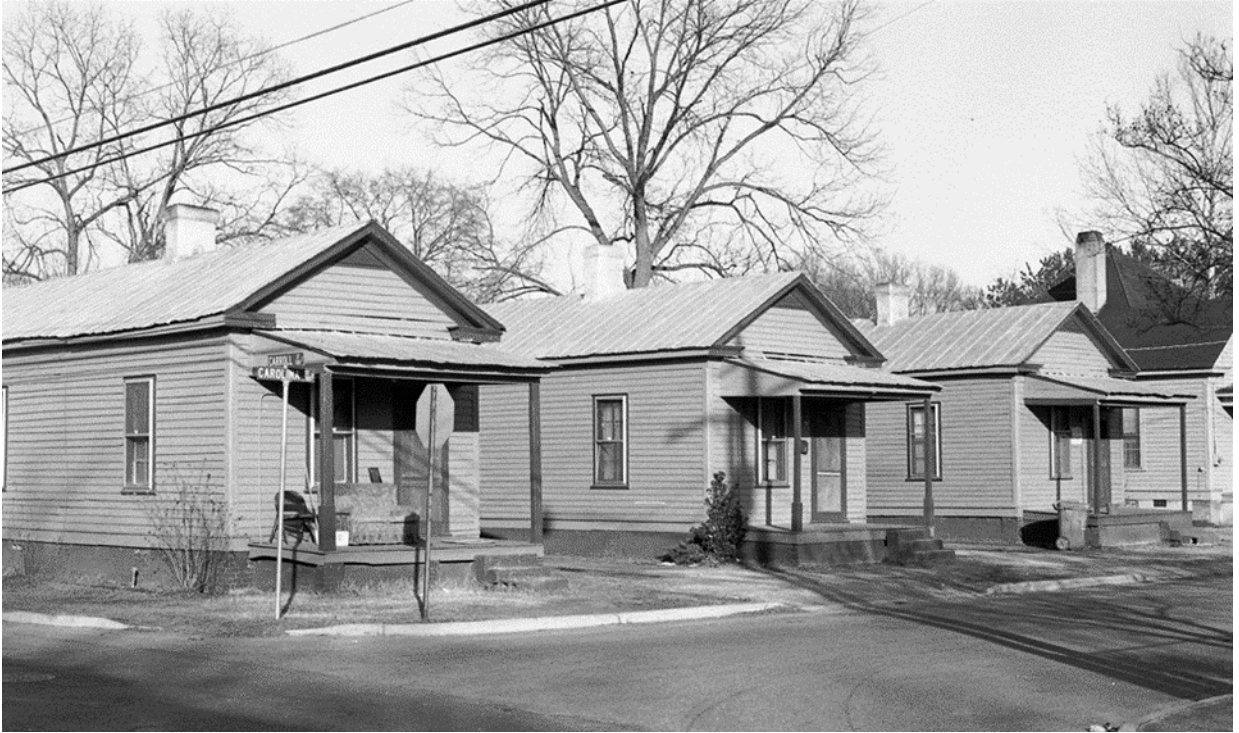
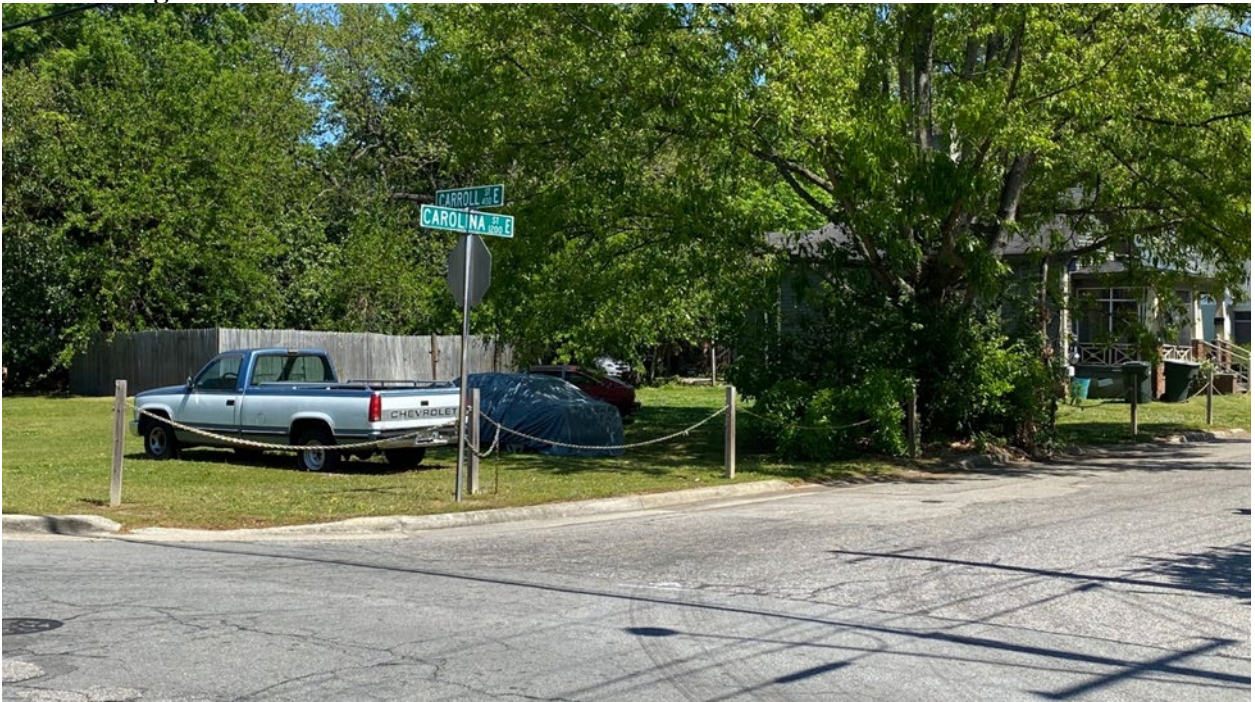
Figure 31: Intersection Carroll and Carolina Street East, Wilson, NC. 1988 Archival Image.

Intersection Carroll and Carolina Street East, Wilson NC – Demolished and Vacant. Top Image, archival photograph. Bottom image, photograph taken Spring 2020. Field Notes: Gone. The entire row of the shotgun houses has been demolished without new construction infill. The vacant land now serves as parking for vehicles. The streetscape and community have been altered significantly due to the demolition of the shotgun houses. Demolition without new construction.

Demolition changes the streetscape and rhythm in a neighborhood. Demolition without new construction leaves an empty lot that, best seen at the Intersection Carroll and Carolina Street East, goes from a streetscape of shotgun houses to a vacant space with parked cars. Incompatible infill or new construction can change the rhythm and material fabric of the neighborhood. New construction challenges the sense of place and orientation created by historic visual character by introducing new materials and different architectural typology.

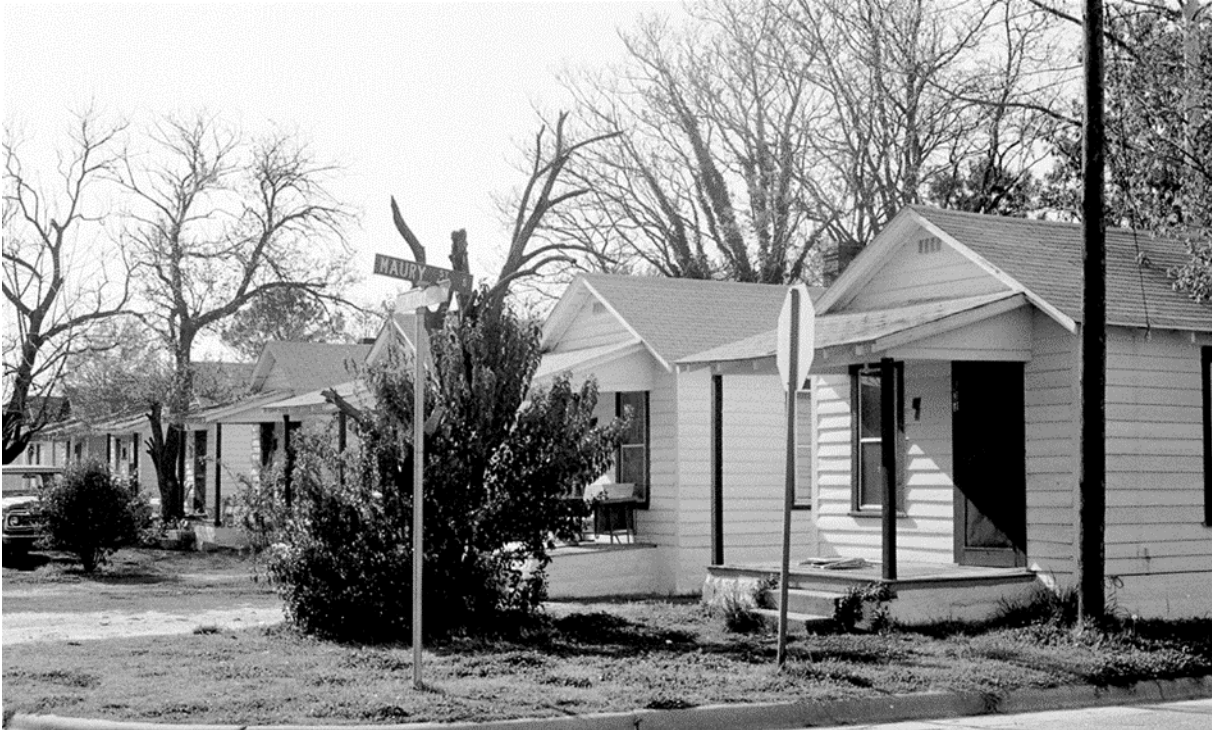
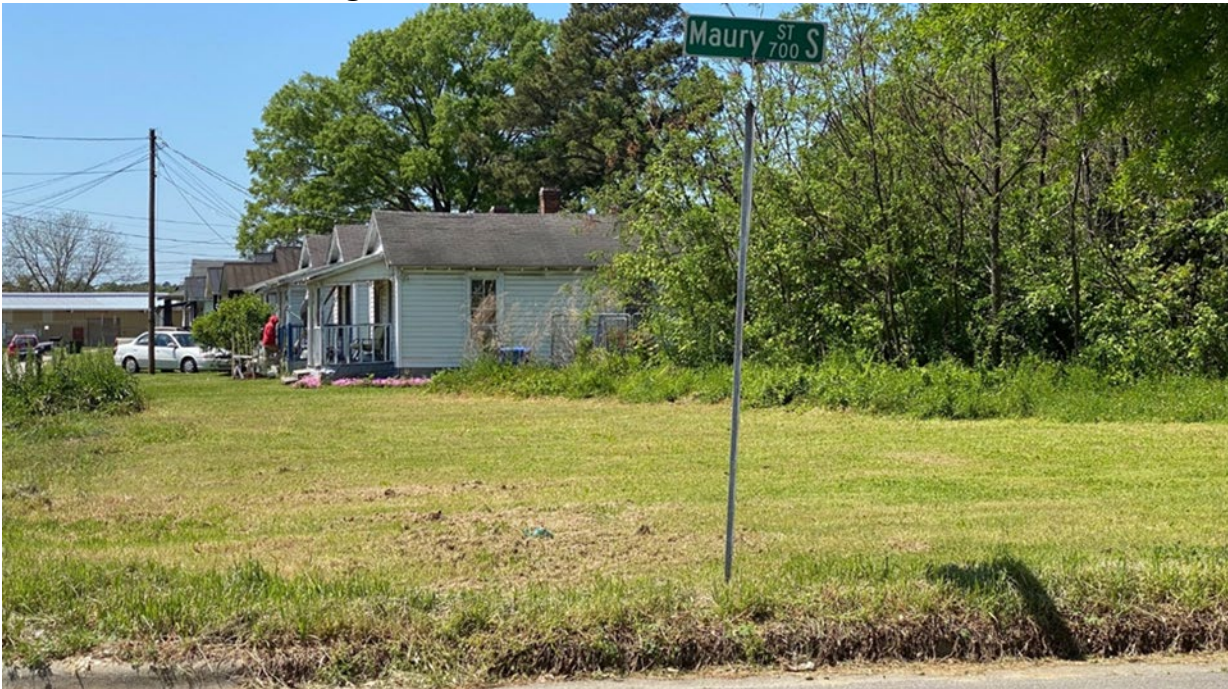
**Figure 33: Intersection Maury Street East and Cemetery Street East, Wilson, NC.
1988 Archival Image.**

Intersection Maury Street East and Cemetery Street East, Wilson NC- Demolished. Top image, archival photograph. Bottom image, photograph taken Spring 2020. Field Notes: Gone.

Approximately five shotgun houses have been demolished without new construction infill. The streetscape and community have been altered significantly due to the demolition of the shotgun houses. The comparison illustrates the visual impact of demolition without new construction.

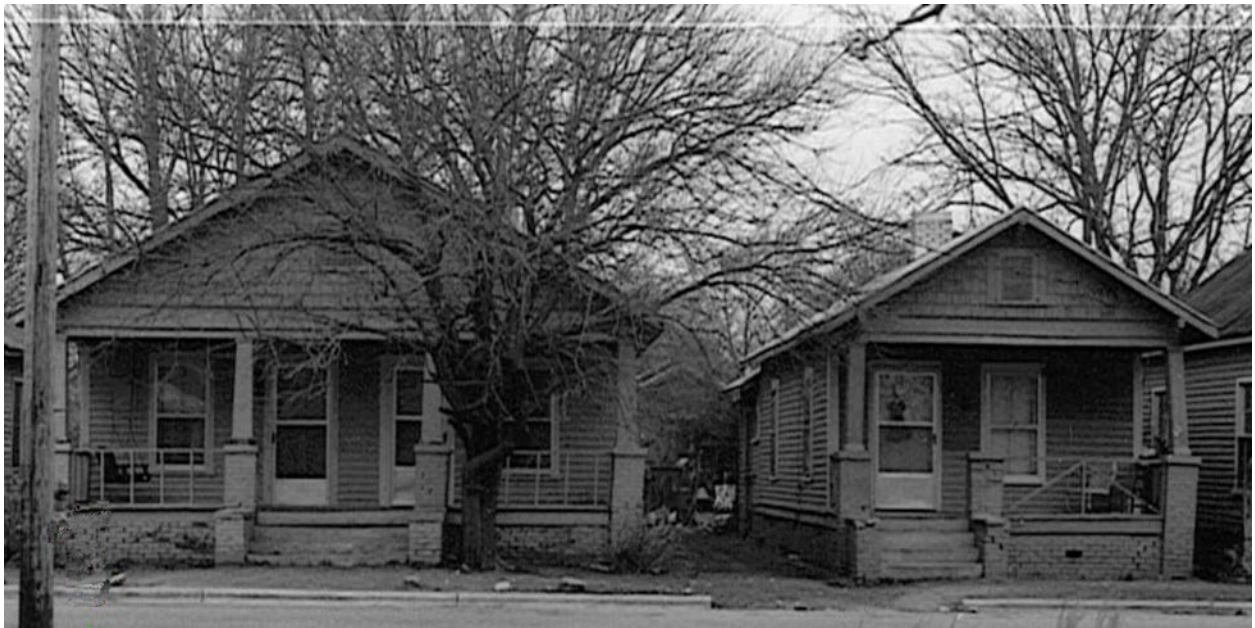
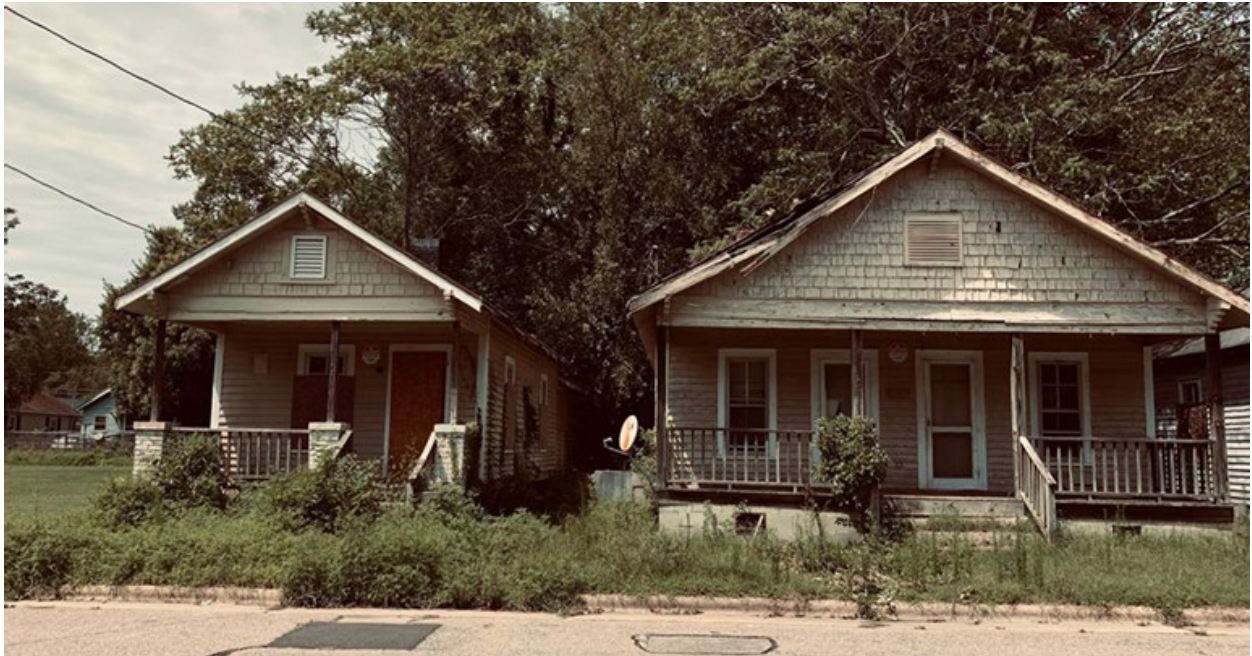
Figure 35: 130-134 Ash Street East, Wilson NC. 1988 Archival Image.

132-134 Ash Street East, Wilson, NC- Deteriorated and Vacant. 130 Ash Street East, Wilson NC – Demolished. This photo does show slightly that a house has been demolished on the far right, but the significance of the photograph comparison illustrates that the two shotgun houses in the photo are still architecturally intact but in deteriorated condition and vacant. Top Image, archival photograph. Bottom image photographed taken Spring 2020.

The material integrity of the shotgun houses illustrates the original standing seam metal roofs, original wood clapboards for the exterior material coverings, and concrete foundation with brick piers. The single shotgun house at 132 Ash Street East front door material and condition cannot be determined because it is boarded up, but it has retained its original front wood window. The double shotgun house at 134 Ash Street East has retained its original front and screen door and original front wood windows. The architectural integrity of the shotgun houses illustrates the original form and the original simple porch form. Seating in the archival

photograph illustrates the use of the front porch as living space. The current photograph illustrates deteriorated current condition, vacant occupancy, and overgrown vegetation. The community and the streetscape have been altered significantly and left in a state of disrepair.

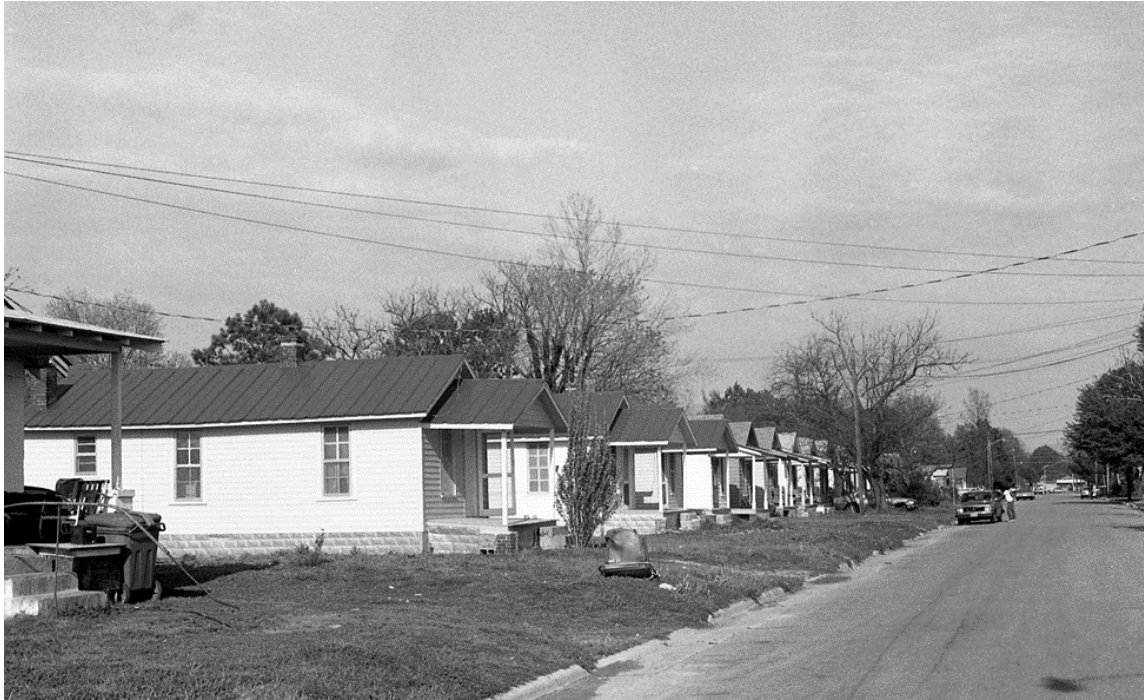
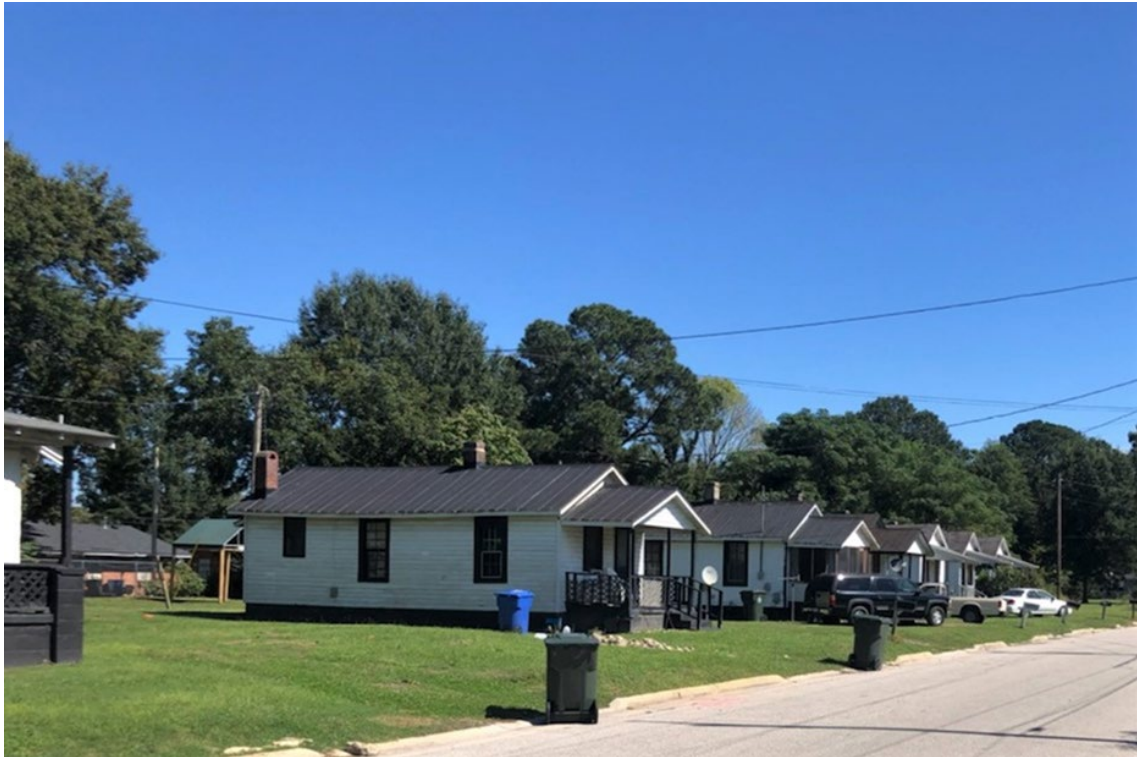
Figure 37: 600 Block Cemetery Street East, Wilson, NC. 1988 Archival Image.

600 Block Cemetery Street East, Wilson, NC – No Substantial Change. Top image, archival photograph. Bottom image, photograph taken Spring 2020.

The material integrity of this row of single shotgun houses illustrates their original standing seam metal roofs and original wood clapboards for the exterior material coverings, and stamped sheet metal foundations. The architectural integrity of the shotgun houses illustrates the original form and the original simple porch form. Detailed wood railings on the front porch are illustrated in the current photographs. The streetscape views of these shotgun houses in the archival photograph and the current photograph displays the architectural character and the ongoing occupancy /residential usage of the shotgun houses. The photographs illustrate the ongoing sense of community and the presence of people in the East Wilson Historic District.
