MORPHOLOGICAL RESPONSE TO REDUCED DISCHARGE
ON A LOSING CATAWBA
RIVER BIFURCATE

A Thesis Submitted to
the Faculty of The Graduate School at
The University of North Carolina at Greensboro
in Partial Fulfillment
of the Requirements for the Degree
Master of Arts

Greensboro
2016

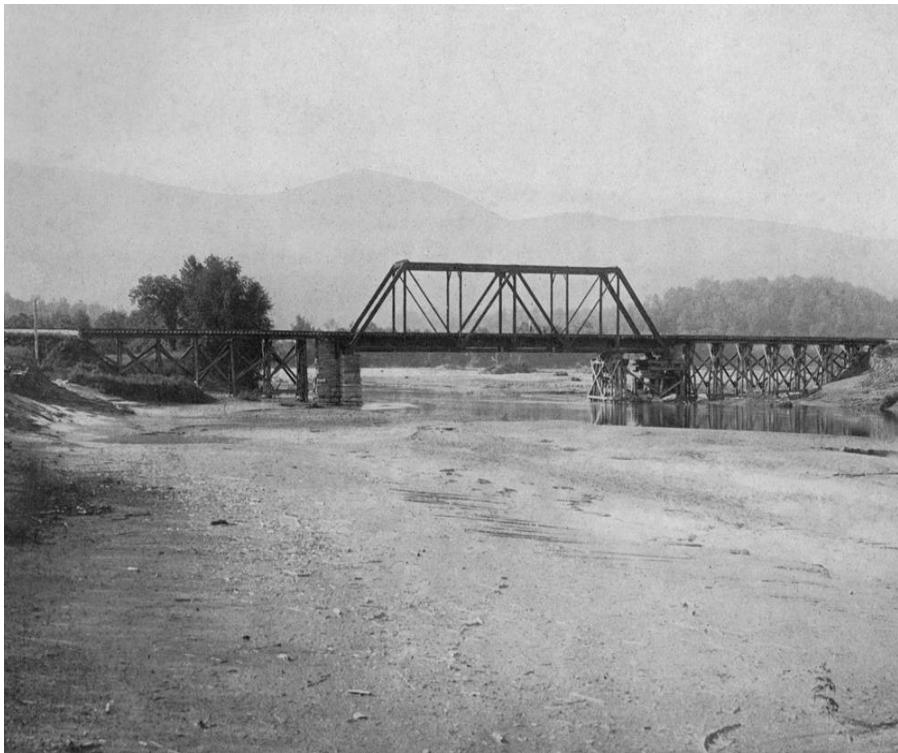
Figure 2. Greenlee Railroad Bridge. *One of two bridges left standing but damaged after the 1916 flood event that left the Catawba River Valley in a state of devastation. D.H. Ramsey Library, Special Collections, University of North Carolina at Asheville. Toto.lib UNCA 1916 Flooding*

The area has experienced many flooding events associated with precursor storms or the set-up of antecedent soil moisture having reached field capacity, then a subsequent meteorological event occurring (Henry, 1916; Corp. of Engineers, 1971; Bailey, 1975; Neary & Swift, 1987; Miller, 1989; Stamey, 1989; La Penta, 1992; Gamble, 1997; Phillips, 2002; Witt, 2005). The well documented flooding event of 1916 left the Catawba River Valley devastated. Practically all growing crops were destroyed along with four bridges that were completely washed away; the Greenlee and Garden City bridges were left standing, but damaged (*Fig. 2*).

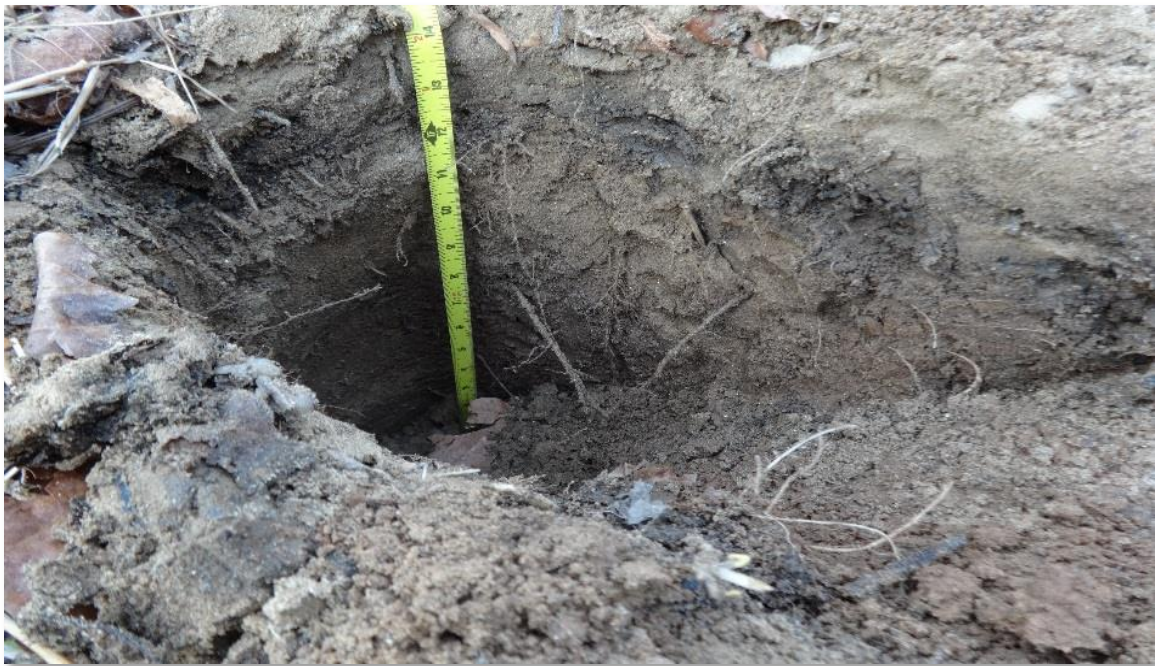
Figure 11. Bench 9 Stratigraphy.

Benches 9 (*Fig. 10*) and 10 consisted of coarse sands and silts of alternating layers ranging from 8cm to 20cm thick. There was a general absence of any pedogenetic features or soil development that might indicate a great age for benches, although a possible incipient A horizon was present in benches 4, 9 (*Fig. 11*), and 16. Organics were also identified at Bench 11. At 20.32 cm in depth from the bench surface a 15.24 cm layer of coarse sand with organics was identified. At the bottom layer of the pit, 52.70 cm in depth from the bench surface, a 2.54 cm thick of organic rich sediment was also exhibited. Bench 13, a tributary bench displayed 15.24 cm of gleyed sediment. There was a gravel or cobble basal layer present in the majority of the low bench stratigraphic profiles that were fully exposed to channel bed level.

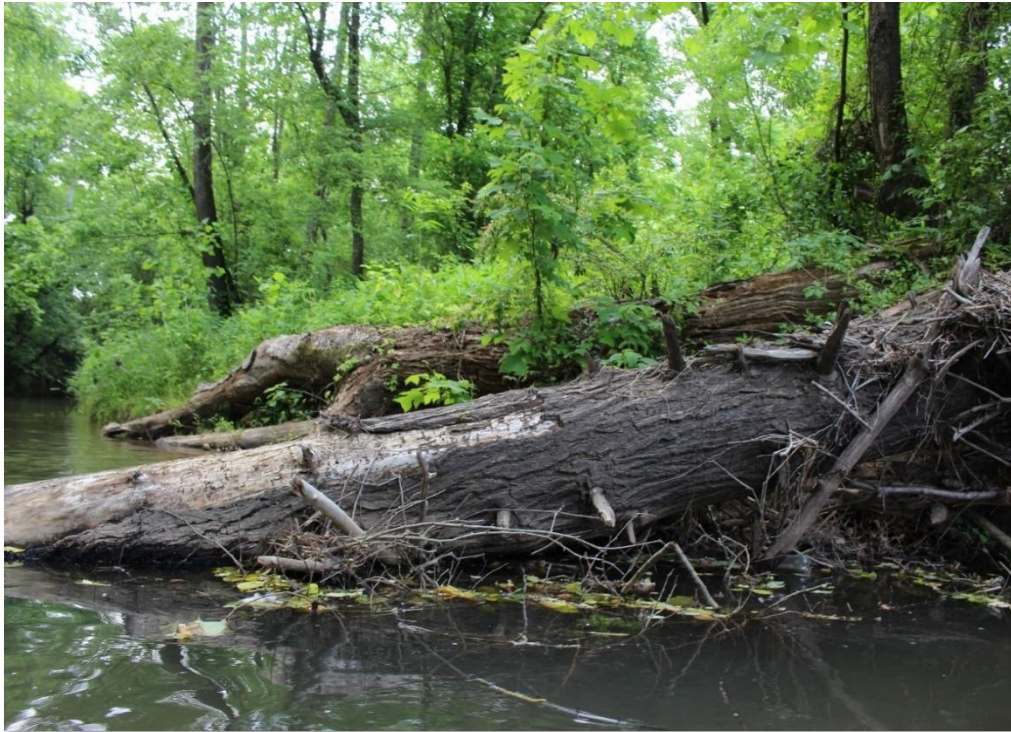
Figure 12. Remnants of a Possible Log Jam. *The presence of large woody debris pile-up immediately downstream of the node, on right bank of losing channel indicating previous high flow event. Photo taken during field survey May 25, 2016*

Field surveys and recent aerial photographs revealed remnants of a possible large log-jam in the node area and immediately downstream of the node. Phillips (2012) found that occurrences of log-jams can influence avulsions. This could also have happened during the 1977 flood event. This area, within what Sorrells and Royall (2014) referred to as the zone of common branching, contains many bifurcated reaches along the Yadkin, Wilson and Linville Rivers- why are all of these reaches bifurcating? Sorrells and Royall (2014, p. 43) felt that bifurcations occur “more likely at landscape positions along major gradient reductions where longitudinal connectivity is diminished and lateral connectivity

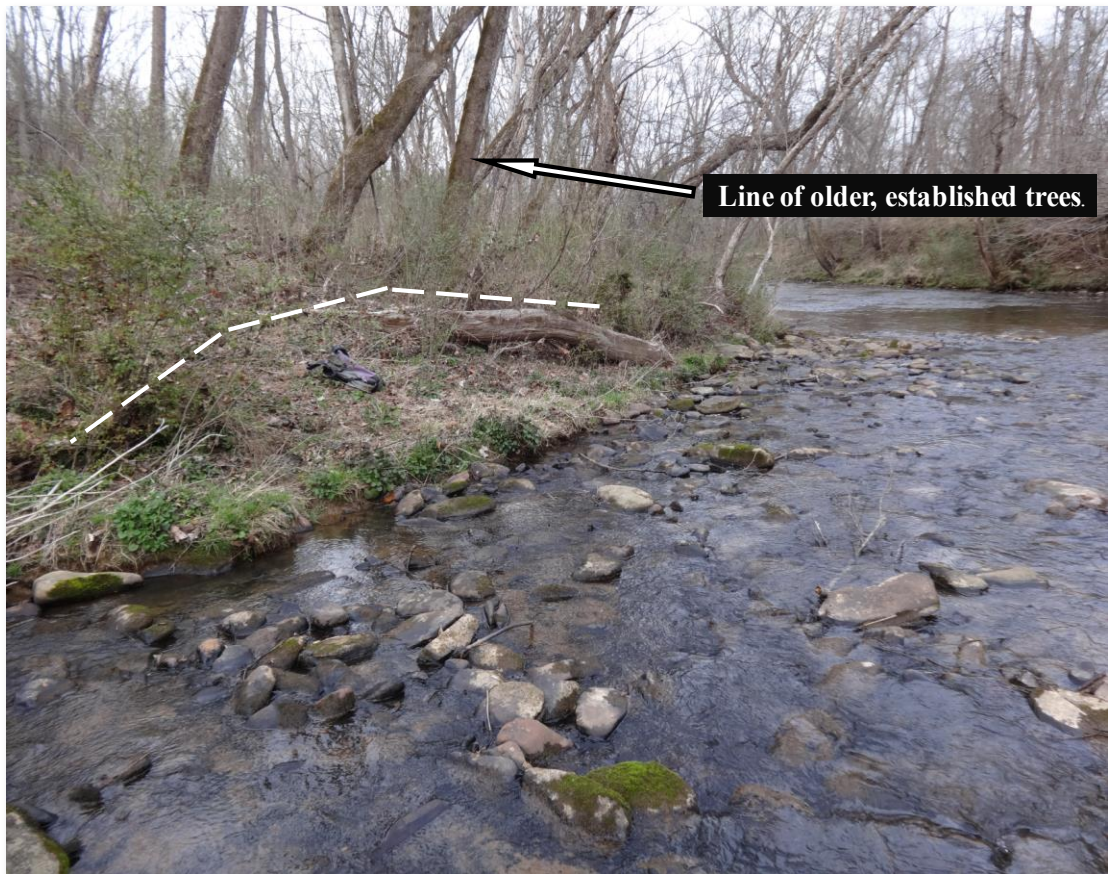
Figure 13. Bench 9, Line of Older, Established Trees. Note the large trees set back from the current bank edge, which indicate the former pre-bifurcation bank. The distance between these trees and the current bank edge represents bank accretion via bench formation since 1977.

decades earlier, shortly after bifurcation. The very large trees were set back from the current bank edge, which indicates the former pre-bifurcation bank. The distance between these trees and the current bank edge represents bank accretion via bench formation presumably since 1977 (*Fig. 13*).

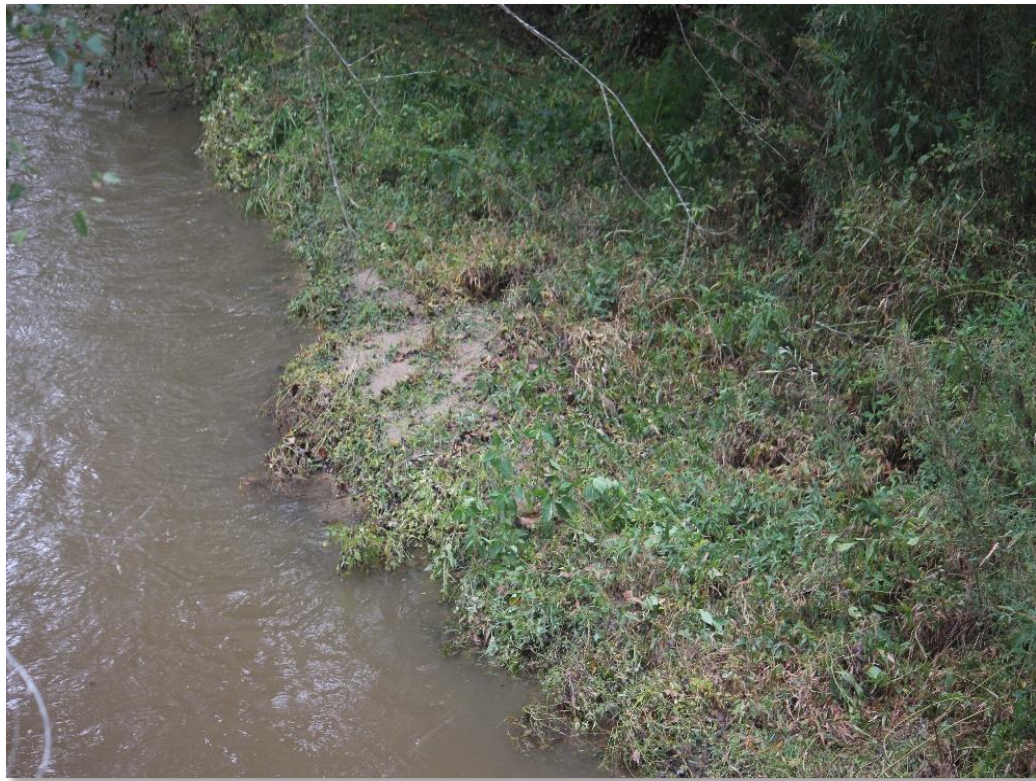
Figure 15. High Flow Event. 3 October, 2015 observed the day after 4 October, 2015. Bench 10 - strandlines and sand evidence of benchfull Q or partial inundation.

The logistics and timing of high flow events prevented many field observations, but one such event was able to be witnessed on 4 October, 2015 (*Fig. 15*). Flood observations relative to benches was able to be conducted through examination of strandlines immediately following flooding. Bench-topping flows were determined based on strandlines and flattened vegetation left on top of benches, or on banks if stages were lower. This observation made it possible to estimate the probable frequencies using the gage data.

At 3:30 pm (EST), 4 October, 2015 bench 10 exhibited evidence of inundation. Strandlines and sand deposited across the top surface of the bench were measured to be an average of 0.41 m in width. At this time the gage at Pleasant Gardens was showing a Q of 1160 cfs and a stage of 4.11 ft. The drainage area adjusted flow for the site as demonstrated above (88.7% by drainage area) would be 1029 cfs. Meaning that the losing branch is estimated to have been carrying 237 cfs. At this flow, Bench 10's elevation was 0.17 m above the water surface.
