MARTY MATOS, LUISA CAROLINA, M.F.A. Adaptive Hospitality: Identifying Design Strategies in the Adaptive Reuse of Historic Buildings as Boutique Hotels. (2018) Directed by Jo Ramsay Leimenstoll. 165 pp.

ADAPTIVE HOSPITALITY: IDENTIFYING DESIGN STRATEGIES
IN THE ADAPTIVE REUSE OF HISTORIC BUILDINGS
AS BOUTIQUE HOTELS

A Thesis Submitted to
the Faculty of The Graduate School at
The University of North Carolina at Greensboro
in Partial Fulfillment
of the Requirements for the Degree
Master of Fine Arts

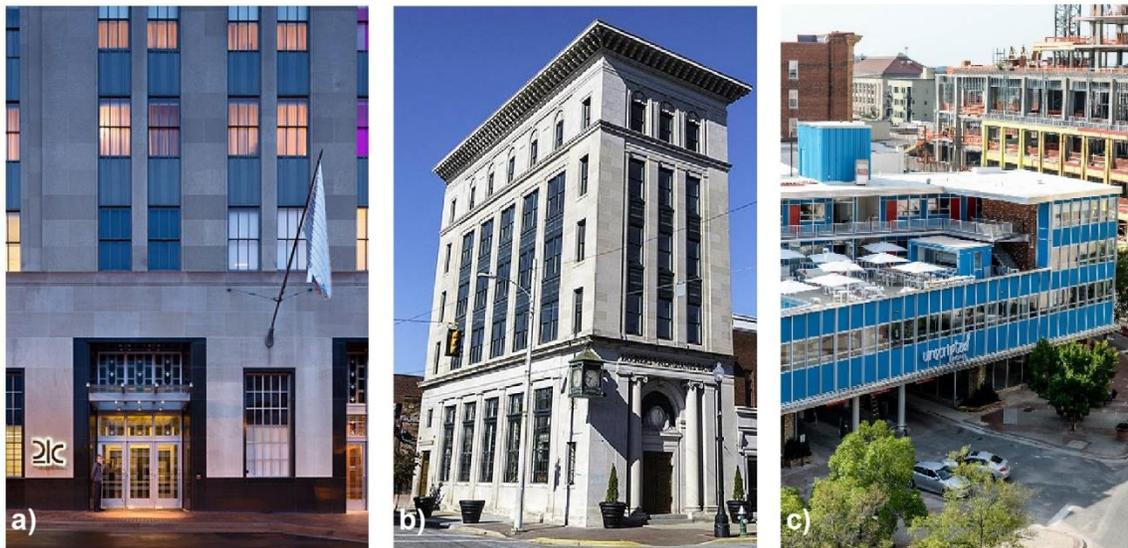
All the cases studied in this research retained the original building façade (Figure 21). The amount of work that these features underwent was limited to cleaning and repointing where necessary. The cleaning of the façades followed the *Preservation Brief No. 1: Cleaning and Water Repellent Treatments for Historic Masonry Building*. The brief serves as a guide of the gentlest cleaning methods available that would not damage the original building materials. The inclusion of new elements was left to a minimum or not added at all. For those buildings that did have an addition to the façade, the newly introduced element was in harmony to the building, and its inclusion did not break the visual continuity of the original façade.

Figure 21. Retained Street Facades of the 21C Museum Hotel, The O'Neil, and Unscripted. (21c Museum Hotel Durham, n.d.; The O'Neil Boutique Hotel, 2015; Unscripted Hotels Durham, 2017)

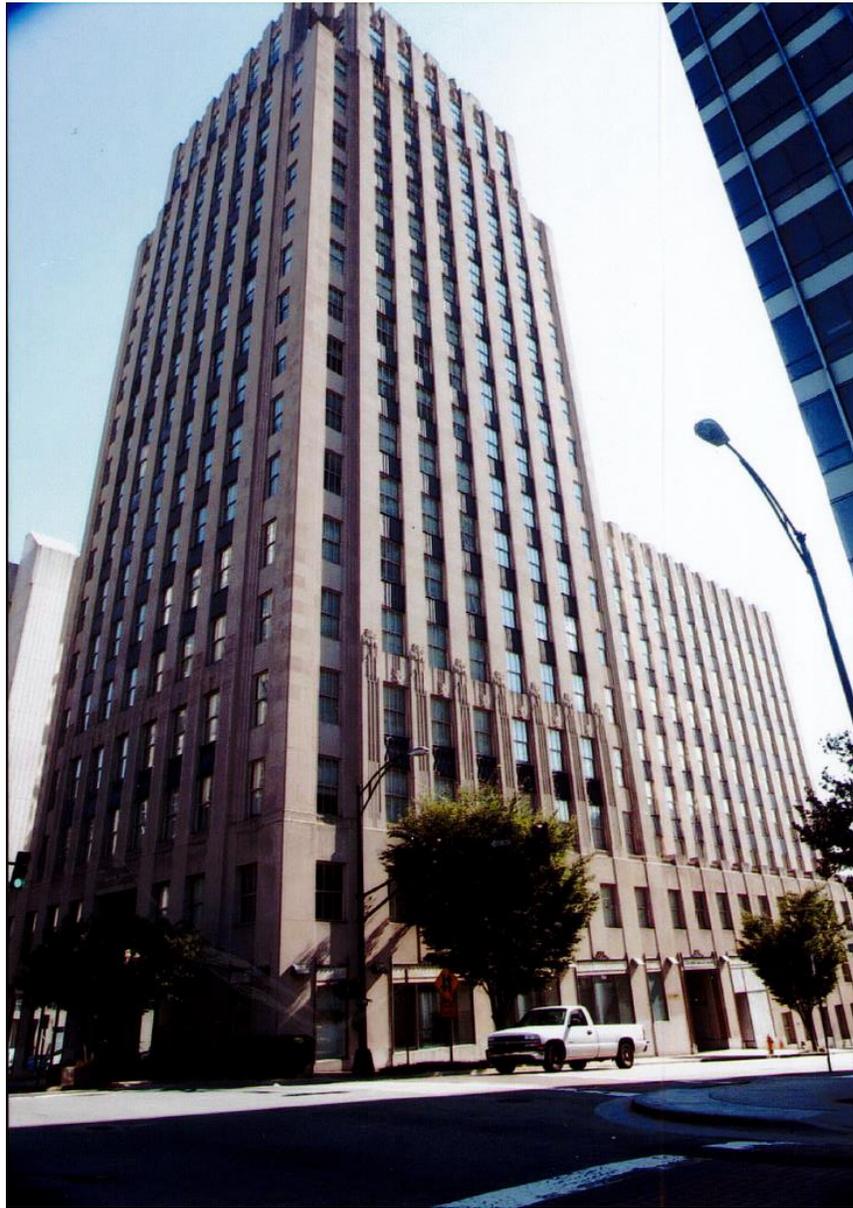
limestone pilasters with low relief carving. The façade of the building was cleaned and spot repointed in 1950, 1960, and 1997-1999, as indicated by the National Register Nomination. During the intervention, the façade was cleaned following *Preservation Brief No. 1: Cleaning and Water Repellent Treatments for Historic Masonry Building* which ensures the use of the gentlest cleaning method. Spot repointing was implemented where necessary.

Figure 28. Before Image of the West (Main Street) Façade. (Heritage Construction Group, 2016).

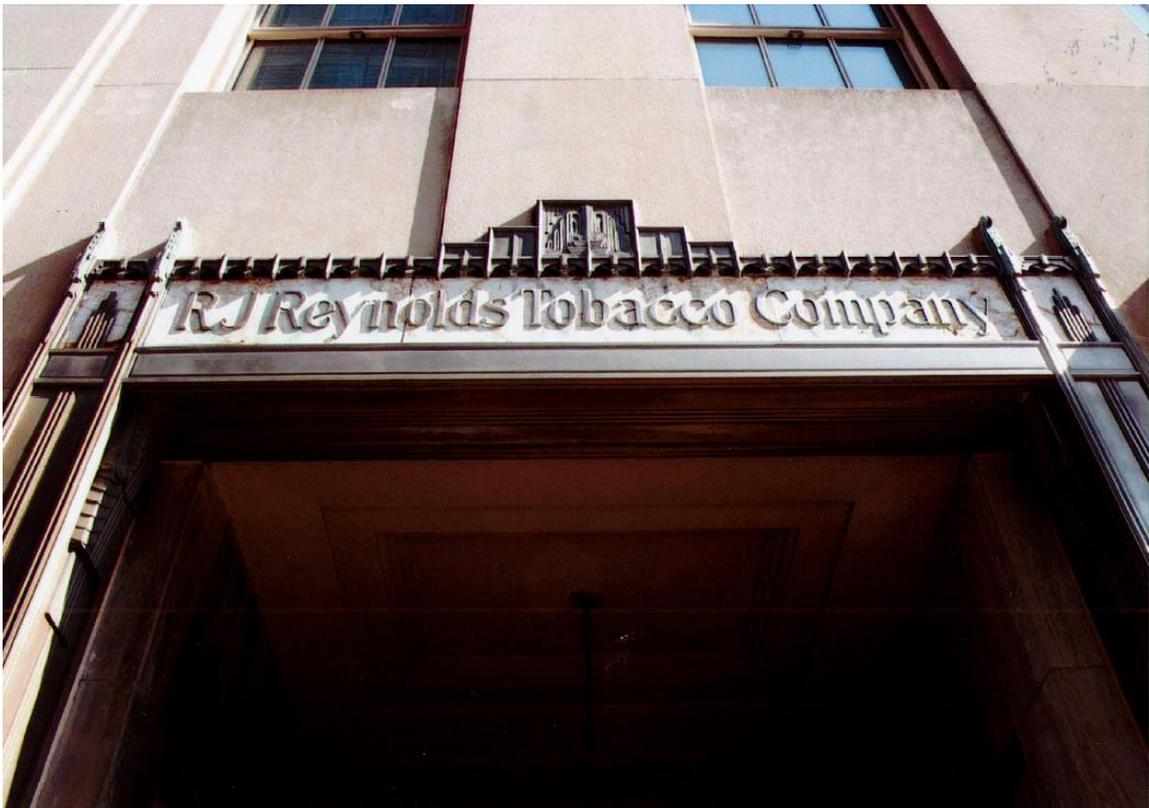
Both of the building's original signs that read "R. J. Reynolds Tobacco and Company," one in metal pin letters (Figure 29) and the other in marble, were removed from the facade. In their place, there is a blade sign that reads "The Cardinal" at the corner of the building.

Figure 29. Original Sign on the Façade of the Reynolds Building. (Heritage Construction Group, 2016).

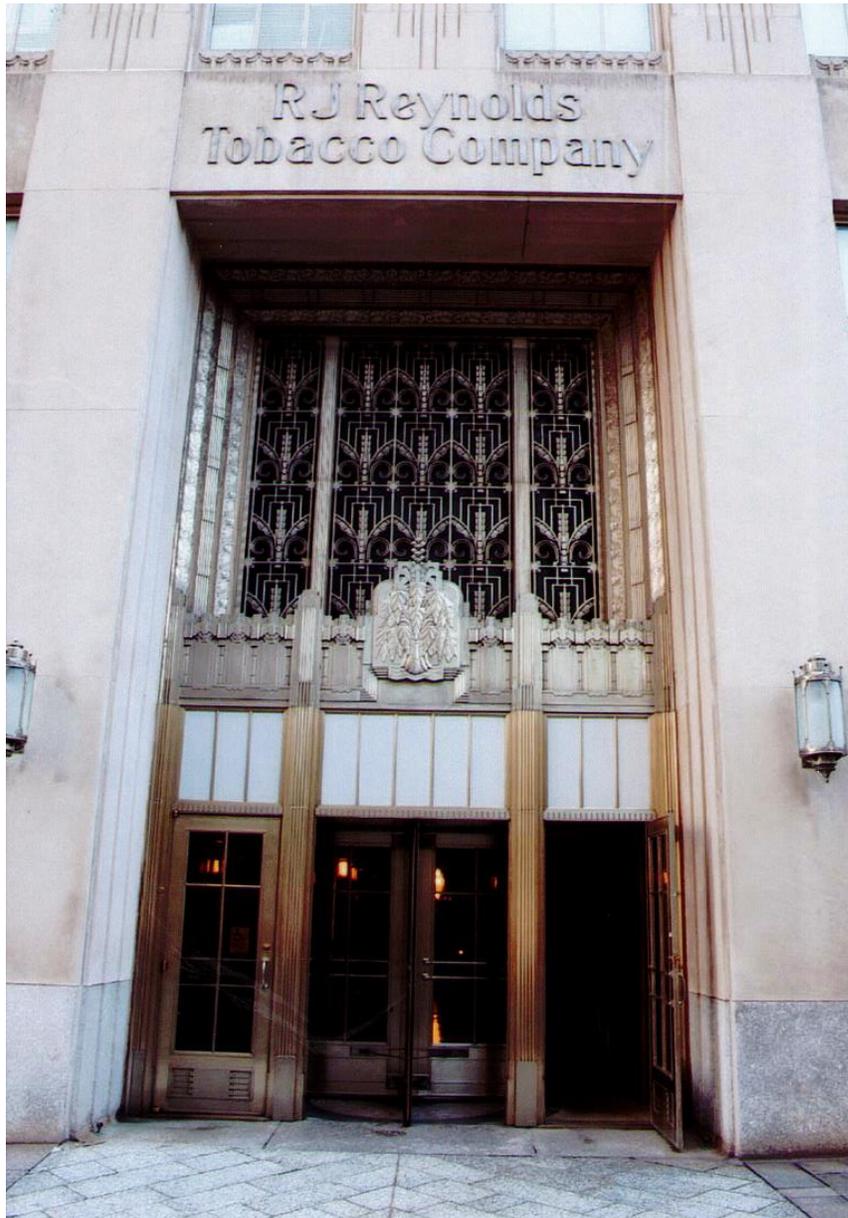
The main entrance contains a nickel-silver revolving door, which is flanked by single-leaf metal-framed doors and a three-part transom with solid metal bands. The entrance retained its original condition, the only alteration being the incorporation of a glass and aluminum canopy. The canopy serves as a shelter when guests arrive and depart from the hotel (Figure 31). The choice of materials for the transom guarantees the visual continuity of the original façade. The canopy was attached to the masonry to protect the decorative metal details present on the transom. This is an excellent example of a harmonic juxtaposition of the new and the old in a historic building, where the new addition can be removed without damaging the original feature.

Figure 30. Before Image of the West Entrance without the Canopy. (Heritage Construction Group, 2016).

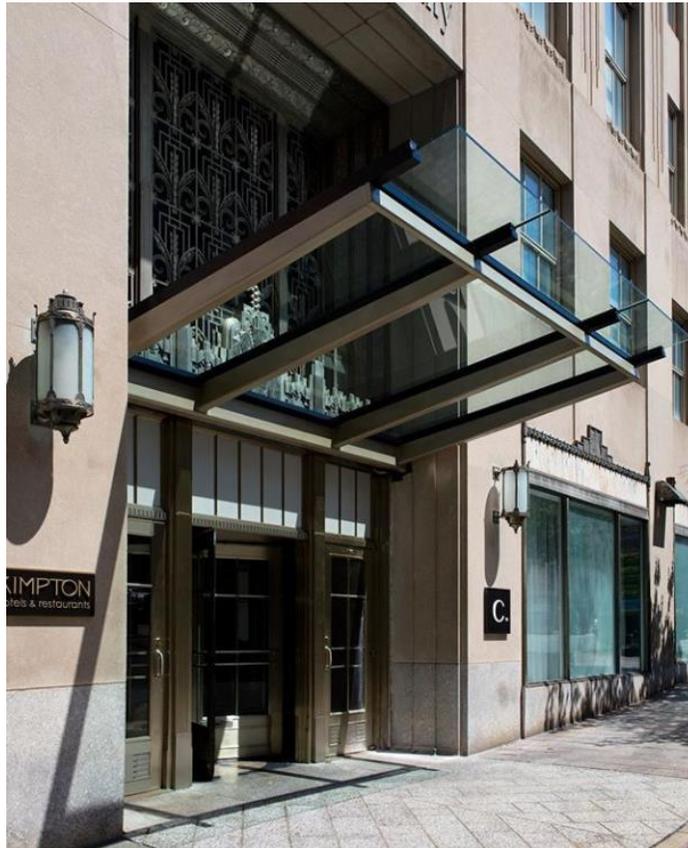
Figure 31. West Entrance with Canopy Addition. (Expedia, n.d.).

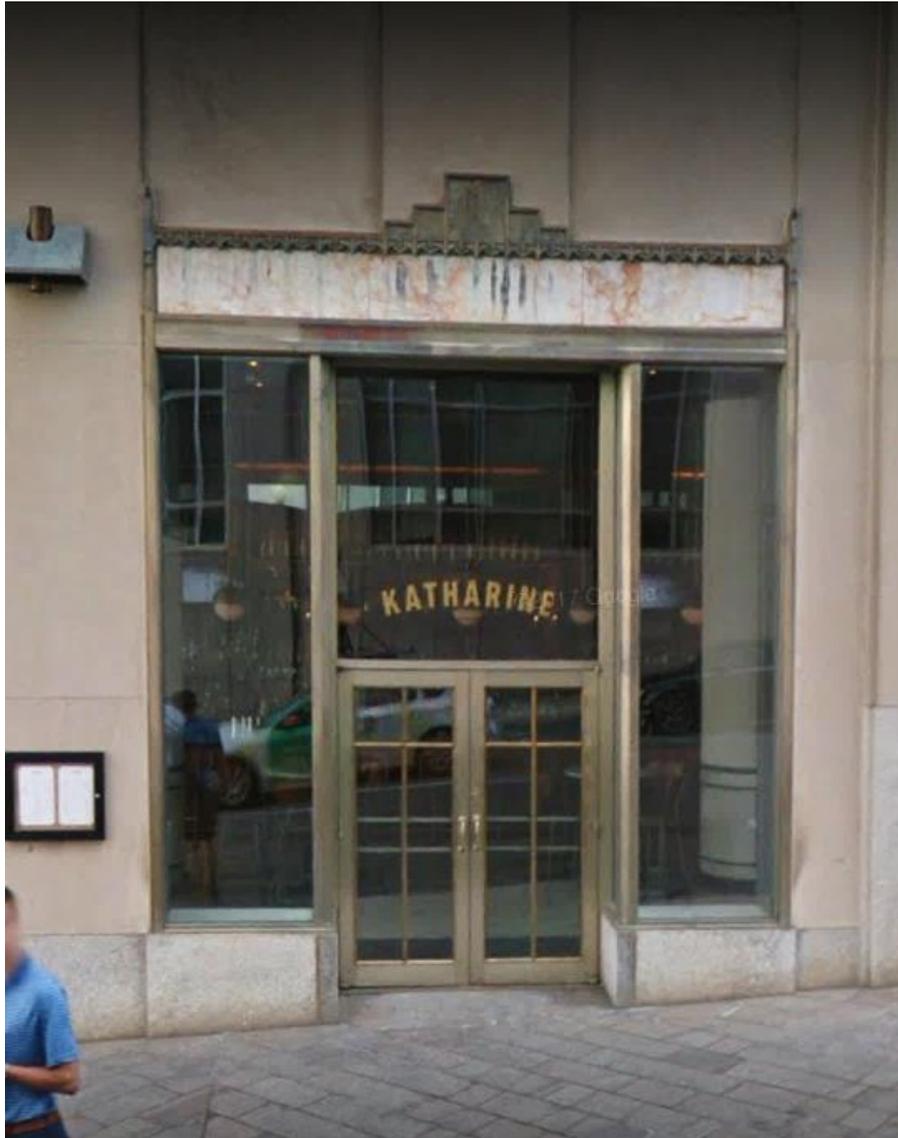
The in-house restaurant of the hotel is named Katherine and possesses an independent entrance also located on Main Street (Figure 32). This entrance has double-leaf glass doors and a transom that, contrary to the main entrance, to the hotel is not ornamented. This entrance also retained in its original condition, and the name of the restaurant was placed on the transom (Figure 32).

Figure 32. Current Restaurant Entrance. (Heritage Construction Group, 2016).

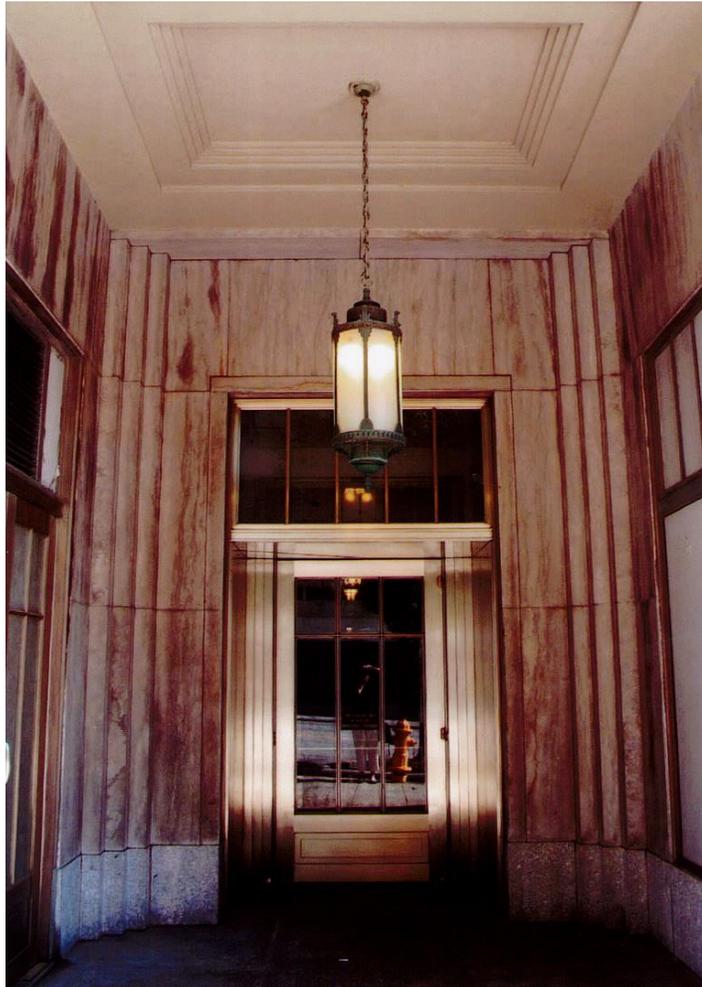
The entrance located on East Fourth Street functions as the secondary entrance to the hotel and the main entrance to the apartments (Figure 33). This entrance has a single-leaf door original to the building. Just like the other entrances, there were no alterations of this feature.

Figure 33. Secondary Entrance to the Hotel and Primary Entrance to Apartments. (Heritage Construction Group, 2016).

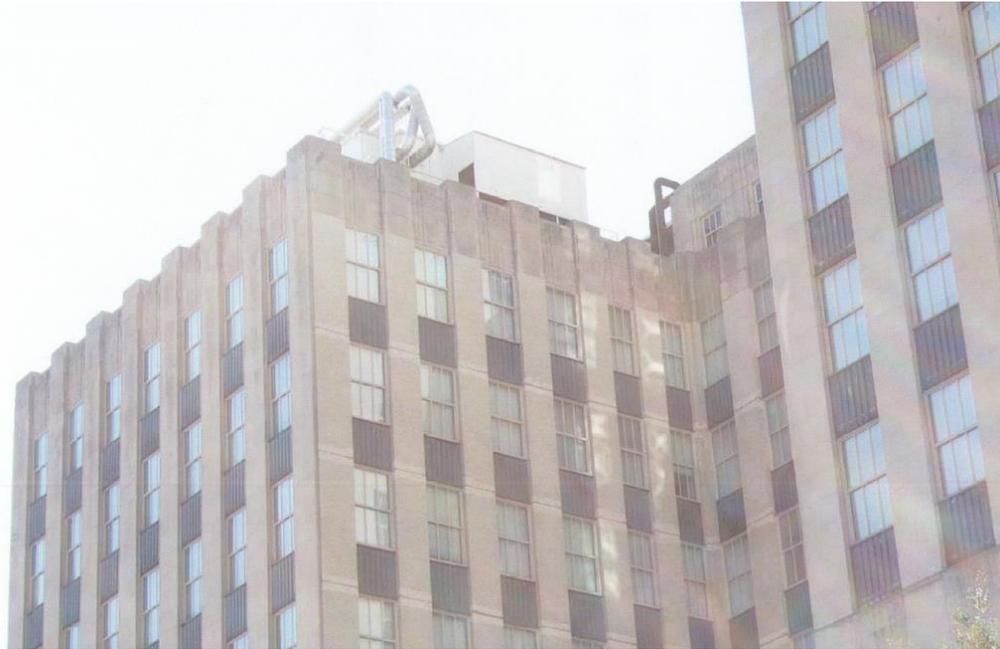
From the seventh to the twenty-first floors, where the apartments are, the windows had to be removed and replaced with operable windows to meet the fresh air code requirements. The new windows were created to match the existing ones in color and finish. Other windows were also removed on the 10th, 18th, and 20th floors and replaced with doors to allow access to the roof areas of those levels. The new doors, however, are not visible from the sidewalk, so they do not disrupt the overall façade of the building.

Figure 34. Upper Floor Windows Before the Adaptation. (Heritage Construction Group, 2016).

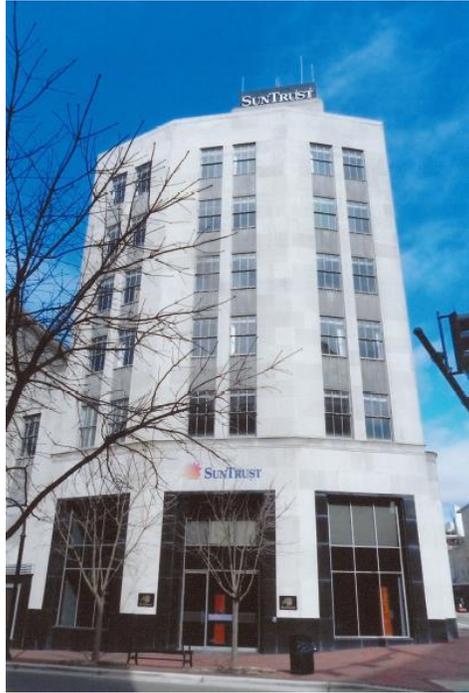
Figure 41. Black Granite on Storefront Façade. Original Condition (Greenberg, 2013a).

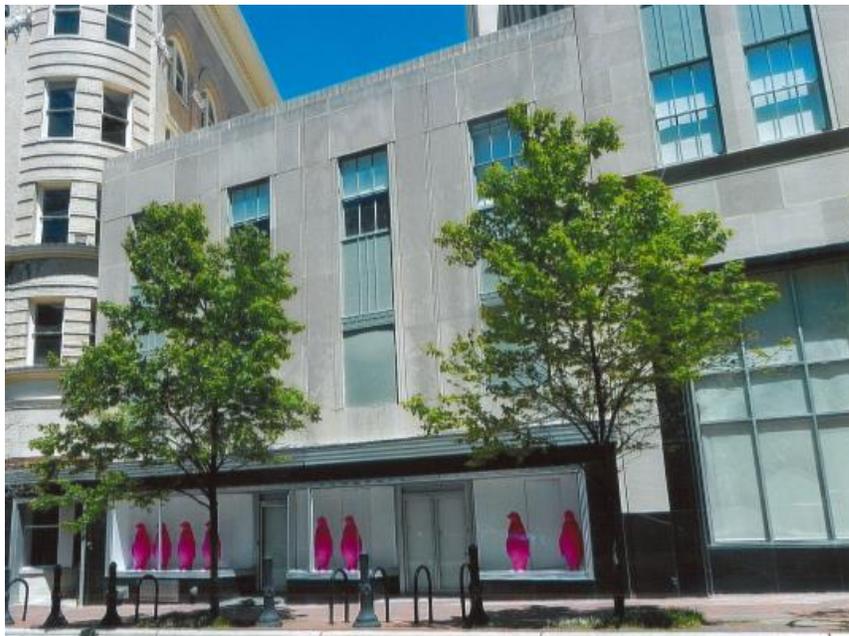
Figure 42. Cleaned Façade of the Hill Building. (Greenberg, 2013a).

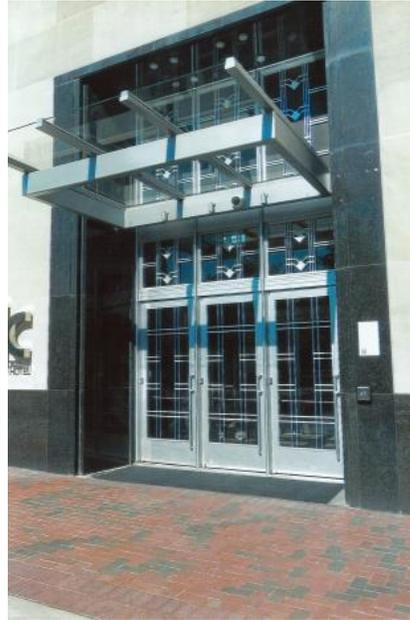
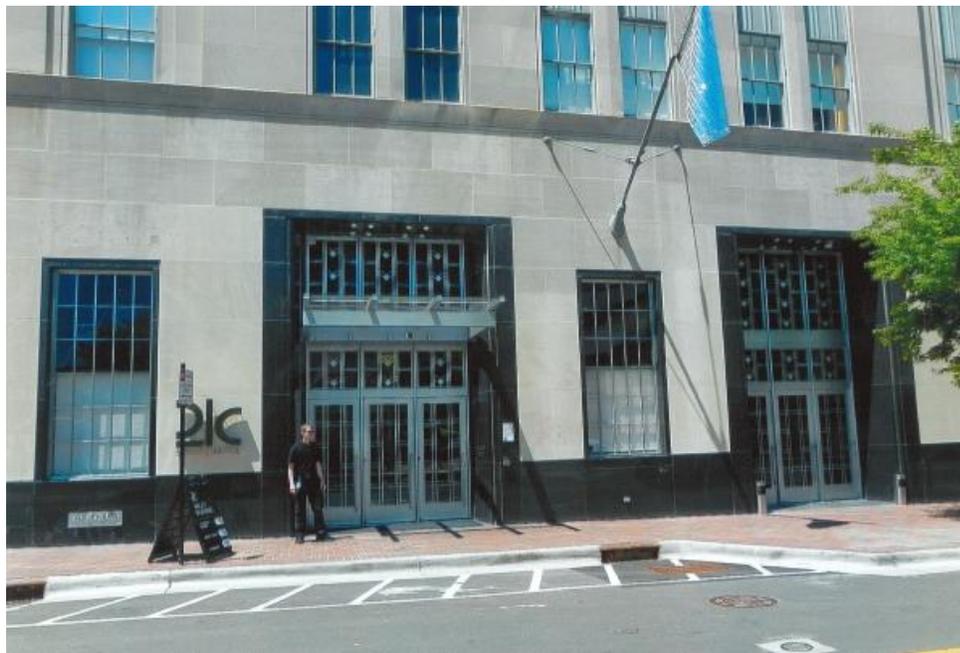
spaces. An aluminum and glass canopy was added to all the entrances to provide shelter for the guests of the hotel (Figure 44).

Figure 44. Canopy and Signage Addition to Entrances. (21c Museum Hotel Durham, n.d.)

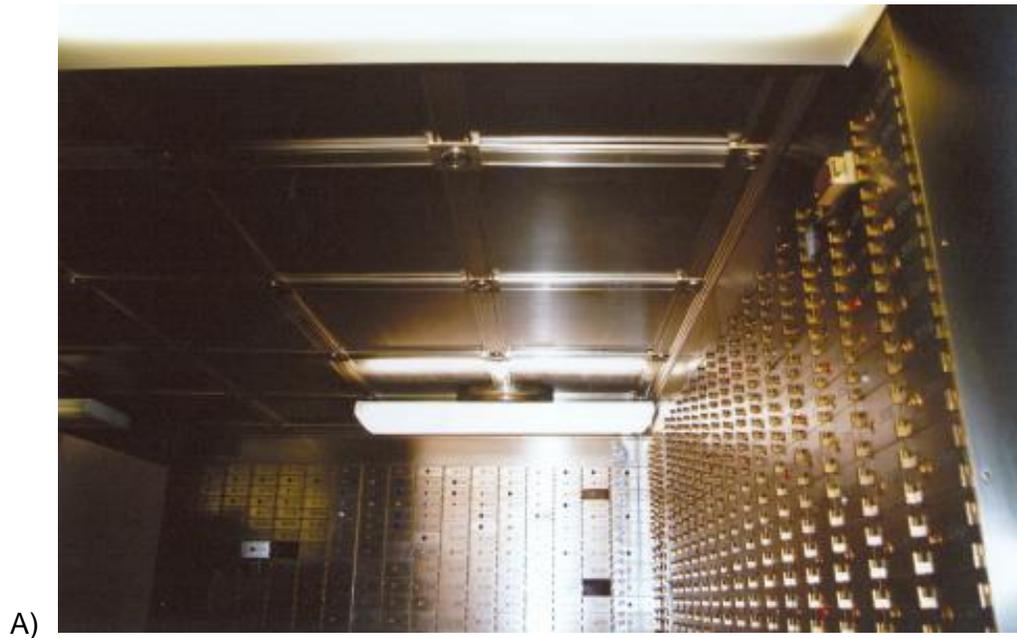
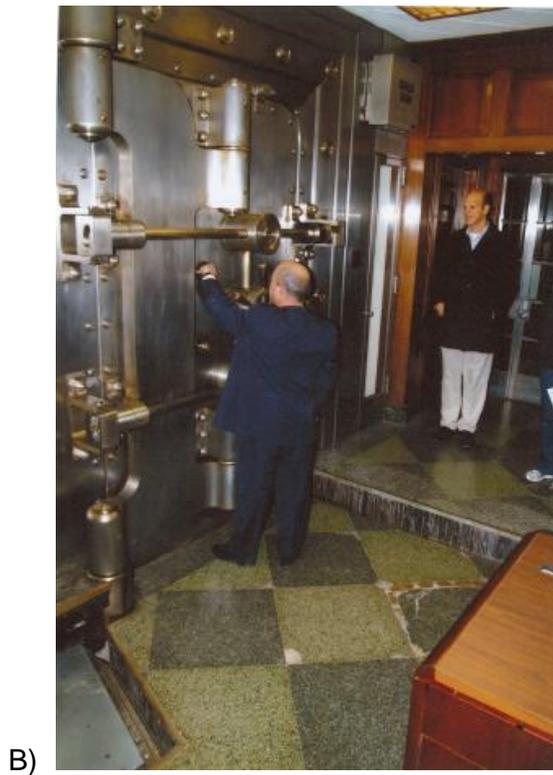
Figure 52. The Original Condition of the Vault at the Time of the Adaptation. (Greenberg, 2013a).

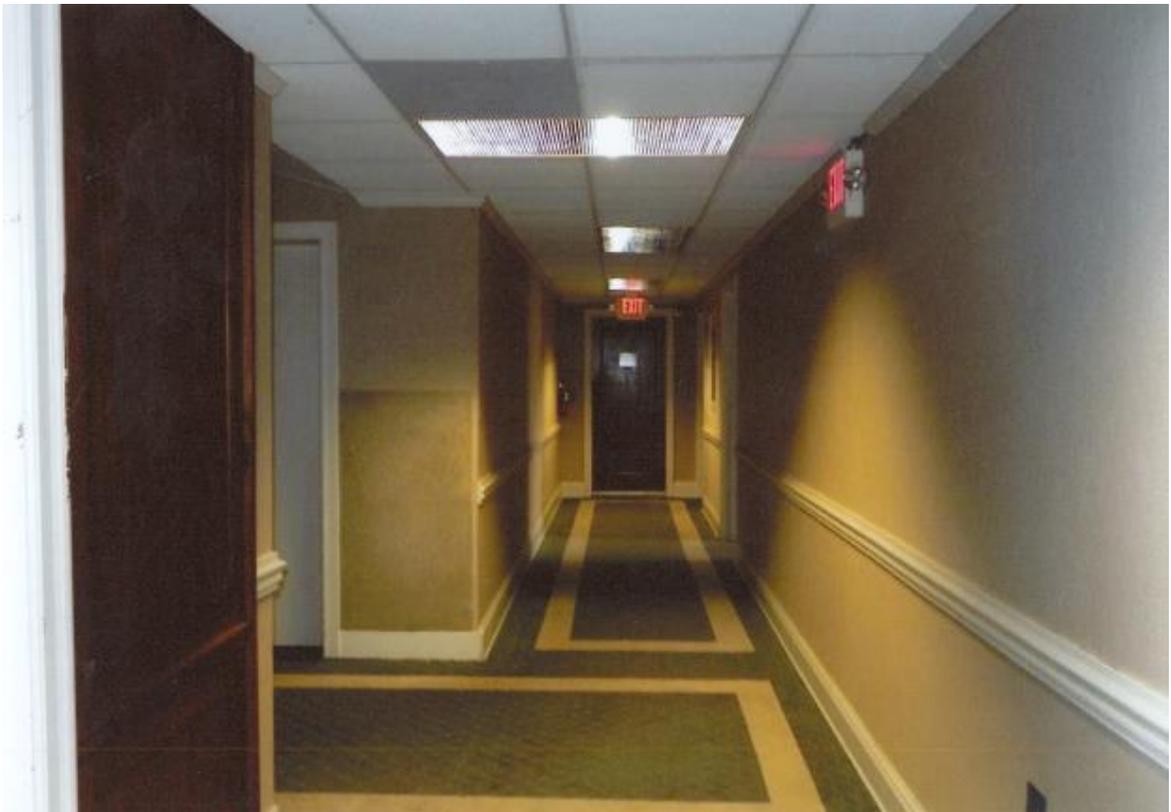
Figure 54. Upper Floors Before Removal of Non-Original Features. (Greenberg, 2013a).

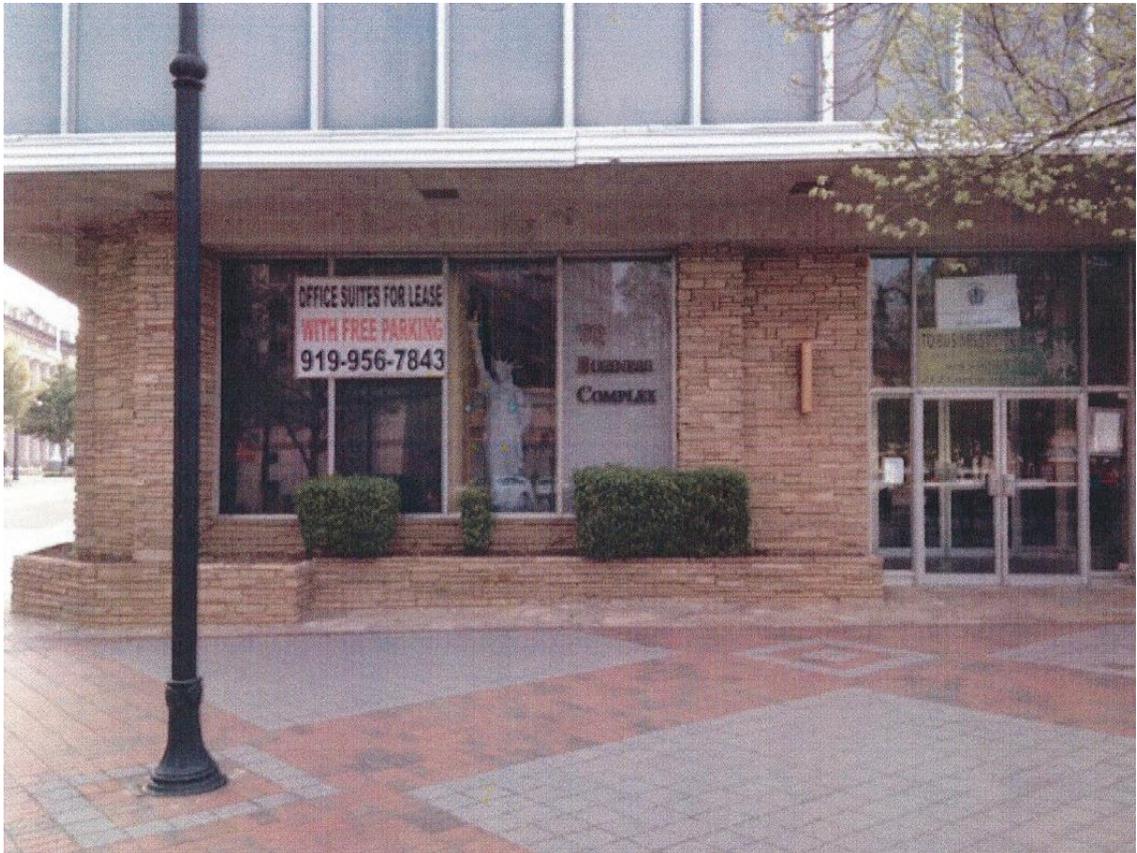
Figure 56. Façade of the Jack Tar Motor Lodge Before the Adaptation. (Hills, 2016).

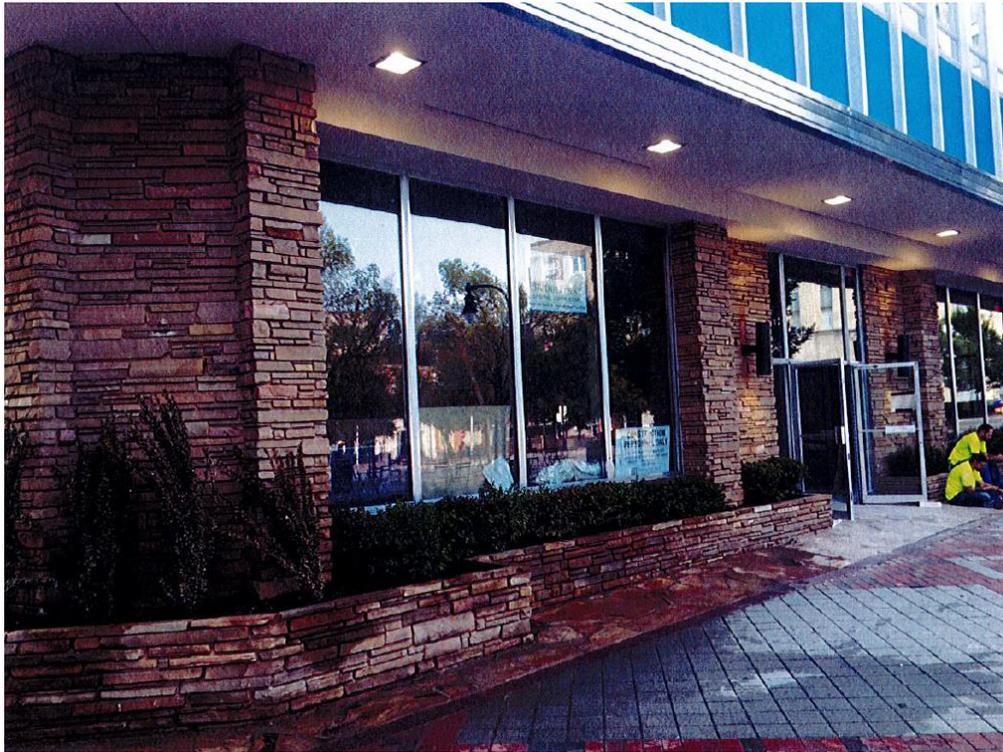
Figure 57. Part of the West Façade Tan-colored Stone After the Restoration. (Hills, 2016)

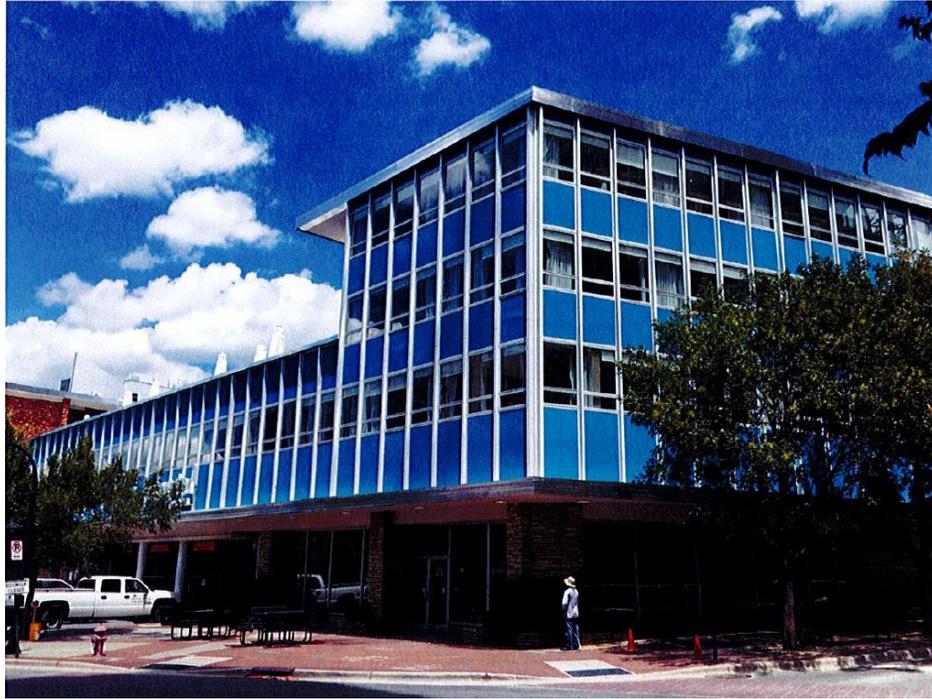
Figure 60. Curtain Wall on the Southwest Corner of the Building After Rehabilitation. (Hills, 2016).

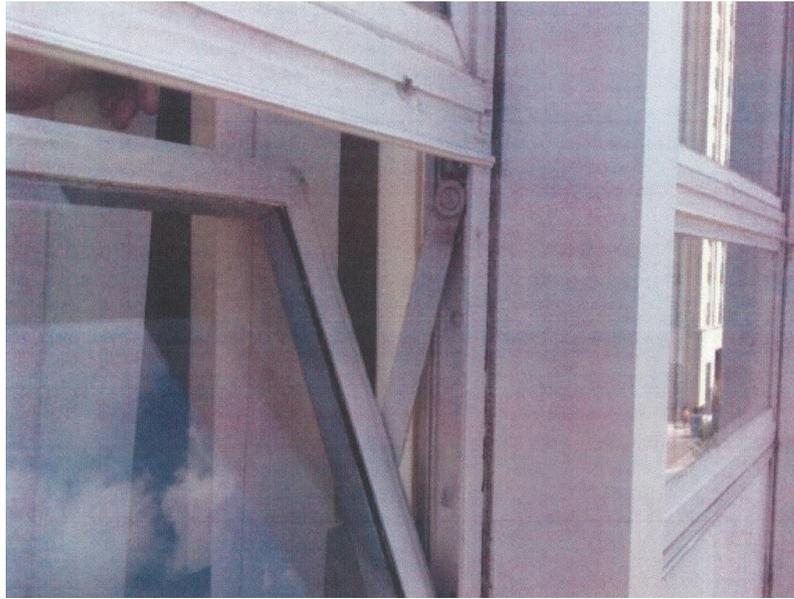
Figure 61. Original Operational Windows on the Motor Lodge Bedrooms. (Hills, 2016)

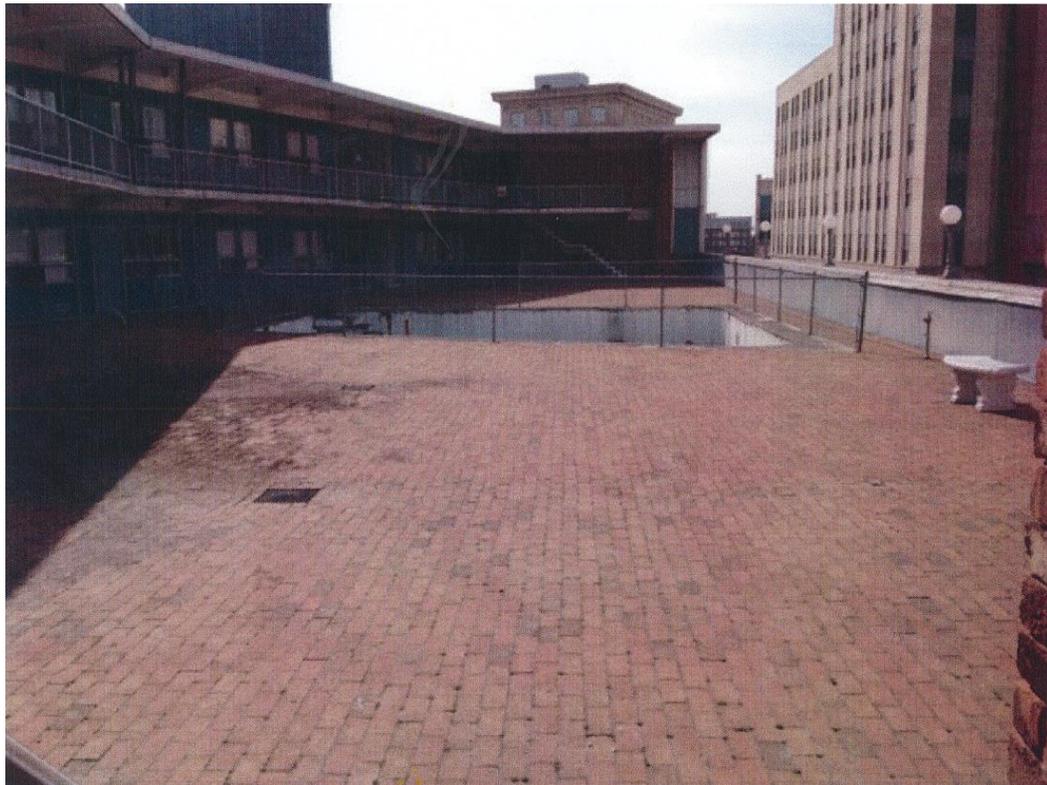
Figure 67. Paver on the Roof Deck Prior to Rehabilitation. (Hills, 2016).

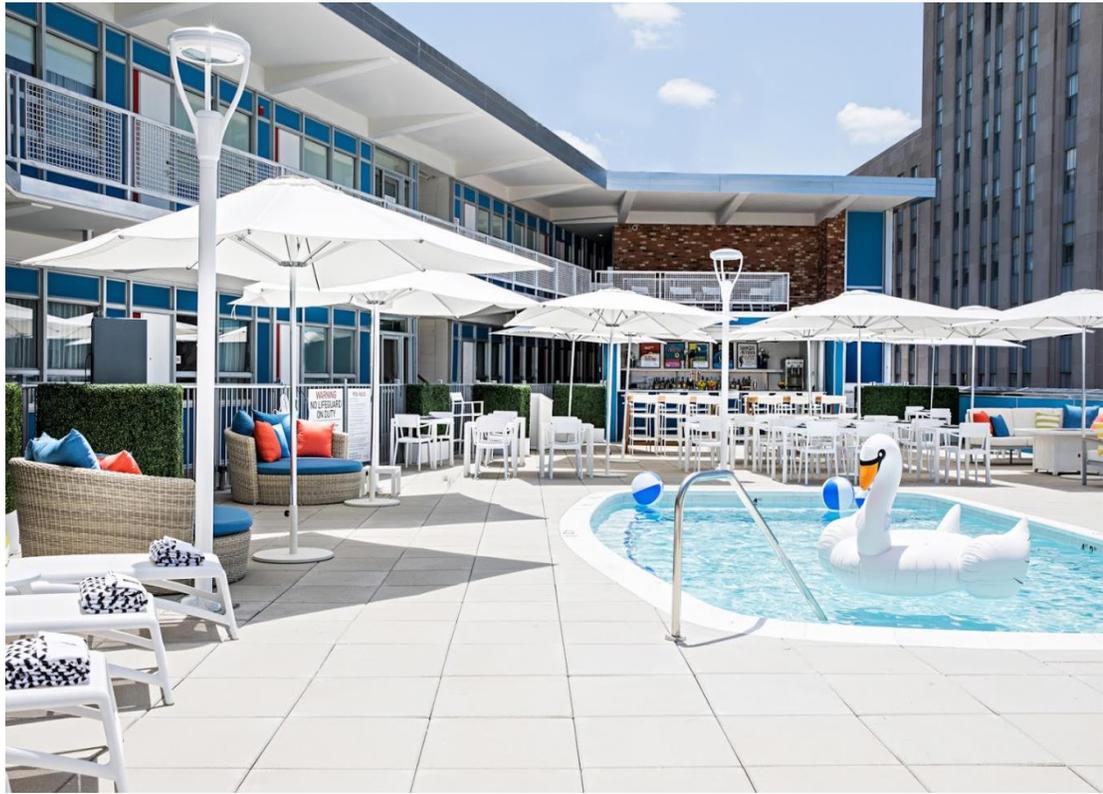
Figure 68. The New Roof Deck Pavers. (Unscripted Hotels Durham, 2017).

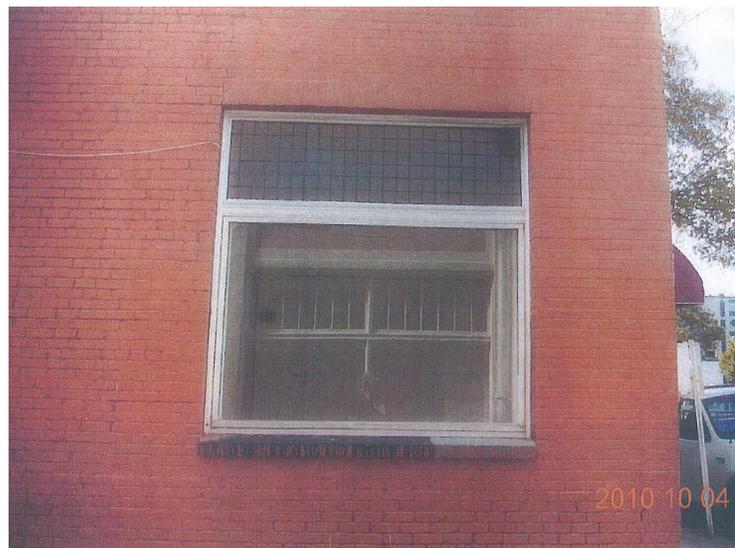
Figure 77. Original Window Before the Rehabilitation. (North Carolina State Historic Preservation Office, 2016).

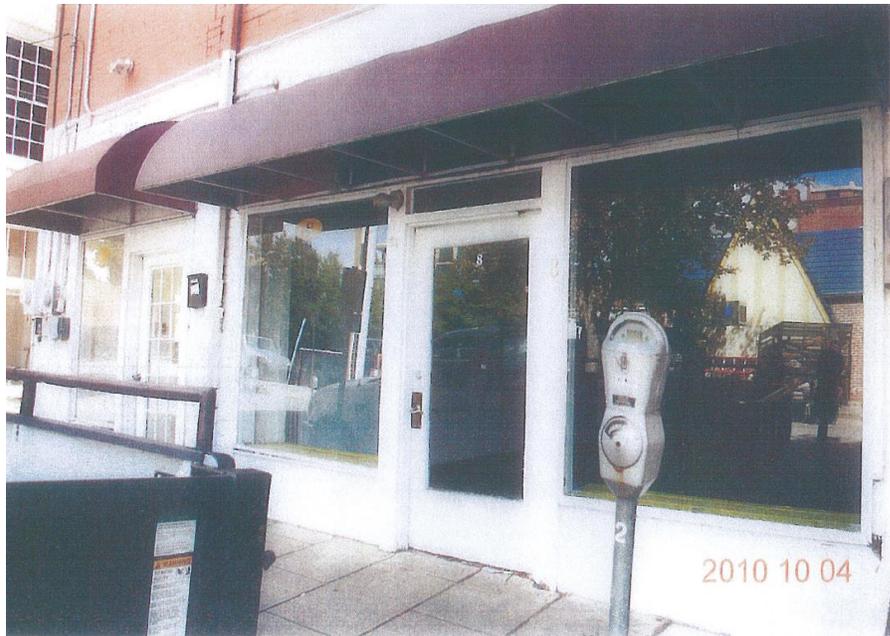
Figure 78. The New Storefronts. (North Carolina State Historic Preservation Office, 2016).
