DENDROARCHAEOLOGY AND THE DATING OF HISTORIC FARM BUILDINGS
ON THE SUMMERS' FARM, SUMMERFIELD, N.C.

A Thesis Submitted to
the Faculty of The Graduate School at
The University of North Carolina at Greensboro
in Partial Fulfillment
of the Requirements for the Degree
Master of Arts

Greensboro
2019

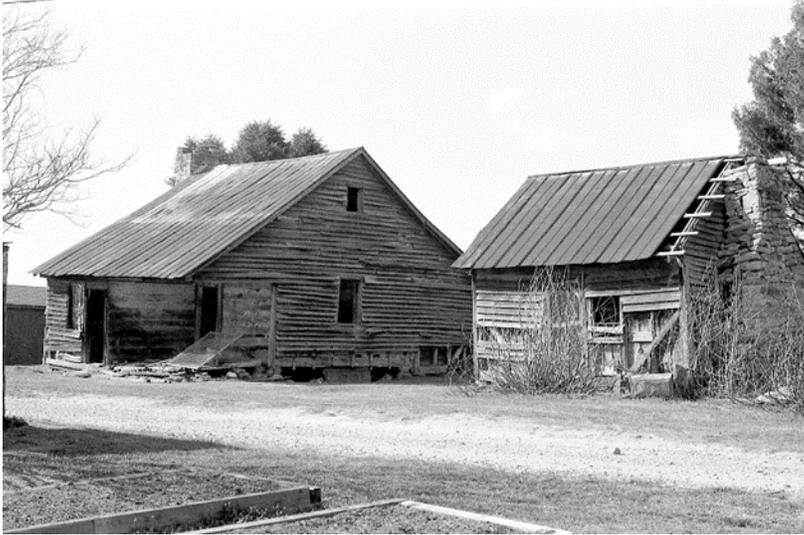
Figure 2. The Main House (Left) from the East Side with Kitchen (Right). (Photography Courtesy of the North Carolina State Historic Preservation Office, Circa 1995).

The main house is marked by diamond V-notching, which is a style of notching not commonly practiced in the Southeast (Swaim, 1978; Jordan, 1985). This style of notching was mainly German that the Scottish then adopted (Swaim, 1978) but because of how labor intensive it is to take so much wood off every side it was not commonly seen. The joists used in the construction of the main house are also hand-hewn logs. The house is covered in clapboard siding except for the front entrance which is covered with a porch overhang, resembling a canter-lever barn. The back of the house has a full-length porch and the joists are planked with boards. The back porch is the most deteriorated part of the structure, but this has exposed several of the main support sills running under the house. The sills were used to raise the house up above the ground and originally set on large smooth stones but there is evidence that some areas were replaced by modern bricks.

The plan of the main house is an English and Scotch-Irish hall-and-parlor structure as evidenced by a chimney along the roof ridge, as well as having the front and back door perpendicular to the roof ridge and aligned with each other (Jordan, 1985; Graybeal, 1995). The hall-and-parlor style is distinguished by a single, square living space on the main floor with a small boxed stairway that leads to the sleeping area upstairs 'parlor' (Swaim, 1978). The Scotch-Irish also had a shed room attached to the house with a small porch and then a large full-length front porch (Swaim, 1978). However, in this house the shed has always been called the front of the house because of the road that runs in front of it. This shed would have been helpful for a farmer; as he drove down the road he could stop and grab what he needed out of the shed. The full-length back porch, which at some point was screened, overlooks the farm. From German ancestry the use of a semi-subterranean cellar is evident by the northeast side of the house has an exposed cellar (Swaim, 1978). This is the principal reason why the inside of the floor is slowly collapsing as the sills rot. The southwest side of the house has a stone chimney on the side wall with an opposite facing window. Originally there was a kitchen that was detached from the house like the dog-trot houses in Northern Europe, though it lacked their characteristic connecting alley (Jordan, 1985). However, the kitchen was dilapidated and suffered extensive damage from a tornado, after which it was torn down and replaced with a new building.

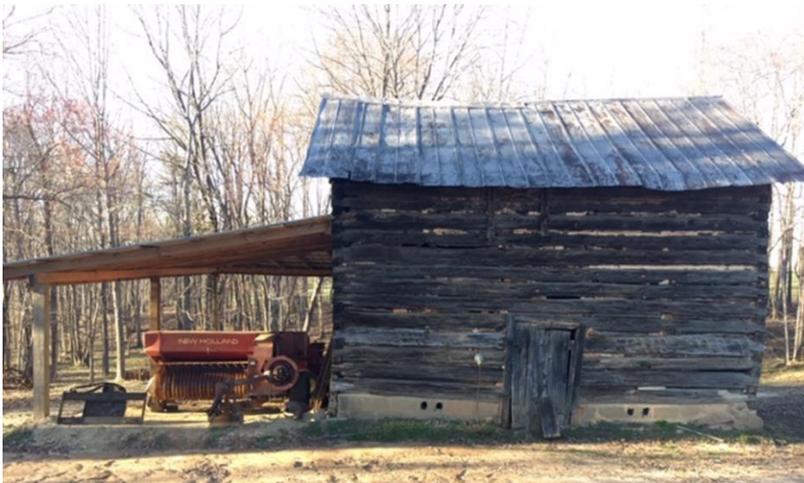
Figure 3. The Tobacco Barn. The Front Foundation was Redone (Date Unknown), but the Remainder of the Foundation is Original Stacked Stone. (Photograph by Author).

The tobacco barn has full and half-dovetail notching. The joists are squared timbers and were likely hand notched by an adze and/or ax because of scarring on the joists instead of a smooth surface. The tobacco barn stands alone without any siding except for a shed that sits at a sharp angle on the back to help protect those that maintained the fires and for protection from the sun as farmers hand tied the tobacco leaves to stakes to prepare them to be hung in the barn. However, in 2018 the old shed was torn down and a new wraparound shed was added for farm equipment storage because the original shed had deteriorated.

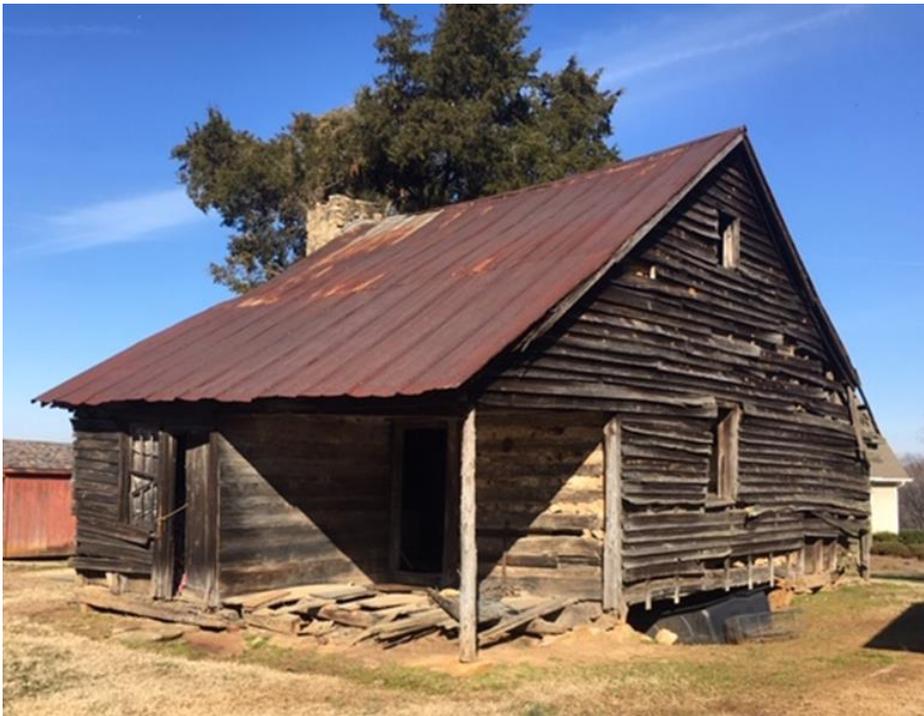
Figure 4. The Northeast Side of the House Where Timber Slabs and Cores were Pulled. (Photograph by Author).

Cores were pulled from the front porch wall and inside back wall in the house, while slabs were pulled from the sills on the northeast side of the house with a DeWalt™ reciprocating saw. On the main house the sills were all squared instead of the joists of diamond V-notching. The squared sills appear to have smooth edges suggesting that several rings were not removed in the process, thus showing a greater number of annual rings (Therrell and Stahle, 2012). The tobacco barn was built using multiple types of tree species, though principally pine (unknown species), while the main house was constructed of red oak. All the species were likely growing on the property as live samples of these trees can be found on the farm. Cores pulled from the tobacco barn were sampled on joists four and higher, because the lower samples pulled out deteriorated ring structures.

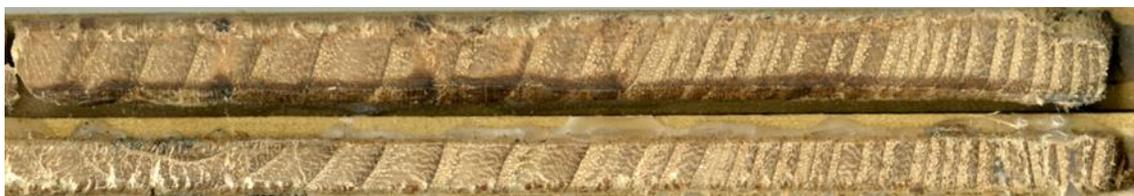
Figure 5. Cores (MH_01A_01B) Pulled from the Front Porch Dating to 1866 (Top) and 1864 (Bottom).

Core	Begin Year	End Year	Years	Correlation
MH_01A	1835	1866	32	0.548
MH_01B	1836	1864	29	0.443
MHS_01A	1857	1877	21	0.782
MHS_01B	1858	1878	21	0.686
MHS_01C	1857	1873	17	0.834
MHS_01D	1858	1874	17	0.826
MHS_02A	1818	1878	61	0.409
MHS_02C	1837	1867	31	0.548
MHS_02D	1832	1858	27	0.564
MHS_02F	1772	1802	31	0.524
MHS_03A	1835	1872	38	0.604
MHS_04B	1771	1855	85	0.604
MHS_04E	1770	1845	76	0.577
MHS_05A	1789	1828	40	0.691
MHS_05B	1789	1827	39	0.835

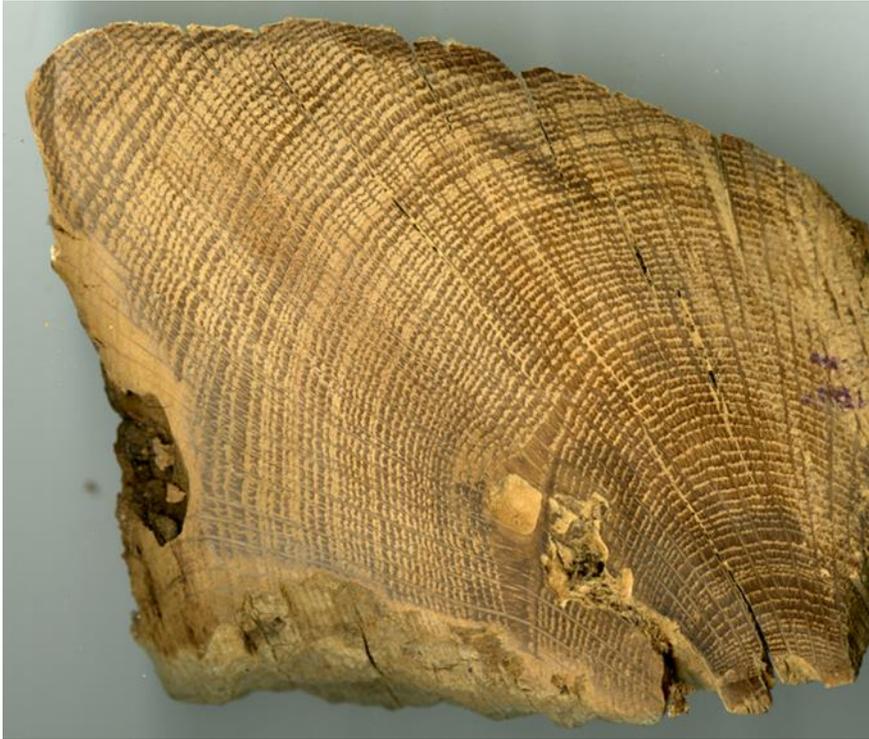
Figure 6. Slab MHS_04, This was the Slab used to First Match up Against the Montane Longleaf Pine and Correlate with the Other Red Oak Cores 1771–1858.

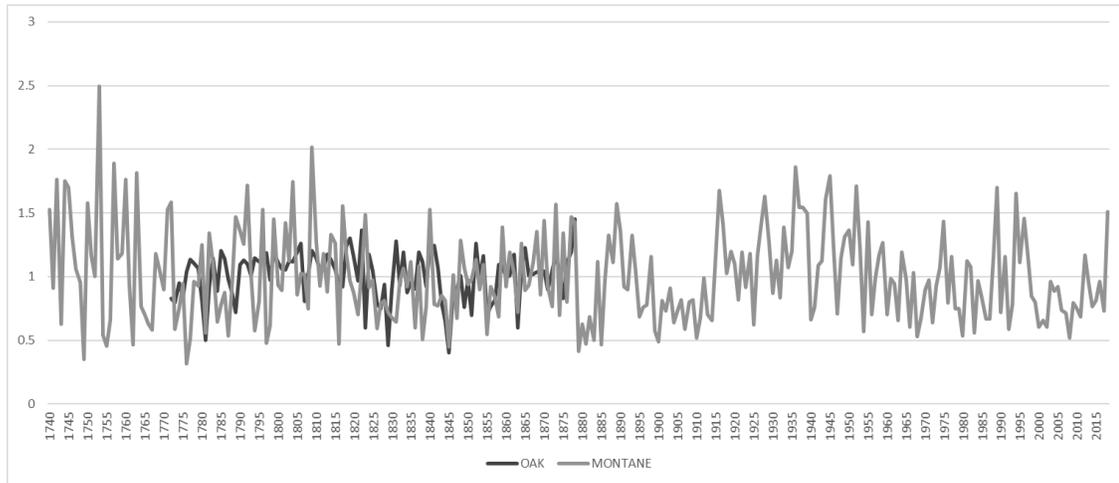
Figure 7. Standardization of Oak vs. Montane from 1772–1878. The Montane Chronology EPS is 1790.

The montane chronology was used to ensure accurate crossdating for the oak chronology. Even though the chronologies are different species the interseries correlation between them is high (0.548). The longleaf pine chronology used was developed from 50 samples (Mitchell *et. al.*, 2019), resulting in high-correlating trees that can thus be used to match to the oak trees. The montane chronology is approximately 96 km distant and located under similar climate conditions. The montane chronology ranges from 1740–2018 with an EPS of >0.85 beginning at 1790 (Mitchell *et. al.*, 2019).

The years for the standardization are 1772–1878 for oak because of 1770–1771 did not have enough data (i.e. only one core) to standardize and was askew. The years 1865, 1855, 1845, 1822, and 1780 are great marker years (i.e. suppressed growth) for oak and correspond to the same years in the montane chronology. By seeing a similar pattern within the oak and montane chronology it shows that different species can be matched up by using drought marker years that are seen only in latewood.
