ABBREVIATED HISTORICAL STRUCTURE REPORT ON THE LUCAS MANSION
IN HIDDENITE, NORTH CAROLINA

A Thesis
by
LEAH EILEEN SIMMERMAN

May 2017
Department of Sustainable Technology & the Built Environment

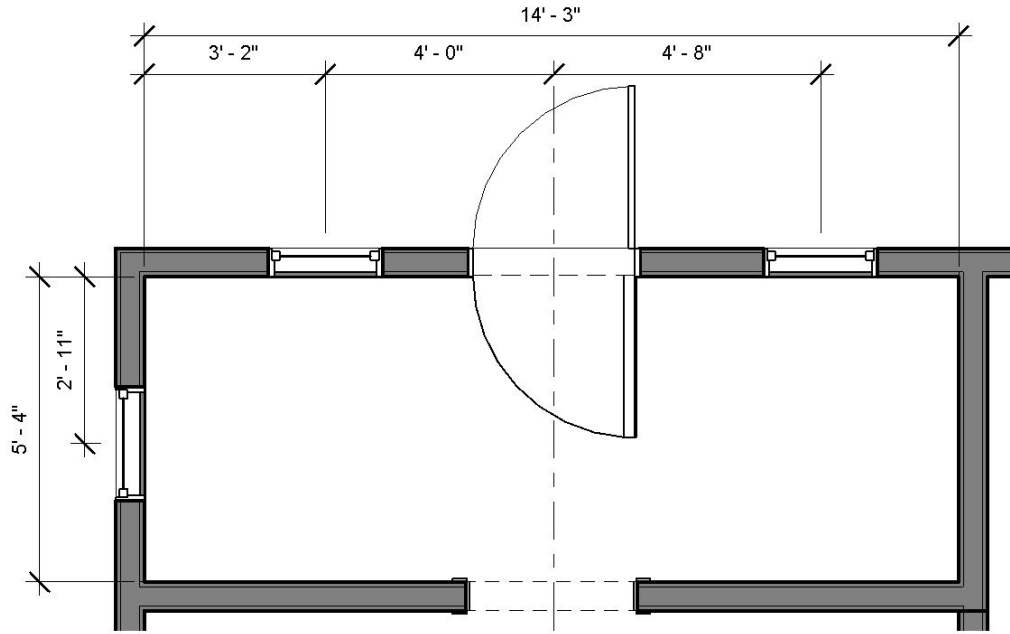
Figure 6. Floor plan of room 217.

Interior finishes of the two exterior walls in gallery room 217 were removed to expose the interior of the wall (Figure 6). Like the other gallery spaces, room 217 is a relatively small five-foot by fourteen-foot space that contains two exterior walls, two interior walls, a door, and three windows that are covered over from the inside. The floors and walls, including the doors and windows, were carpeted in a previous (1981) renovation. The windows are fully covered and indistinguishable from the surrounding wall and the doors have a second door covering them from the inside that closes flush with the wall. The doors are still operable, but the windows are not. Exhibition room 217 was chosen for this portion of the study for a variety of reasons. First, the room contains elements, finishes, and problems typical of all the other gallery rooms (i.e., it is representative of the gallery space as a whole). Second, restricting the destructive investigation to a small room limited the potential damage to historic materials. Lastly, Room 217 is located such that the remaining second-floor gallery spaces operated normally while the study was going on. The west and north walls were chosen because they are adjacent exterior walls. Their adjacency allowed for the evaluation of exterior corner conditions. The condition of the three historic windows and door was also evaluated. The window and door conditions, the assembly materials, the size of members, and the construction style were recorded in field notes and photographs.⁹

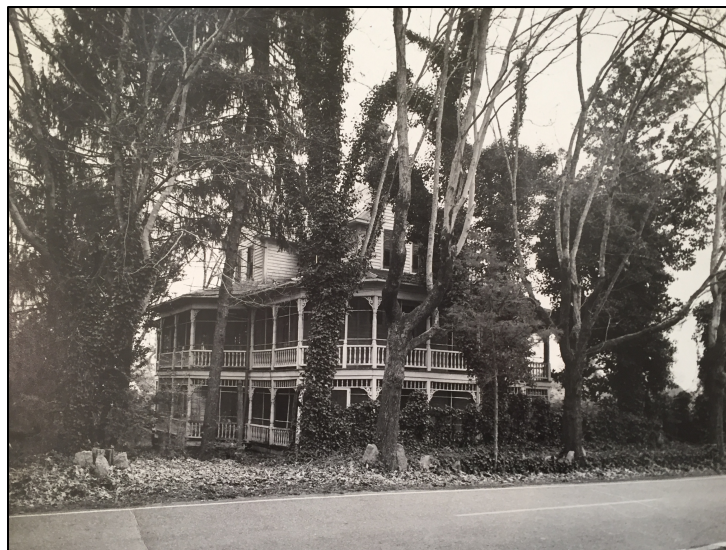
After Lucas' death on July 15, 1952 his collections and home were sold at a public auction in Hickory, NC. Two out-of-state families bought Lucas' house and used it as a summer home and hunting lodge for years. Eventually the house stood vacant, falling into disrepair (Figure 15) until Eileen Lackey Sharpe of Winston-Salem bought it in spring 1981 (Cross & Southern, 1981). Sharpe described Lucas Mansion at the time she purchased it in her book as a "dilapidated twenty-two room mansion encased with brambles, briars, and kudzu, and surrounded by privet hedge and broken down fence" (1984, p. 9).

Figure 15. Lucas Mansion fell into disrepair for several years (Approx. 1980) (scanned copy of photograph in the Hiddenite Arts and Heritage Center's archival collection).

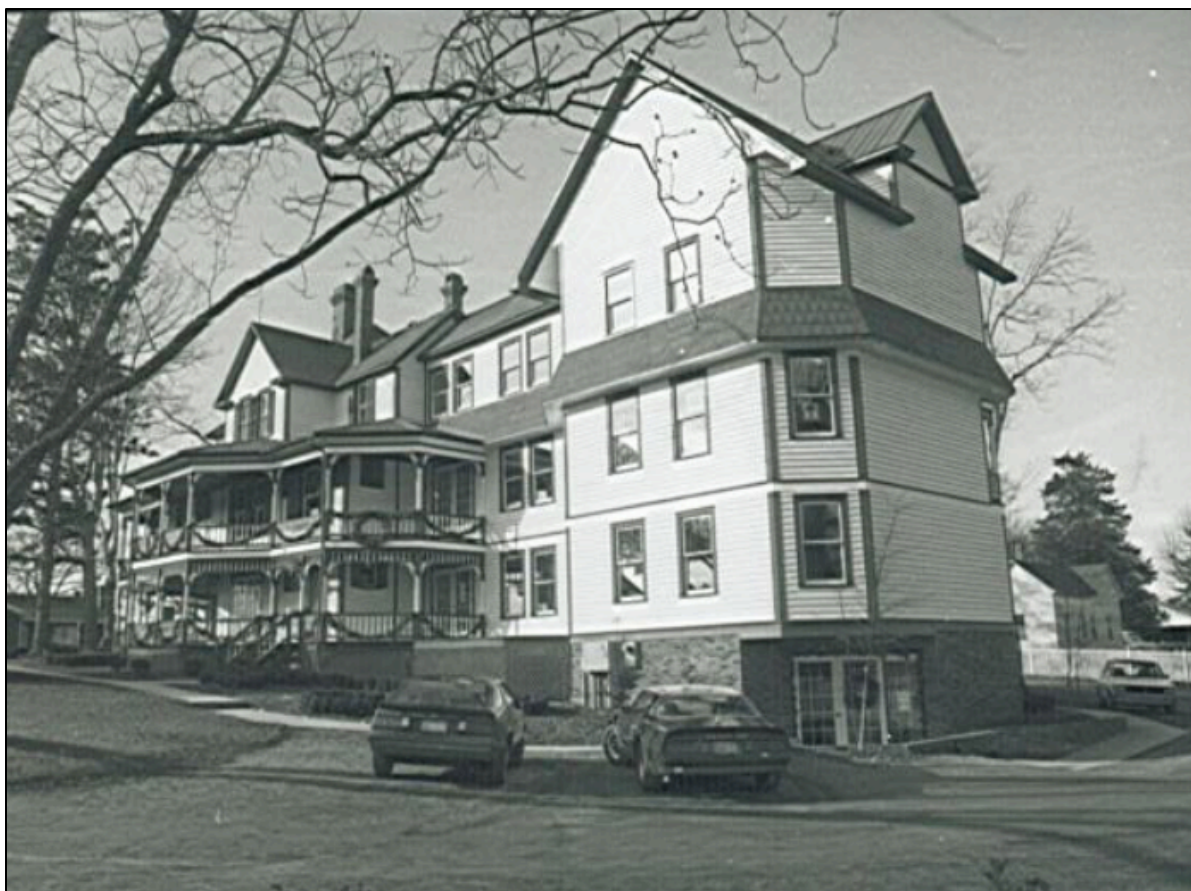
Goode also designed and oversaw the construction of an attached four-story tower that added more than 3,600 square feet, more than doubling the size of the building (Figure 18). The addition was designed to match the existing building architecturally and included accessible restrooms, elevators, a staircase, reception areas, display space, storage space, and offices (Coley, 1990).

Figure 18. Photo taken shortly after the completion of the addition (scanned copy of photograph from the North Carolina Preservation Office's file on Lucas Mansion).¹²

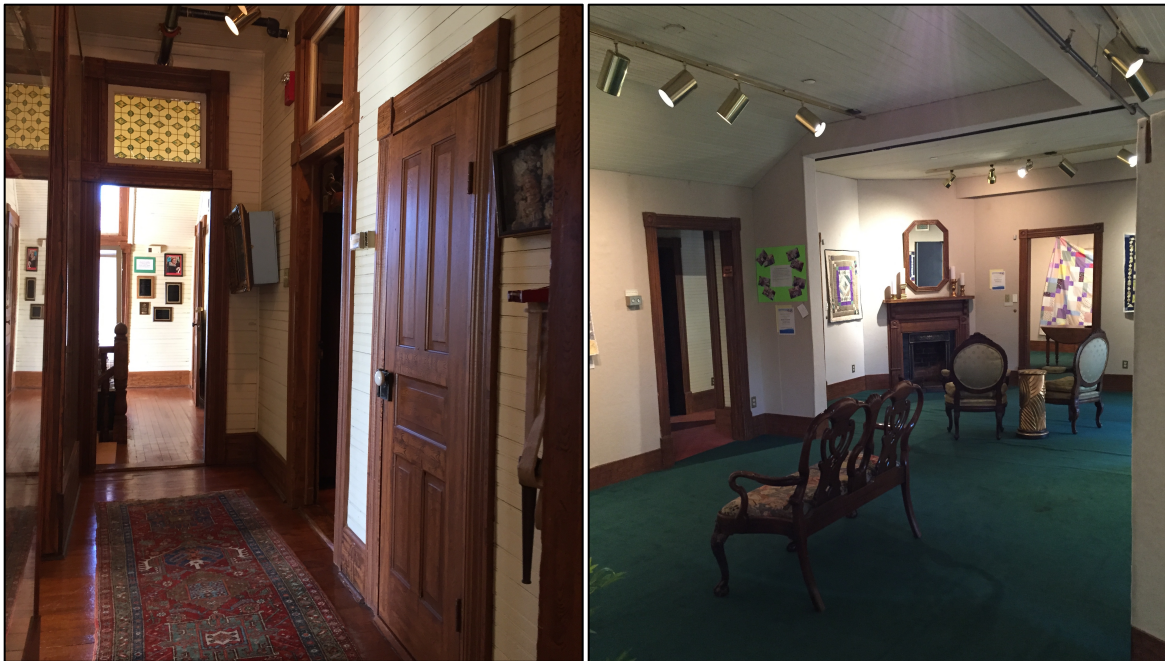
Figure 20. Left: photograph of room 313, which has most of its historical character intact. Right: photograph of the main gallery room (room 215), which had a significant amount of its character-defining elements removed or covered.

The window and door trims on the exterior walls of the gallery space were removed during the 1980s renovation. The removal of this trim unquestionably impacted the character of the space. These rooms now feel lopsided, with the heavy visual impact of wood only on their interior sides. The original baseboards were kept in the gallery spaces, but when compared to photos from the early 1980s it appears that the shoe mold that sat on top of the baseboard was

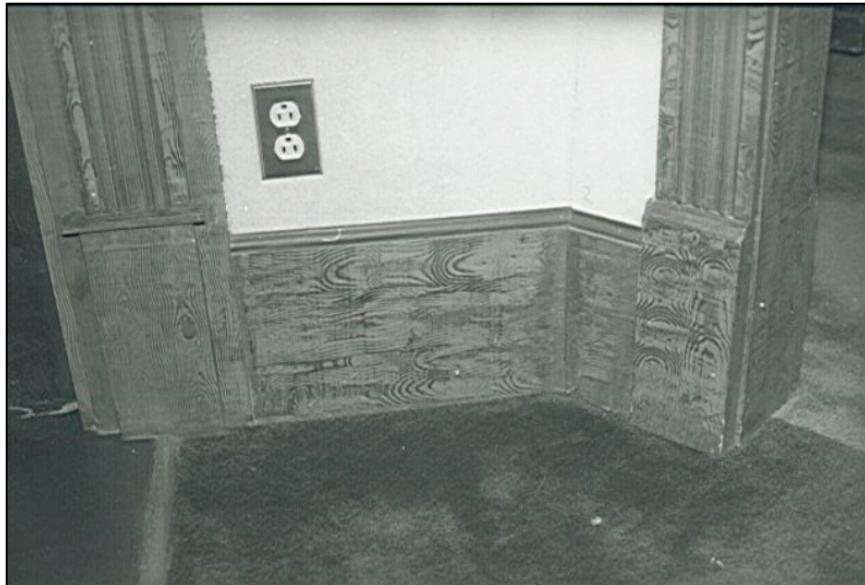
removed at some point after the renovation (Figure 22). Considering baseboards in the building that were not carpeted, it is also likely that the baseboards originally had a base shoe mold as well (A. Houchins, personal communication, December 10, 2016).

Figure 22. Photograph from early 1980s of baseboard, base of doorframe, and base of fireplace in gallery room 216 (scanned copy of photograph from the North Carolina Preservation Office's file on Lucas Mansion).

The shoe molding that once sat on top of the baseboards in these rooms should also be replaced. It can be seen in photographs from the early 1980s that a shoe mold with an angled

profile like that in the hallway of the second floor once sat on top of the baseboard. The baseboards themselves are reportedly original and should be retained and protected during the renovation (A. Houchins, personal communication, December 12, 2016).

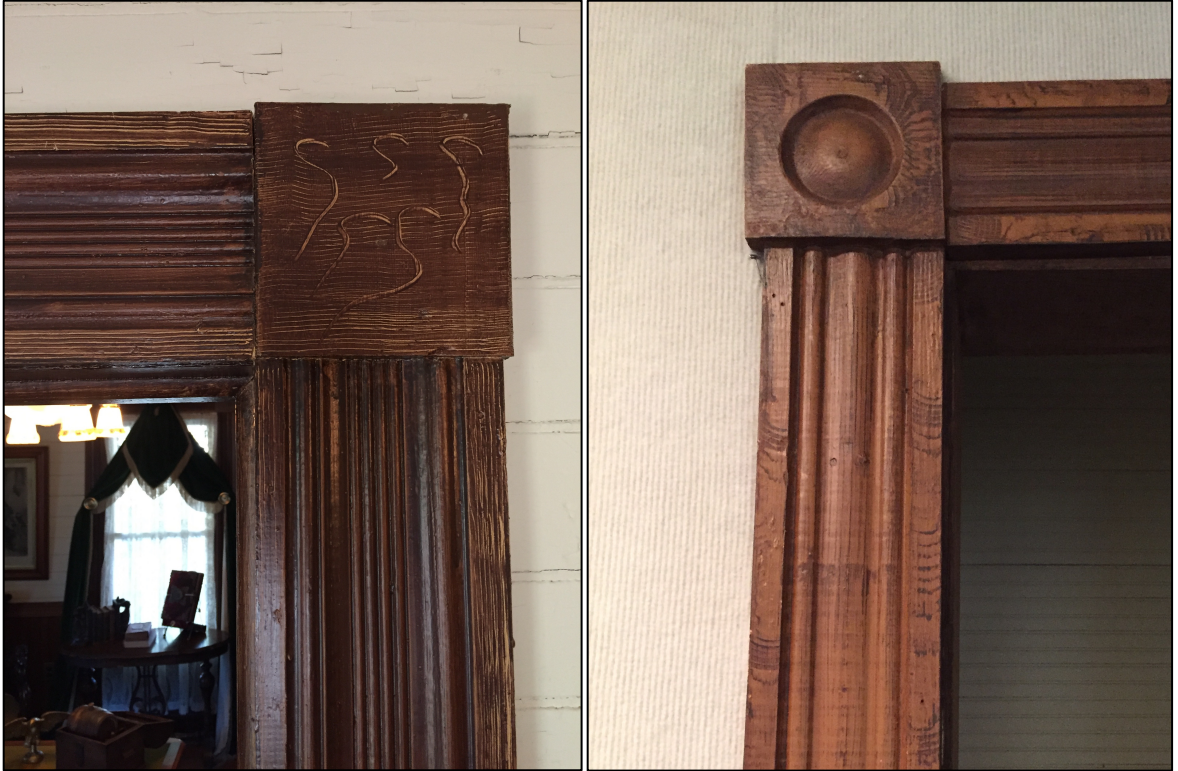
All of the trim and baseboards in the building were originally wood grained. Wood graining is a decorative paint technique that imitates the look of wood. This technique is used to make non-wood surfaces look like wood or to make cheaper wood look like a more desirable species. The only places in the building where the original wood graining survives are the two front rooms (rooms 115 & 114) on the first floor. When Mrs. Sharpe bought the building some of the trim had been painted over and many other areas were peeling beyond repair. The majority of the moldings, doors, and fireplaces in the building had to be stripped down to the wood and redone with wood grained finish in the 1980s renovation (Cross & Southern, 1981; A. Houchins, personal communication, March 27, 2017). The appearance of the restored wood graining on the second and third floors is clearly different from the original (Figure 23).

Figure 23. Left: Original wood graining on a doorframe in the historic entry (room 115) on the first floor. Right: redone wood graining in main gallery (room 215) on the second floor.

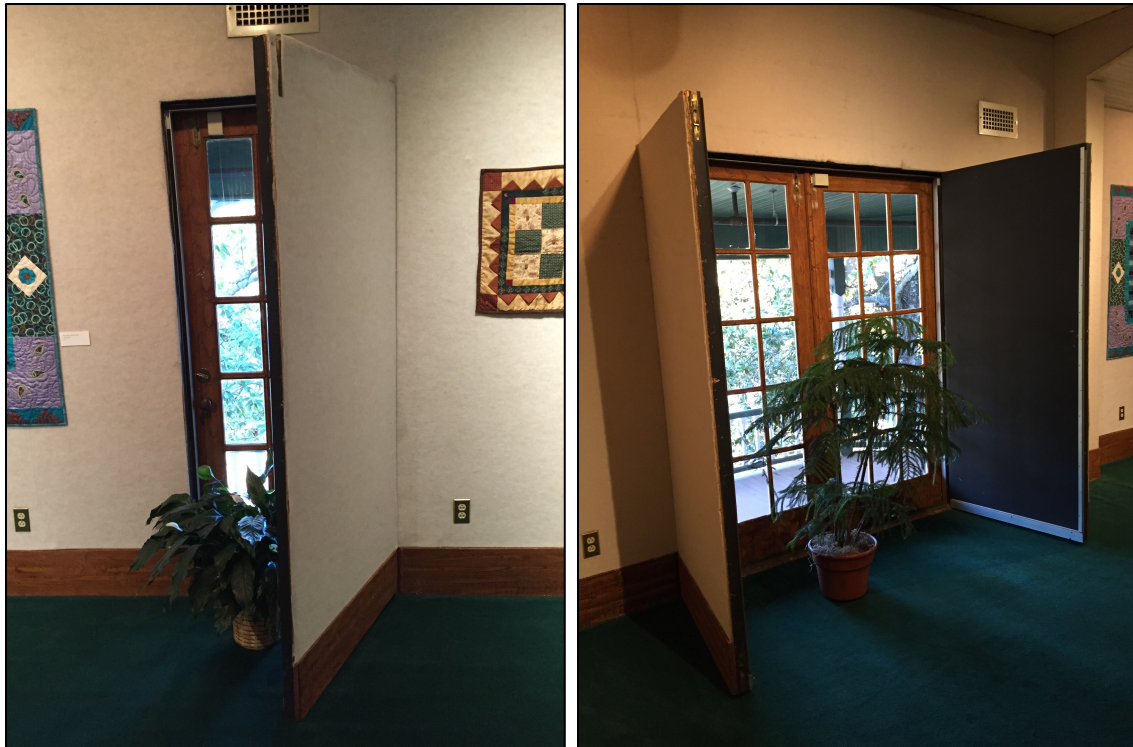
The exterior doors of the gallery rooms had a second door installed over them during the interior in the 1980s renovation (Figure 25). These doors are painted solid black to the exterior side and have the same carpet finish as the walls to the interior side. The carpeted doors close flush to the interior walls, with the baseboards continuing across their base, and have no hardware except a bolt latch in their upper corner. These doors are extremely well sealed with continuous weather stripping all the way around them. All four of the exterior doors off the gallery space received this treatment. The original doors underneath are paneled glass that is wood grained on the interior and painted white on the exterior. Three are single doors and one is a French door. The original doors have a mix of original and new hardware. Each door has a newer brass-colored dead bolt, but the handles and hinges appear to be original.

Figure 25. Exterior doors of the gallery spaces.

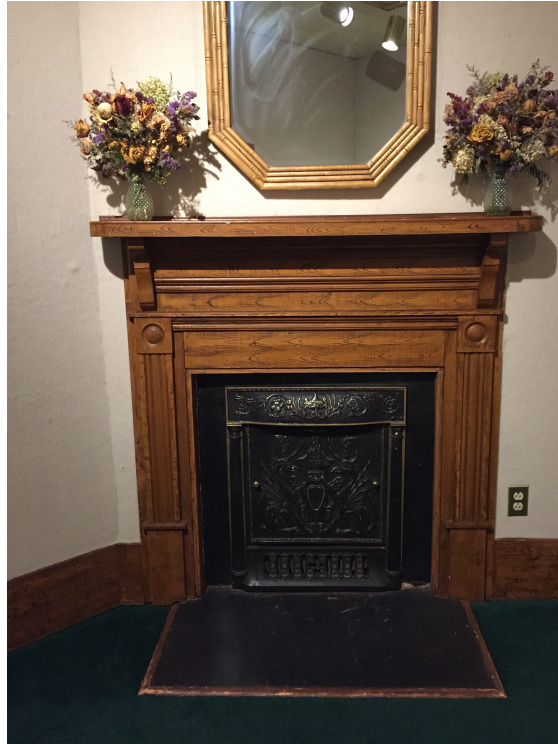
fireplaces are nearly identical, while the second floor fireplaces differ. The second floor's fireplaces are very similar in form but different in detail from those on the other two floors. The second floor fireplace surrounds utilize the unique trim found only on that floor of the mansion (Figure 26).

Figure 26. Fireplace in gallery (room 216).

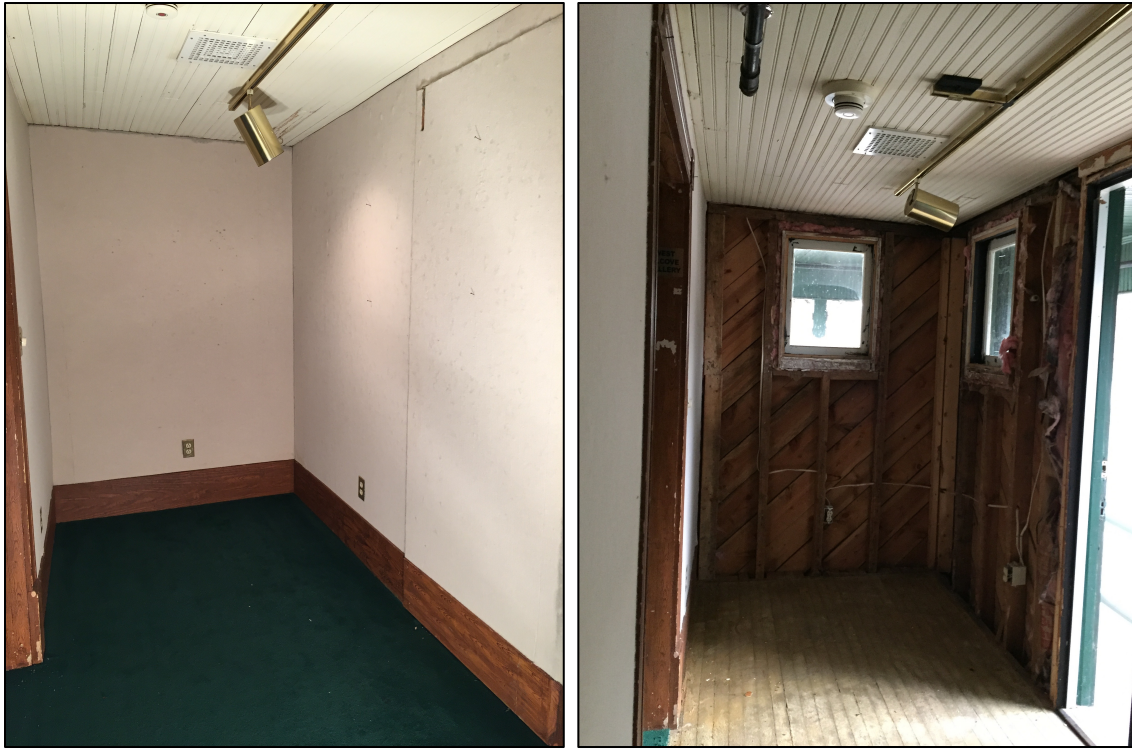
The west and north walls of gallery room 217 were disassembled from the inside to gain an understanding of the assemblies and interior wall conditions (Figure 39). From exterior to interior the wall is comprised of: painted wood clapboard siding, asphalt paper, diagonal board

sheeting, approximately 4-inch deep wood framed cavities filled with R-11 paper backed fiberglass batts, $\frac{3}{4}$ -inch plywood, and $\frac{1}{4}$ -inch hardboard covered in carpet.

Figure 39. Before and after the disassembling of the walls in gallery room 217.

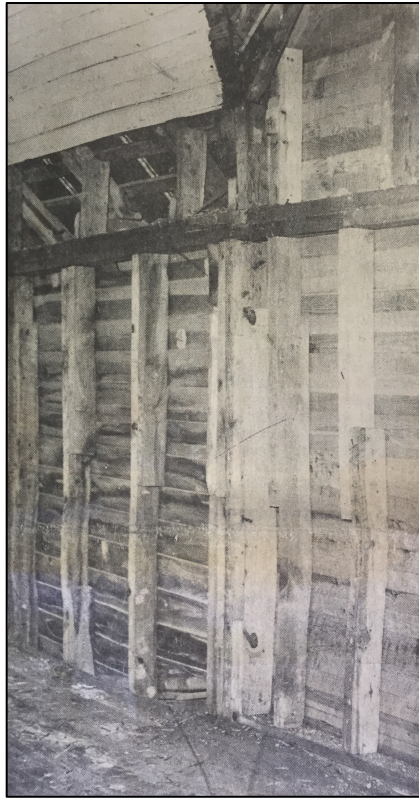
This is notably different than what was expected, in two ways. First, a photograph of the third floor during the 1980s renovation shows a wall with no exterior sheathing (Figure 40). The wall shown in that photograph has the clapboard siding applied directly to the studs. It is likely that when the second floor was added the builder used an assembly different from that used when the building was originally constructed. The presence of diagonal boards on the second floor likely makes a considerable contribution to the building's resistance to shear stress. Second, tarpaper or a similar material was found between the diagonal board sheathing and the siding. Based on photographs and descriptions by individuals who were involved in the building renovation it was not expected to find any moisture control layers in the wall. The tarpaper was

Figure 40. Photograph of 3rd floor wall striped down to the stud (Joines, 1982).

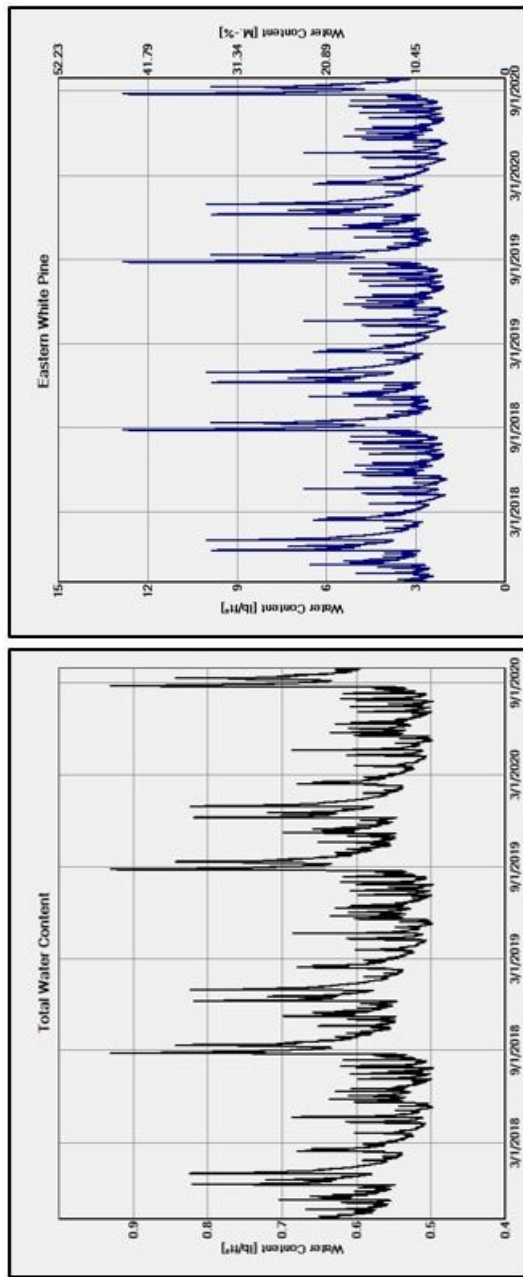
The total water content of this assembly did not stabilize during the three-year simulation. The water content fluctuated wildly, with high spikes for the entire period (Figure 42, left). Once the layers were examined individually it was clear that the siding layer was the cause. All other layers of the assembly reached a dynamic steady state, with relatively minor fluctuations in water content that followed the seasons, and ended with either lower or similar water content to what they started with. The siding, on the other hand, was marked by dramatic spikes in moisture content, likely caused by simulated weather events (Figure 42, right). A second model was run that was identical in all ways except a layer to represent paint was added to the exterior of the assembly. With this change, both the siding layer and the overall moisture content achieved a dynamic steady state (Figure 43).

Similarly, when the max water content of the wood layer of the existing wall modeled without paint was converted to mass percent by dividing the water content by the material's density it was found that all layers stayed under the 20% threshold for the duration of the test, except the siding layer (Table 6). The water content of the siding reached as high as 44.74%. It can be seen in the graph depicting the water content of siding that this high percentage corresponded to large spikes in the moisture content, and was not sustained (Figure 42, right). The hourly data were analyzed to determine whether the siding exceeded the 20% threshold for decay potential 8.7% of the testing period. This would typically indicate rot, but in this case it was most likely the result of choosing to run the worst-case scenario and not accounting for the paint layer that helps protect the siding. The model with a paint layer added had a maximum moisture content of only 10.41% (Table 7). Even if the actual paint does not perform as well as the paint layer in this model, it can be assumed that the existing wall performs better than the model with no paint represented at all. The actual moisture content likely sits between these two values. Further, a visual inspection of the building exterior reveals that the siding is in relatively good shape. There is very little rot on the exterior of the building, with the exception of areas that have bulk water conditions. Additionally, all the siding on the second floor is protected from direct rainfall by the deck's deep overhangs that encircle the building

Figure 42. Left: graph of the total moisture content the assembly. Right: Graph of the moisture content of the siding. Both are from the WUFI ® model of the existing wall without a layer representing paint.

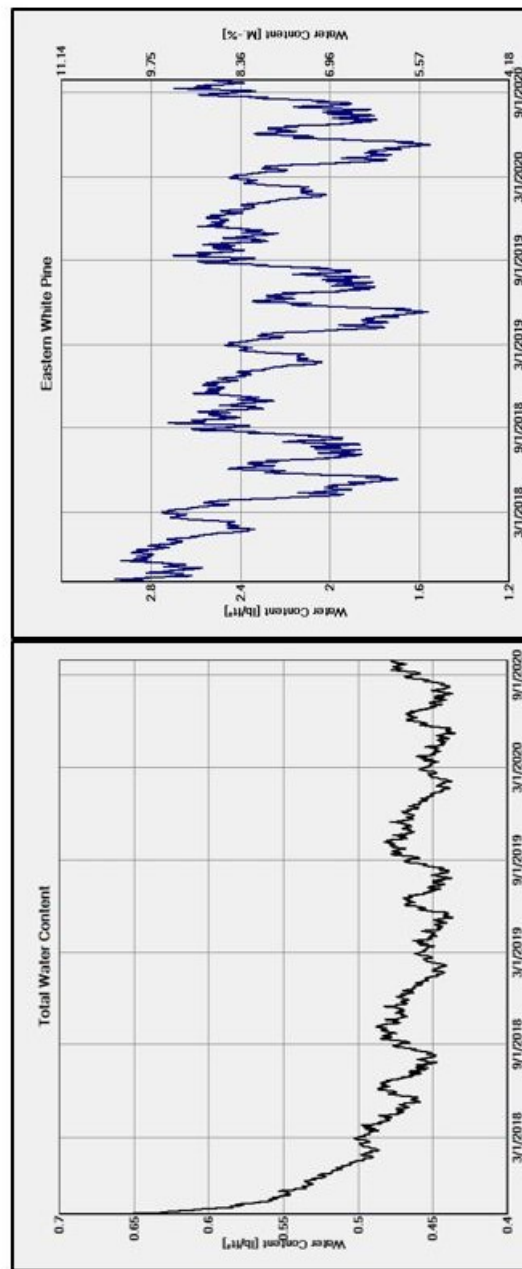
Figure 43. Left: graph of the total moisture content the assembly. Right: Graph of moisture content of the siding. Both from the WUFI ® model of the existing wall with a separate layer representing paint.

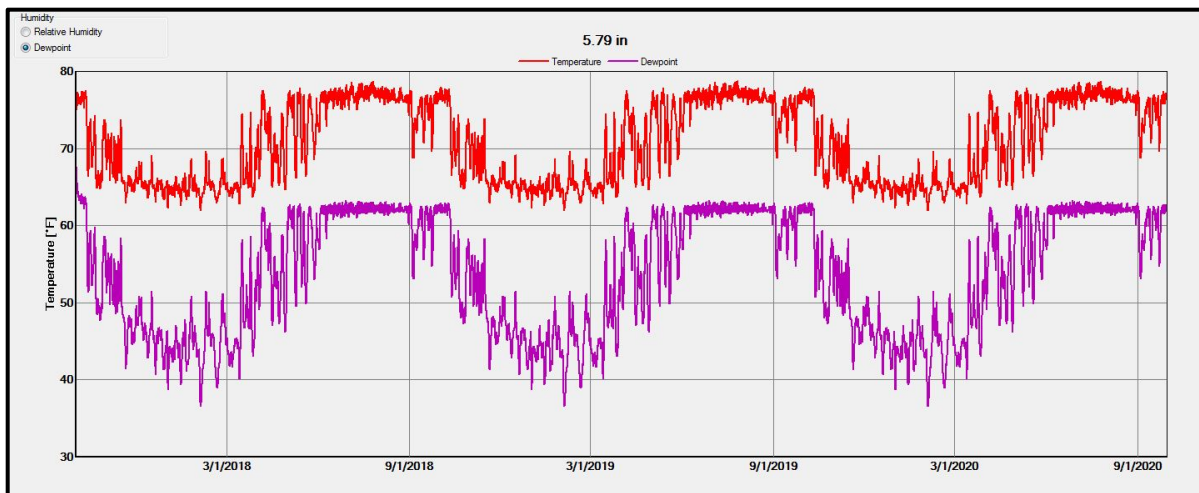
Dew point was examined alongside dry bulb temperature at several points in the assembly, including each side of every sheathing layer (i.e., diagonal sheathing boards, plywood, gypsum wall board, hardboard). At each monitoring point the dry bulb temperature remained above dew point at all times. At the monitoring points close to the exterior the temperature and dew point follow each other closely but did not cross (Figure 44). The distance between dew point and dry bulb temperature gradually increased as the monitoring points moved closer to the interior (Figure 45). This shows this assembly, as modeled, has no condensation potential from vapor diffusion. However, it is important to note that these calculations do not account for air infiltration, which could have a significant effect on condensation potential.

Figure 45. Dry bulb temperature and dew point of the existing wall model at a monitoring point between the plywood and hardboard layers.

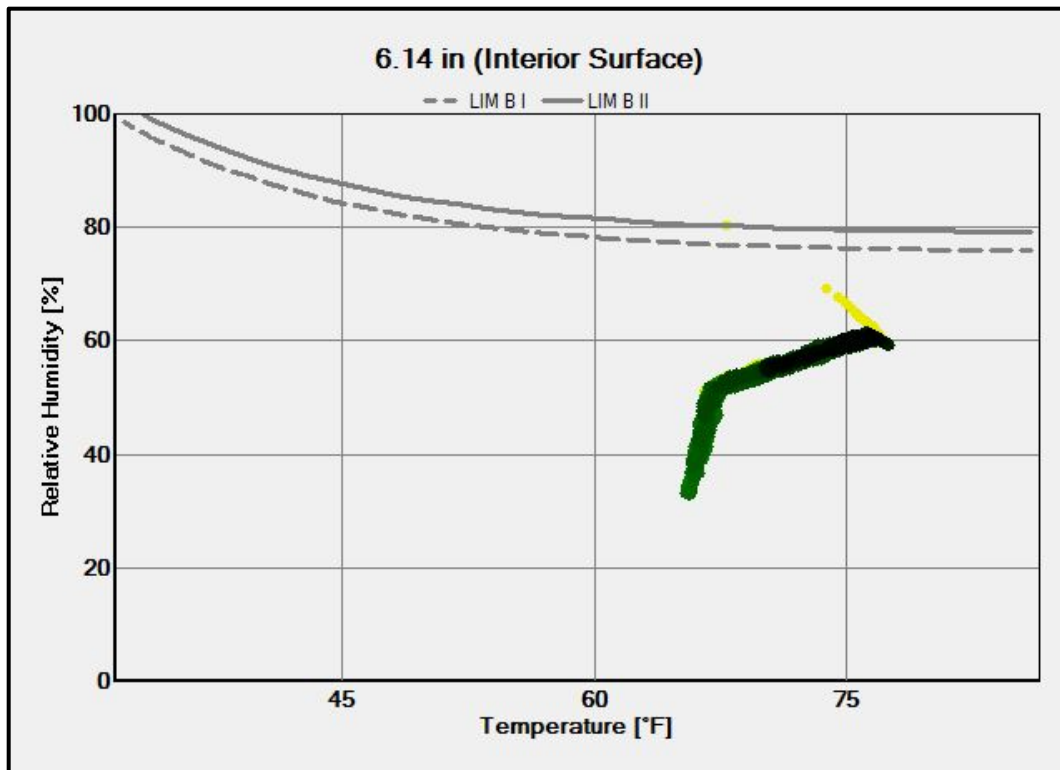
The isopleth graph, created by WUFI®, shows that the condition on the interior surface of the wall never exceeds the lowest isopleths for mold for either class of substrate (Figure 46). This alone is not sufficient for a firm assertion that mold will not grow, so the model was also run through WUFI-Bio (Mantha & Arena, 2012). WUFI-Bio indicated that the wall assembly had very low mold growth potential (Figure 47). It gave the assembly a green light; indicating that the total mold growth potential is less than 1.96 inches per year.

Figure 46. Screenshot of isopleth graph produced by WUFI® showing the modeled condition of the interior surface never exceed the lowest isopleths for mold.

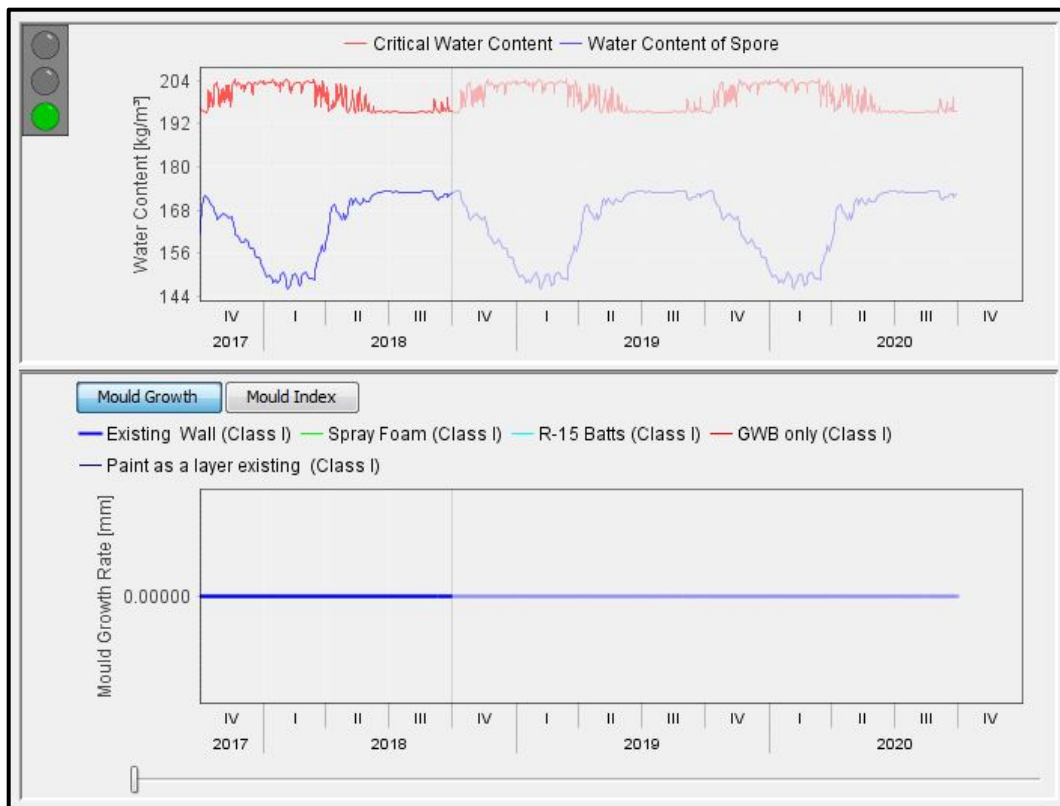
Figure 47. Screenshot of results graph produced by WUFI-Bio showing the modeled condition have little to no mold growth potential.

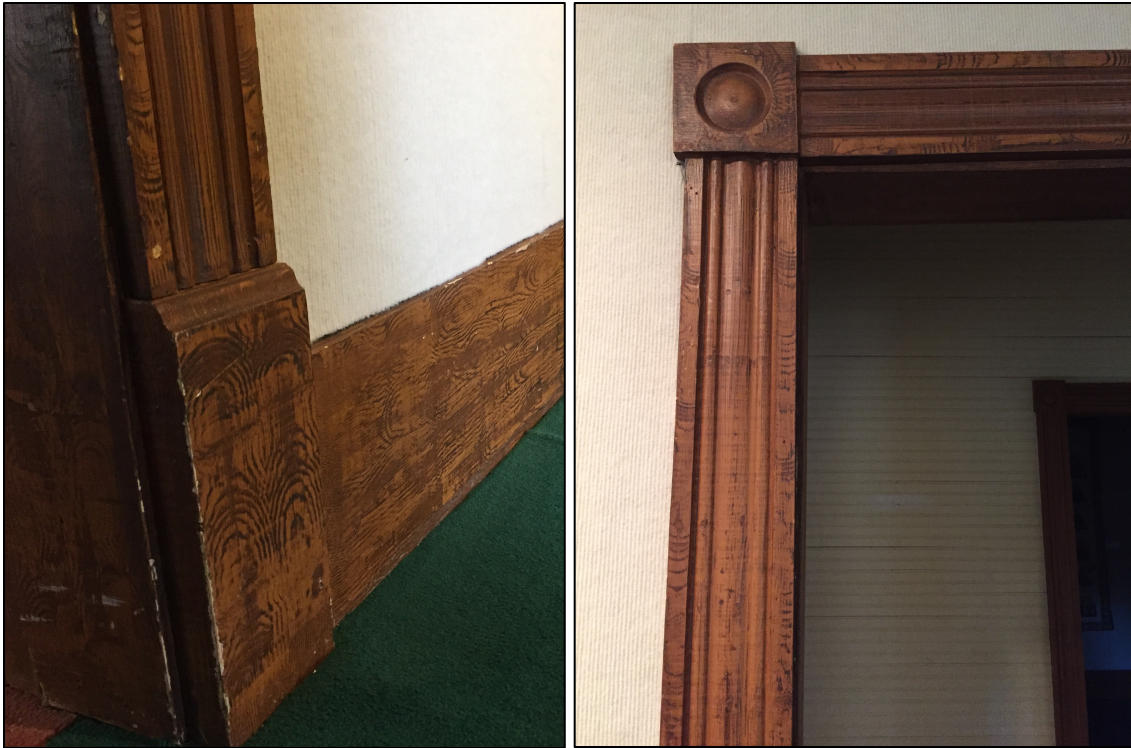
Figure 49. Surviving original moldings in the second floor gallery spaces.

The trim on the second floor is unique from the rest of the building, likely because this part of the building was added later in the unusual addition completed by James Lucas in the early 1900s. The reproduction molding to be installed around windows and doors should match profiles of the other historic trim on the second floor, including bull's-eye corner blocks and plinth blocks (Figure 49).
